PRE-CONSTRUCTION TREE EVALUATION FOR LARK STREET CORRIDOR IMPROVEMENTS

Jay Lavigne, City Arborist
ISA Certified Arborist and Municipal Specialist, NE-7257 AM
Massachusetts Certified Arborist MCA-2534
June 1, 2023

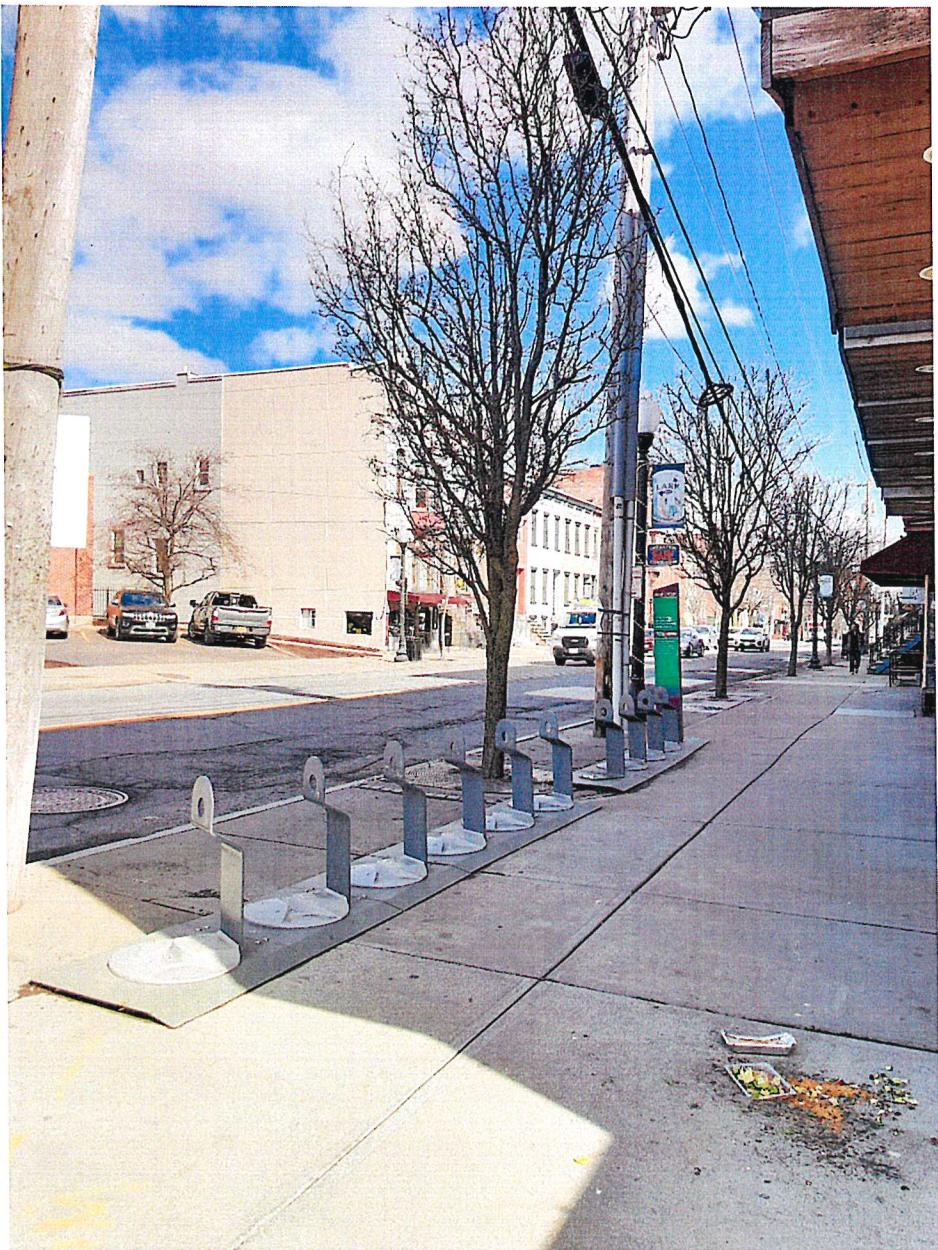
Low Branching Callery Pear at 425 Madison Avenue with bike racks around it and between two utility poles carrying Primary, Secondary, and Voice/data overhead.

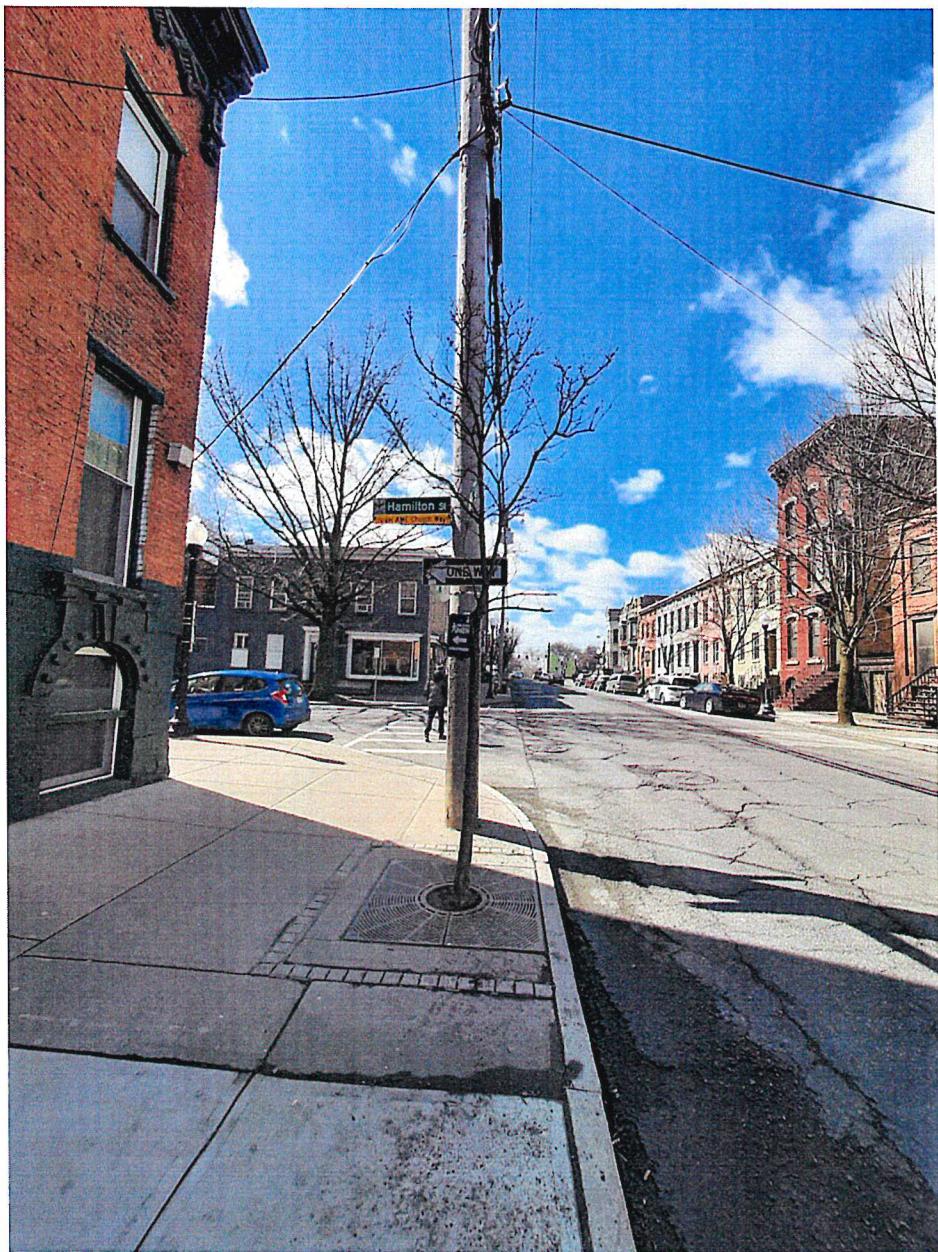
There is only one tree lilac in the project area at 284 Lark Street. Tree lilacs are another very hardy introduction from Asia that is now viewed as highly invasive. This tree is slated for removal due to location/construction.

Tree Lilac at 284 Lark Street. Very Close to utility pole and obstructing site lines to signage.

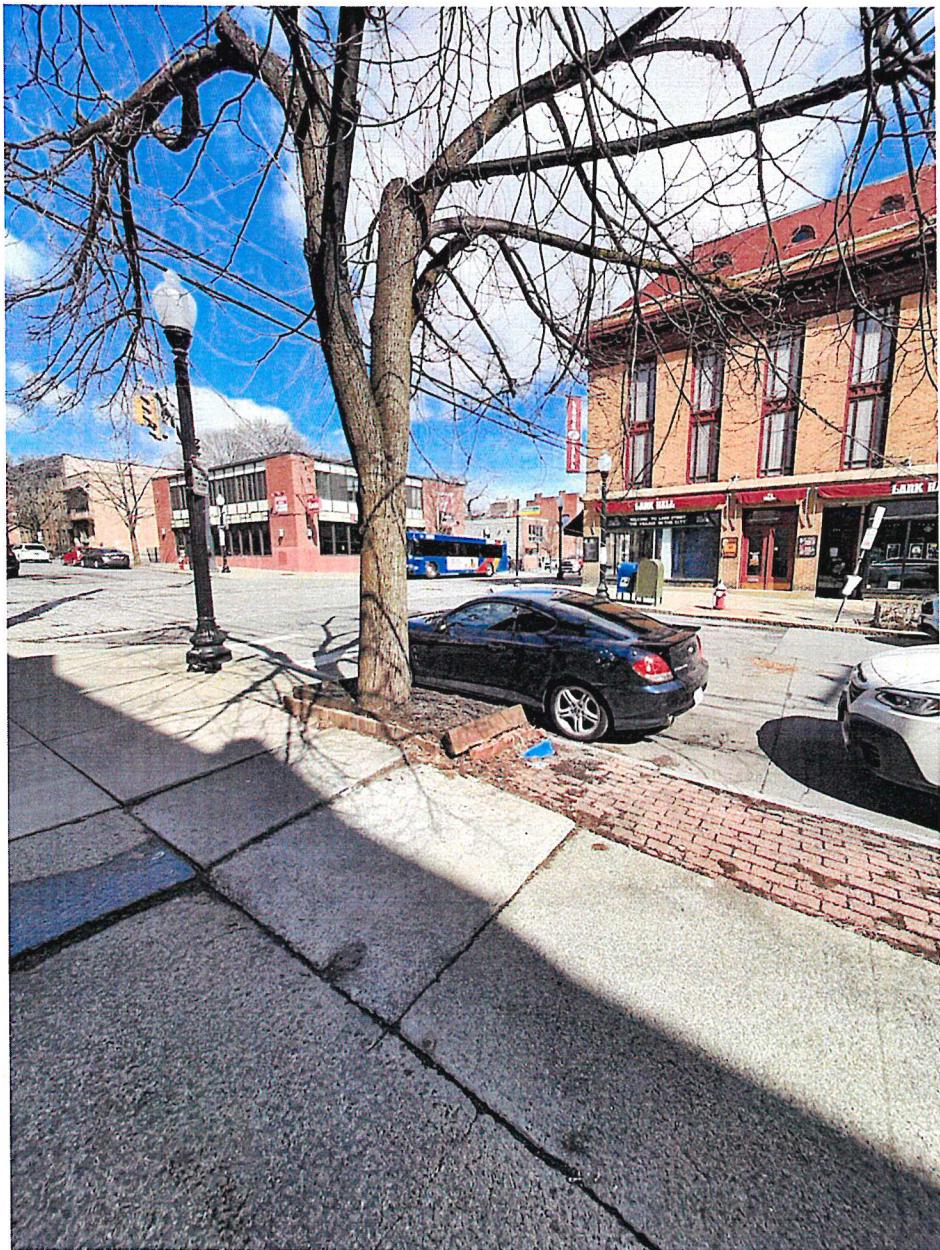
There is only one of these in the project area at 358 Hudson Avenue. It has been topped multiple times by line clearance trimming and has heaved the sidewalk in multiple places. A classic example of the wrong tree in the wrong place, it should be removed.

Topped little leaf linden with heaved Sidewalks around it at 358 Hudson Avenue. Wrong tree in the wrong place.

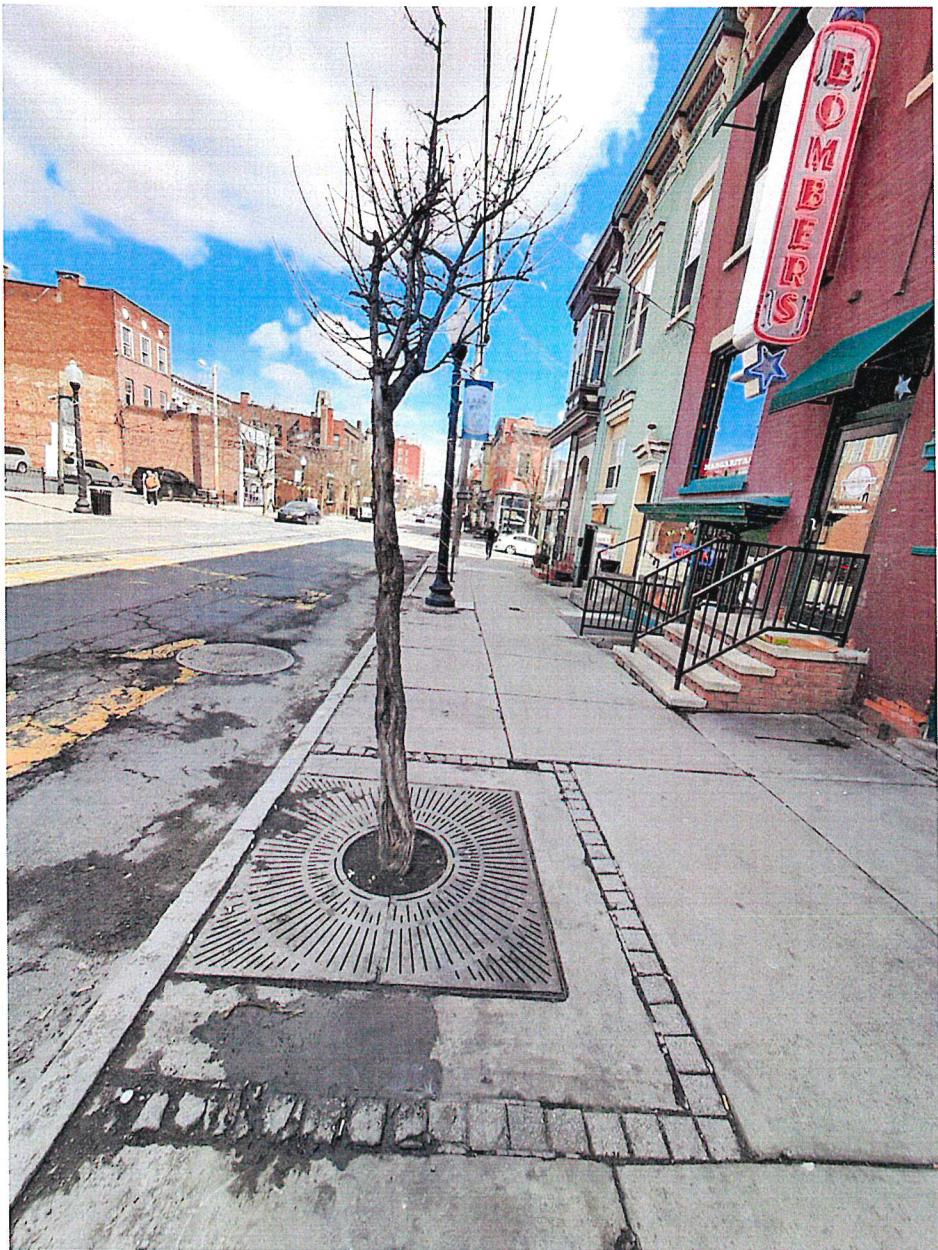
Hedge Maple at 258 Lark Street. Condition is very poor.

There are 9 small form maples planted in the project area (5 Hedge Maples, 4 'Pacific Sunset'). Some look good and vigorous, others terrible. I recommend removing the hedge maple at 258 Lark because of condition and two Pacific Sunset Maples, one at 287 Lark because of construction and another at 439 Madison due to its condition.

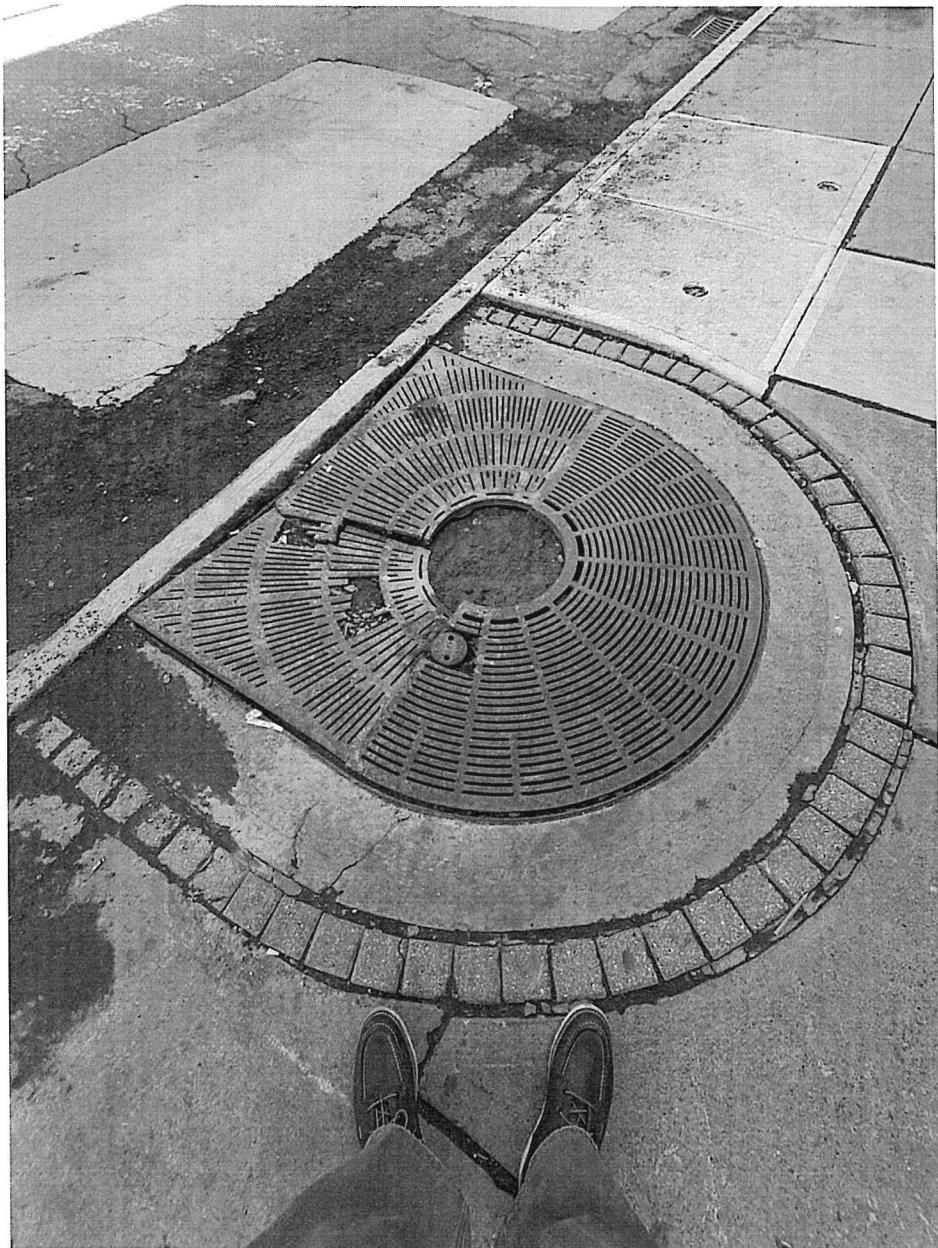
Water Valve Shut off in Tree Well at 254 Lark. Originally proposed as a planting site, if this shut off is operational, then the site should be abandoned and restored to sidewalk.

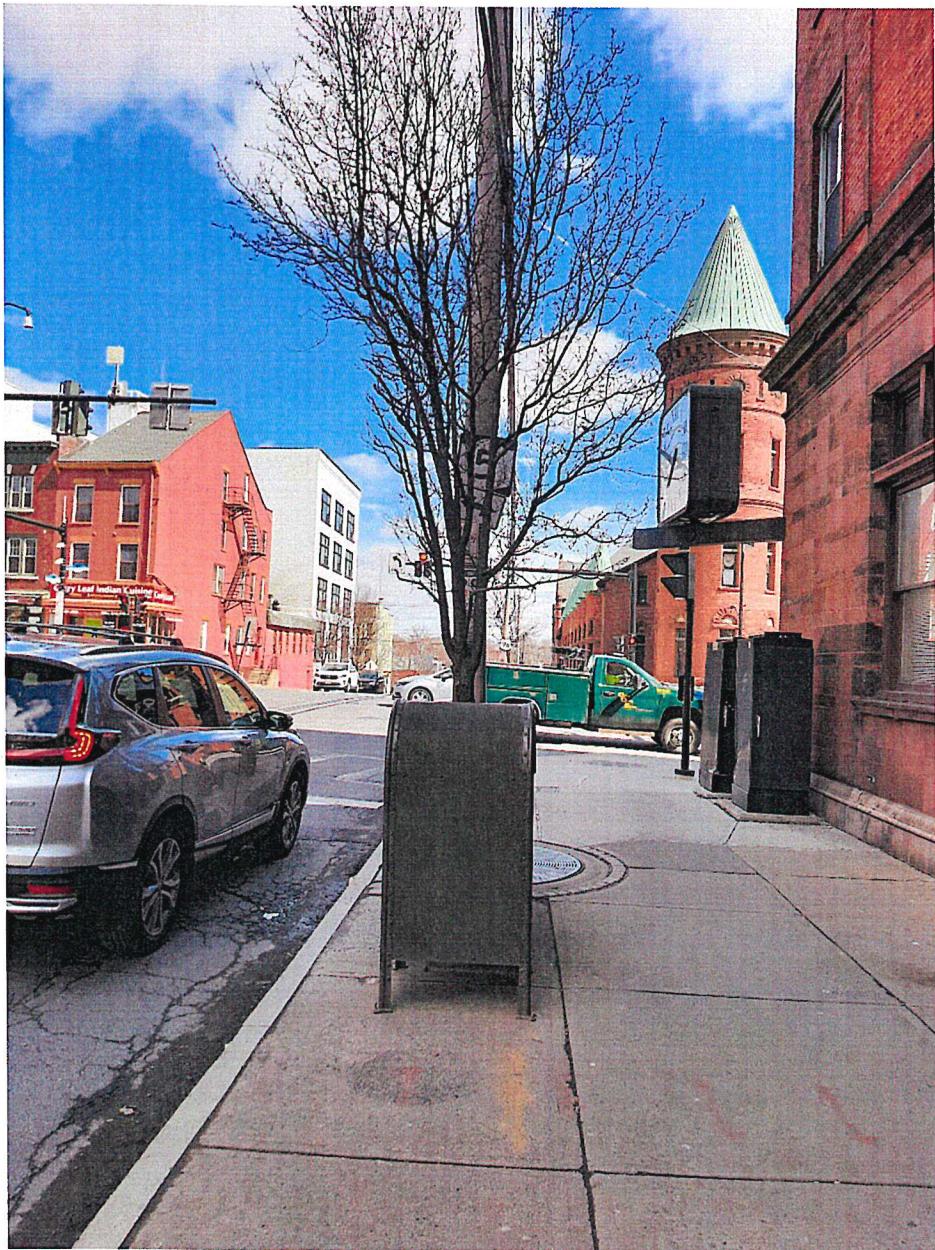
Callery Pear on Lark Street Adjacent to 196 Washington Avenue, under utilities and wedged between mail box and utility pole, blocking signage.

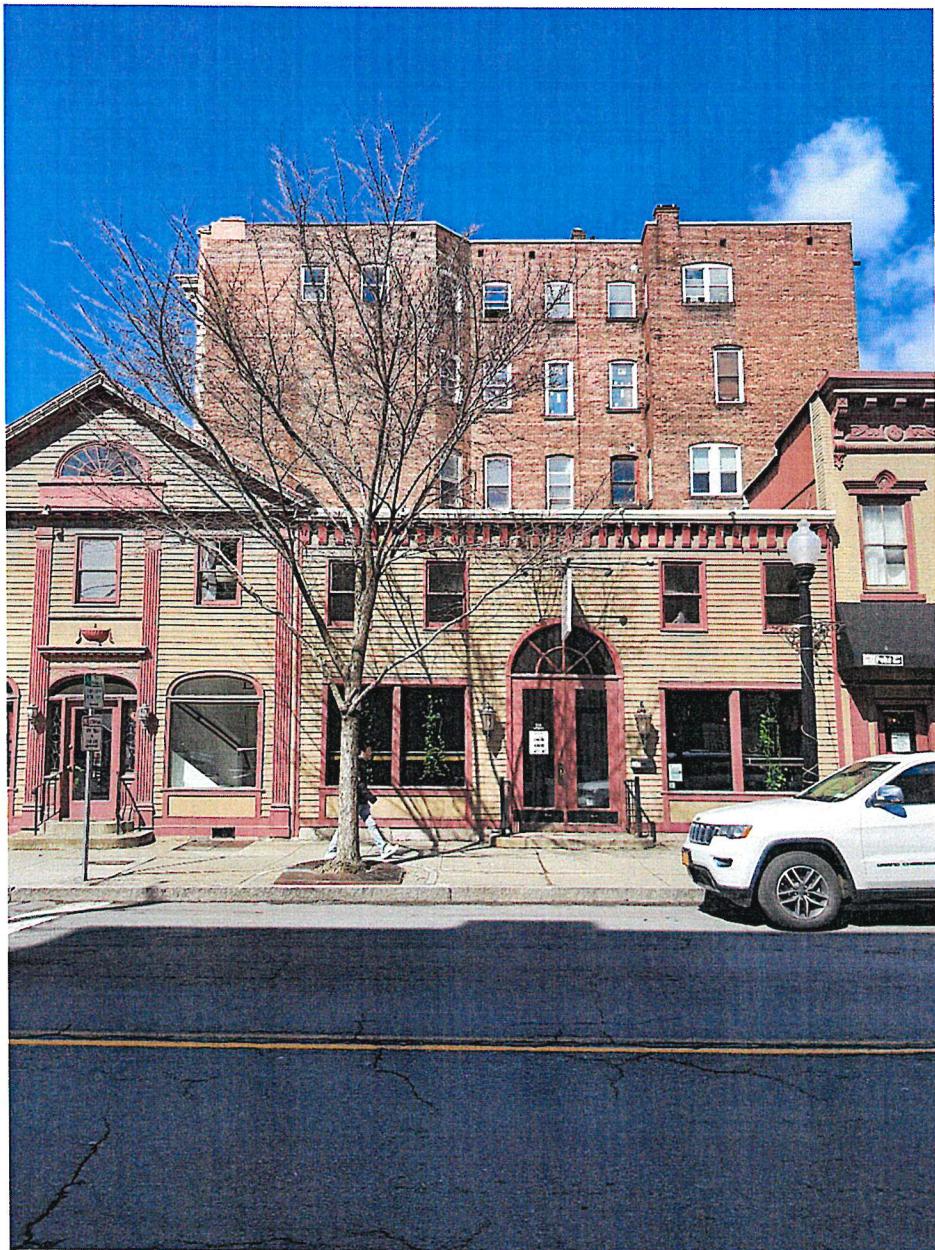
Young American Elm at 207 Lark Street.

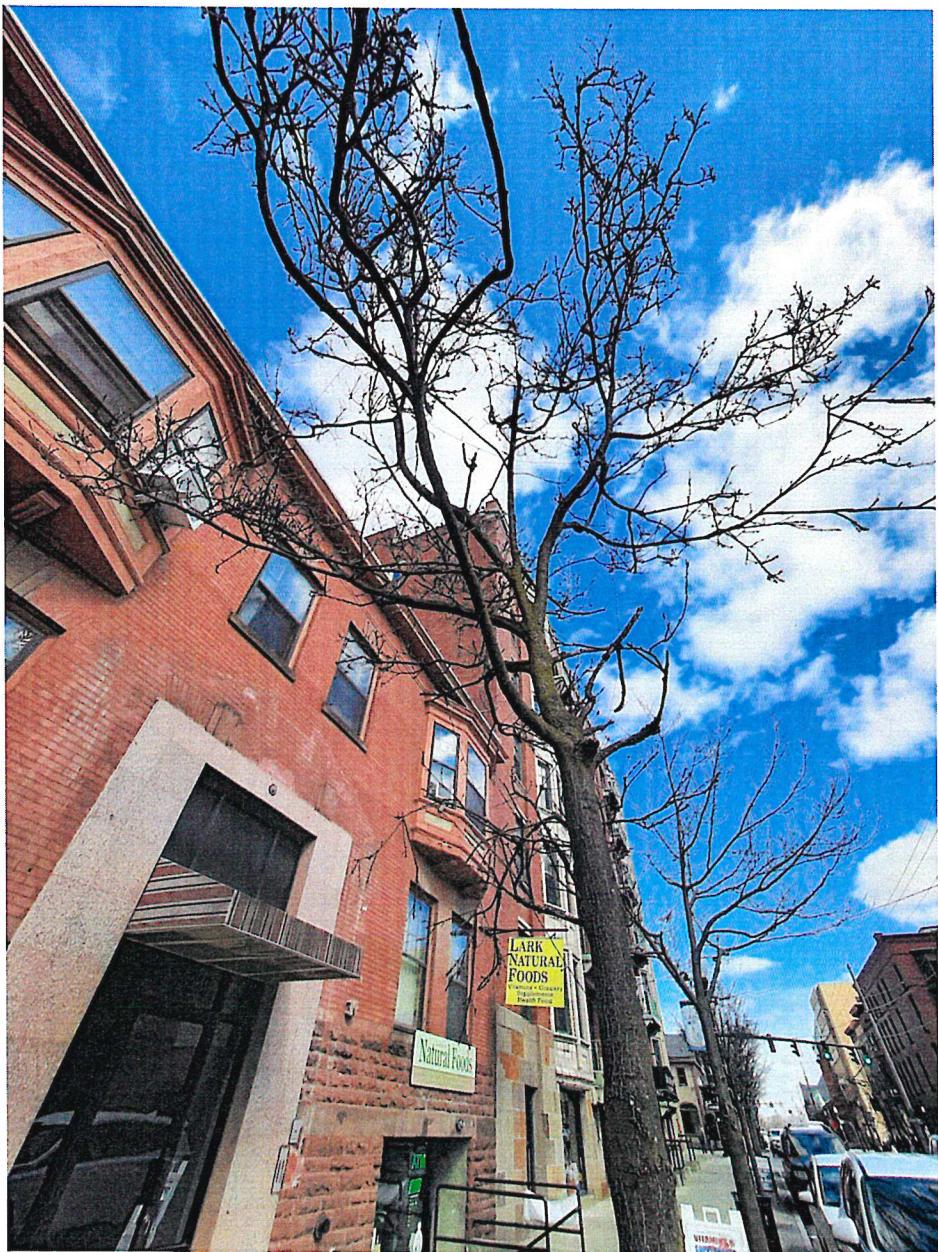
Red Oaks comprise the second most common tree species in the project area. 8 of these were planted on Lark Street after the last Improvements, however none have grown to a DBH greater than 10". They are struggling and stunted, with very dense branching and very short intervals between buds. There are all kinds of potential reasons for this, from drought stress, poor soil nutrition, compacted soils, to the impacts of artificial light on plant biology. There is no easy answer. I recommend removing the tree at 231 Lark Street due to construction.

Stunted red oaks at 219 Lark

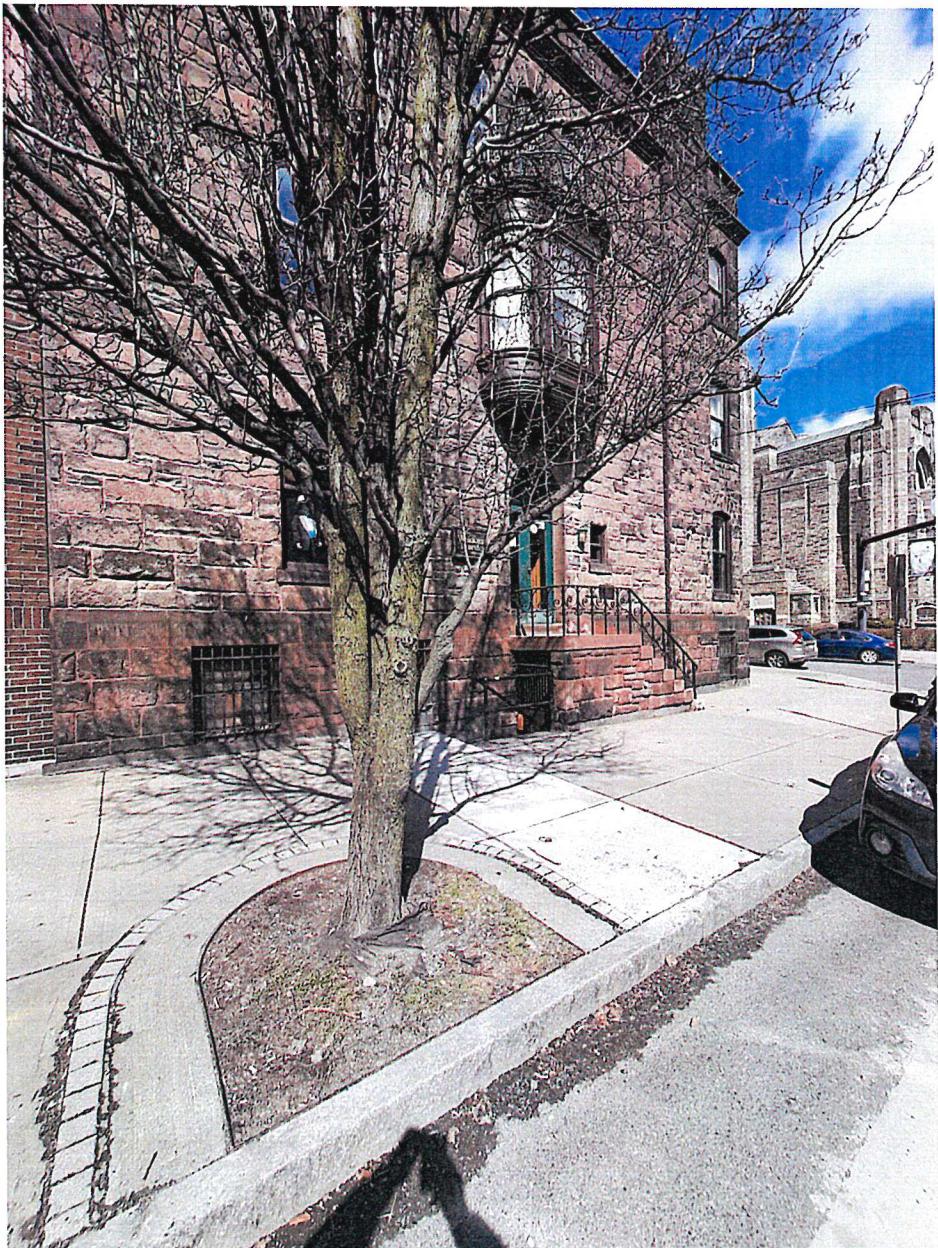
Low Branching Callery Pear on Lark Street Adjacent to 204 Lancaster Street

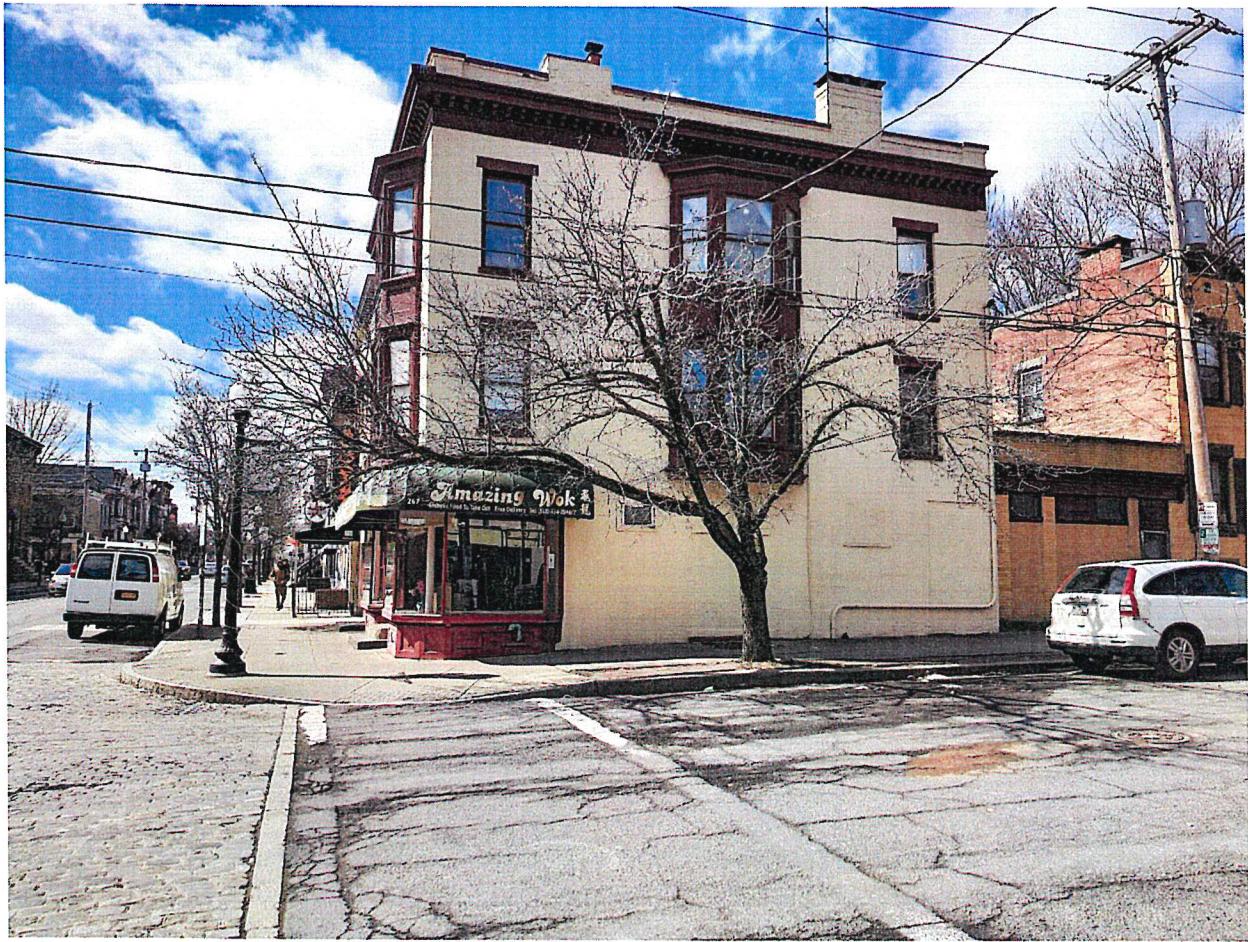
Topped and reaching Callery Pear at 267 Lark Street.

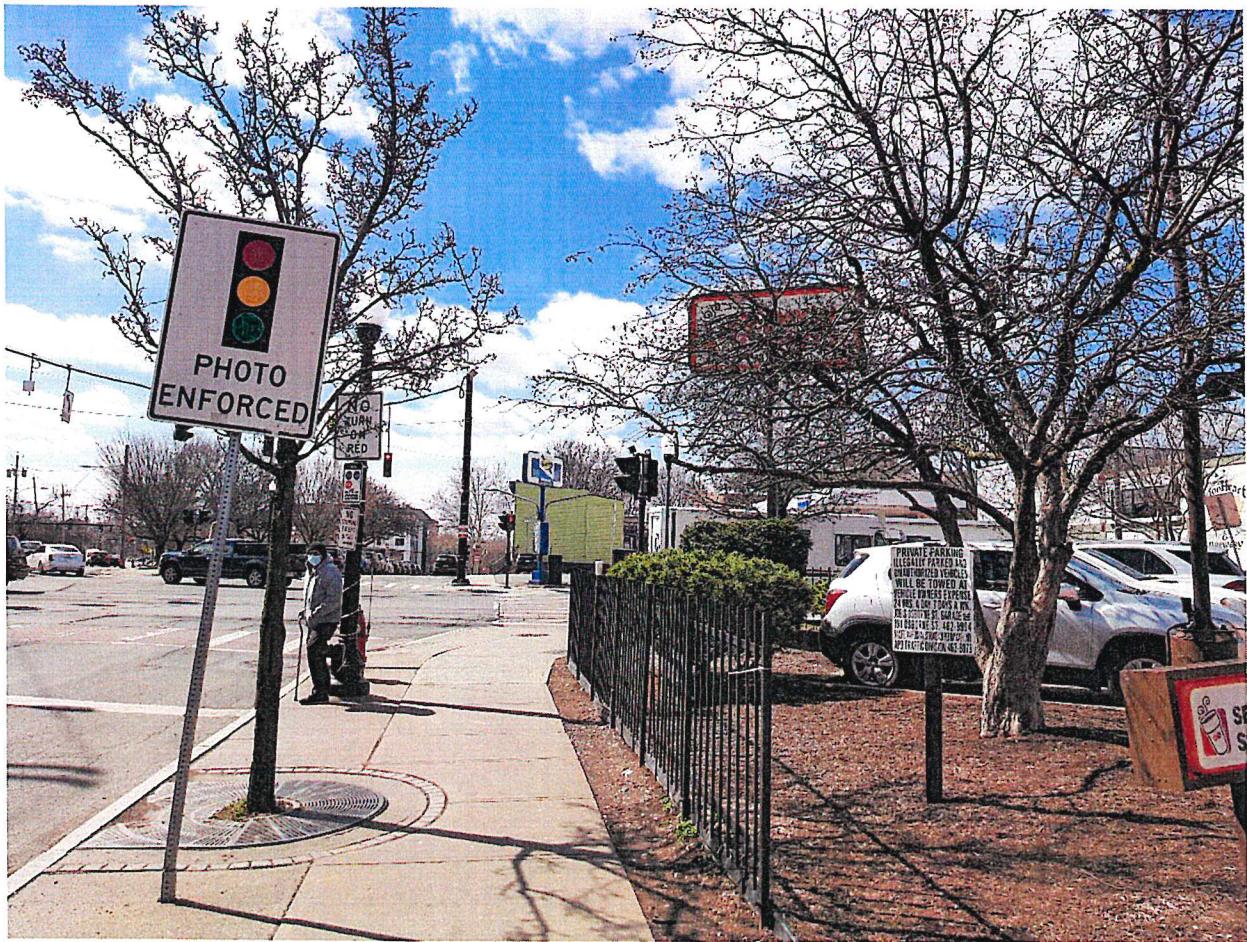
Callery Pear on Lark Street at 439 Madison Avenue, obstructing site lines to signage at corner/bus stop.
