ALBANY CITY HALL MASTER PLAN

100% DRAFT: AUGUST 2020

John G. Waite Associates, Architects PLLC
384 Broadway, Albany NY 12207
64 Fulton Street, Suite 402, New York, NY 10038

EXTERIOR CONDITIONS ASSESSMENT

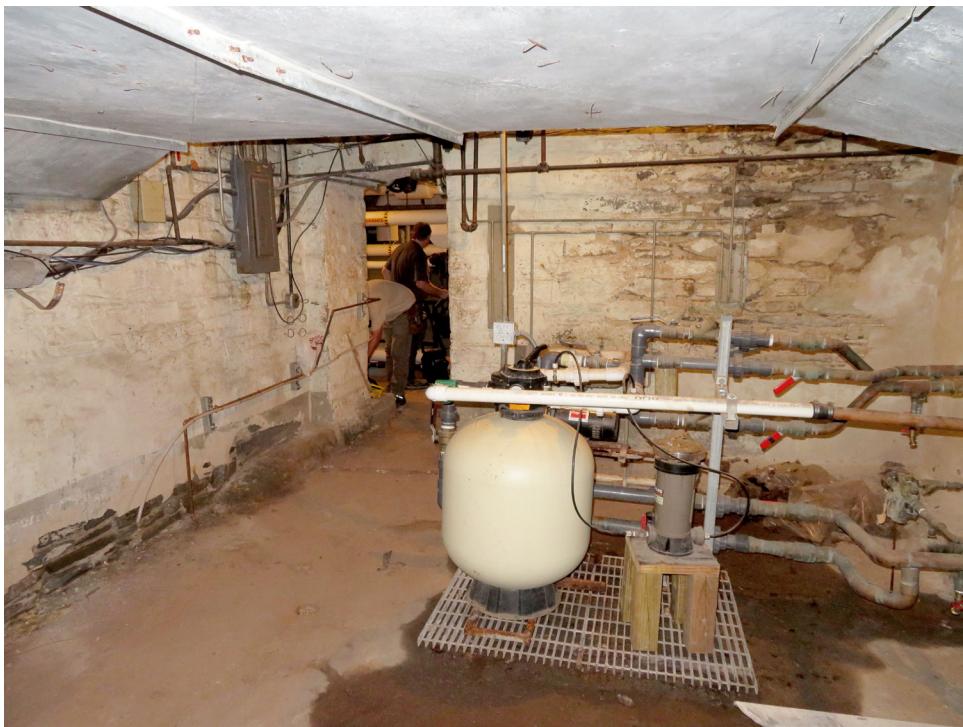
Room 004 (Ash Room). Unsecured wiring and piping. Mortar at masonry walls in fair to poor condition. JGWA, 2019.

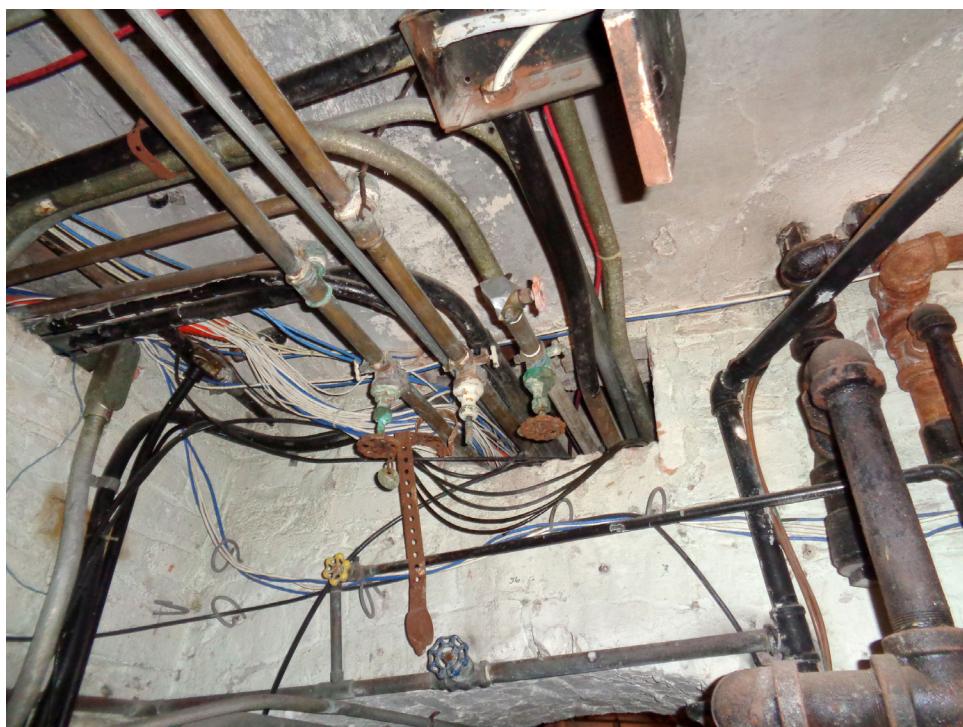
Room 004 (Ash Room). Unsecured piping and wiring. Open junction boxes. Corroded valves. JGWA, 2020.

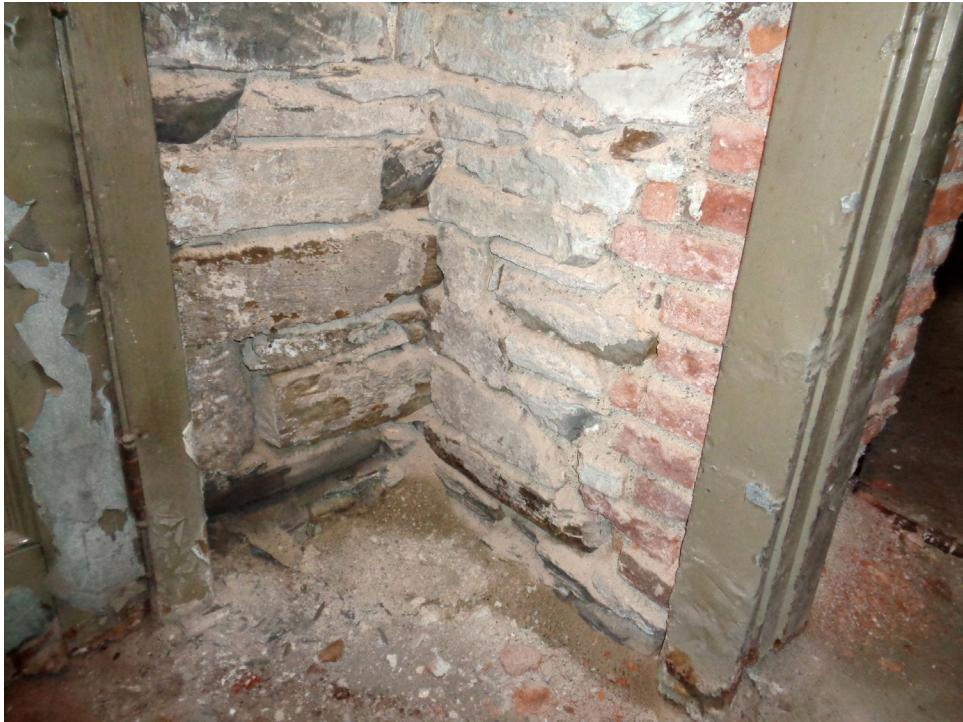
Room 003 (Vestibule). Mortar washed out of joints. JGWA, 2020.

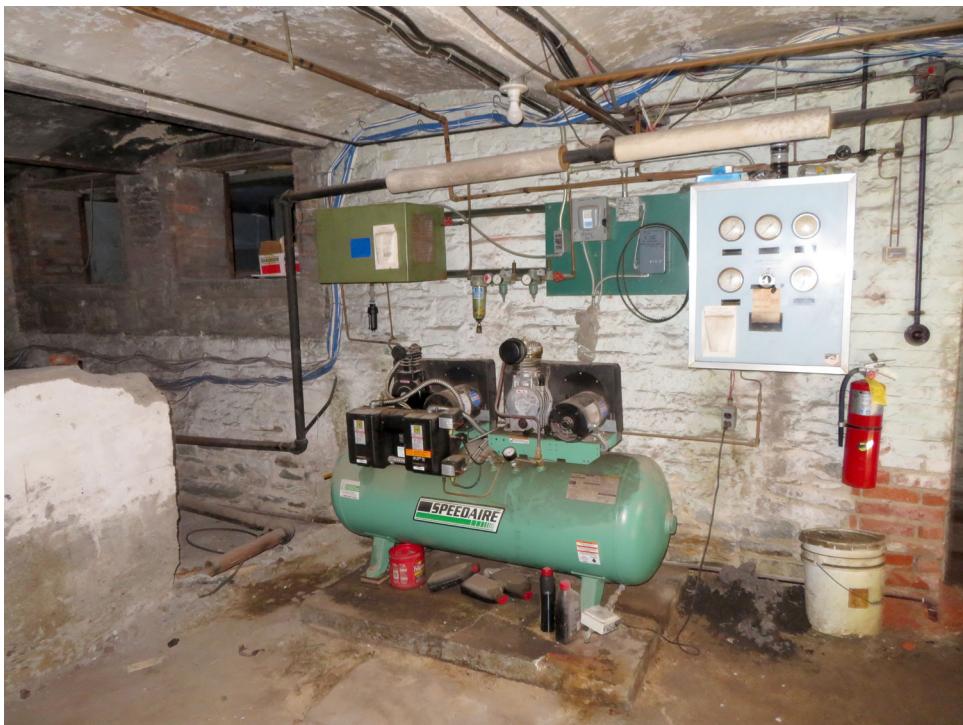
Room 001 (Fan Room). Pneumatic control air compressor. Unsafe electrical connection. Equipment running constantly. Gauges not functioning. JGWA, 2019.

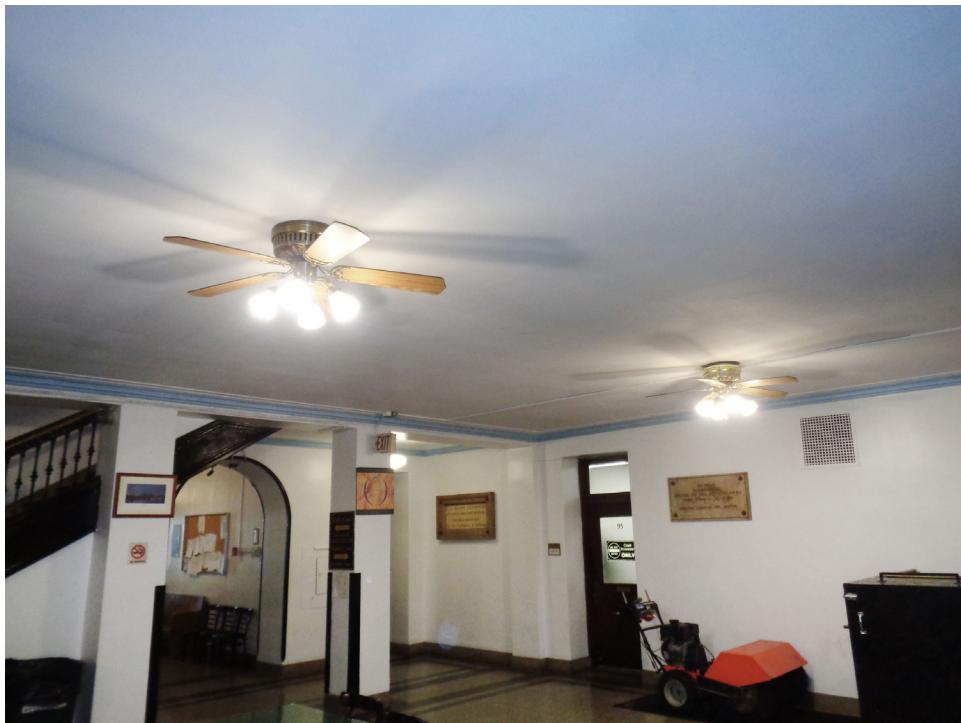
(Above) Room 3
(Basement Lobby).
Residential-style ceiling
fixtures. Snow removal
equipment stored in
public view. JGWA, 2020.

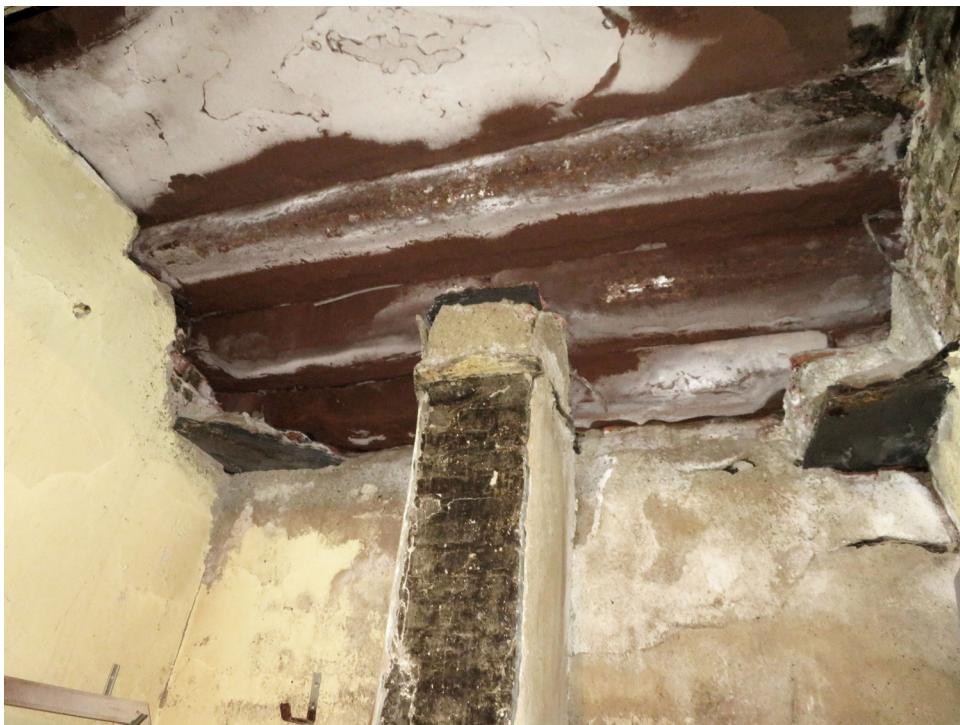
Room 16 (Storage). Deteriorated underside of front entry stairs. Open joints in the stair and foundation have allowed water entry. JGWA, 2019.

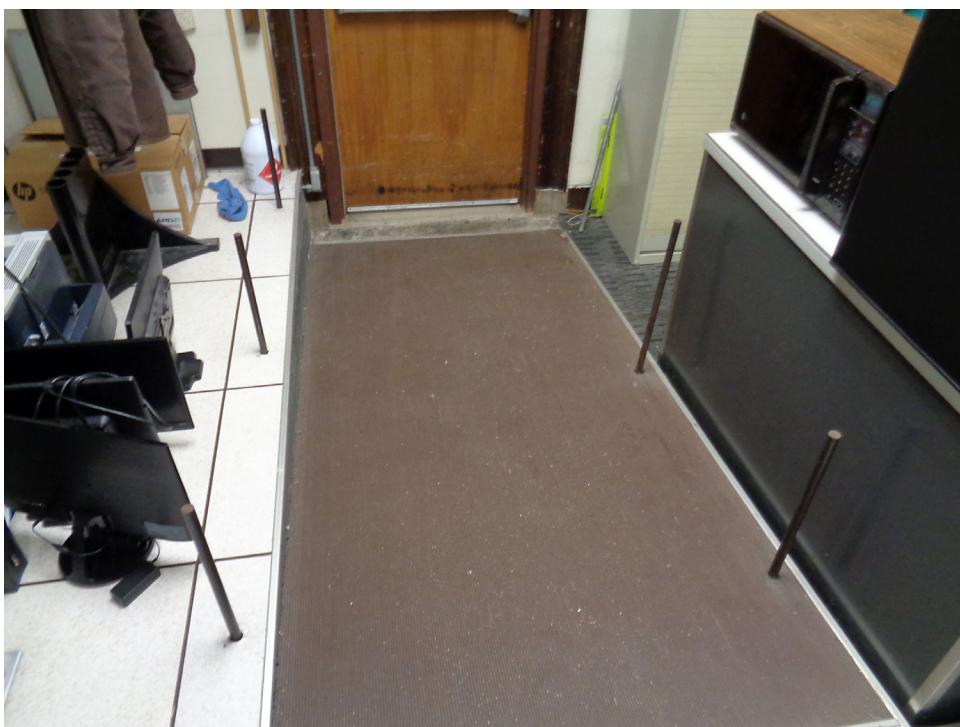
Room 91 (Server Room). Impalement hazard at unfinished or removed railings. JGWA, 2020.

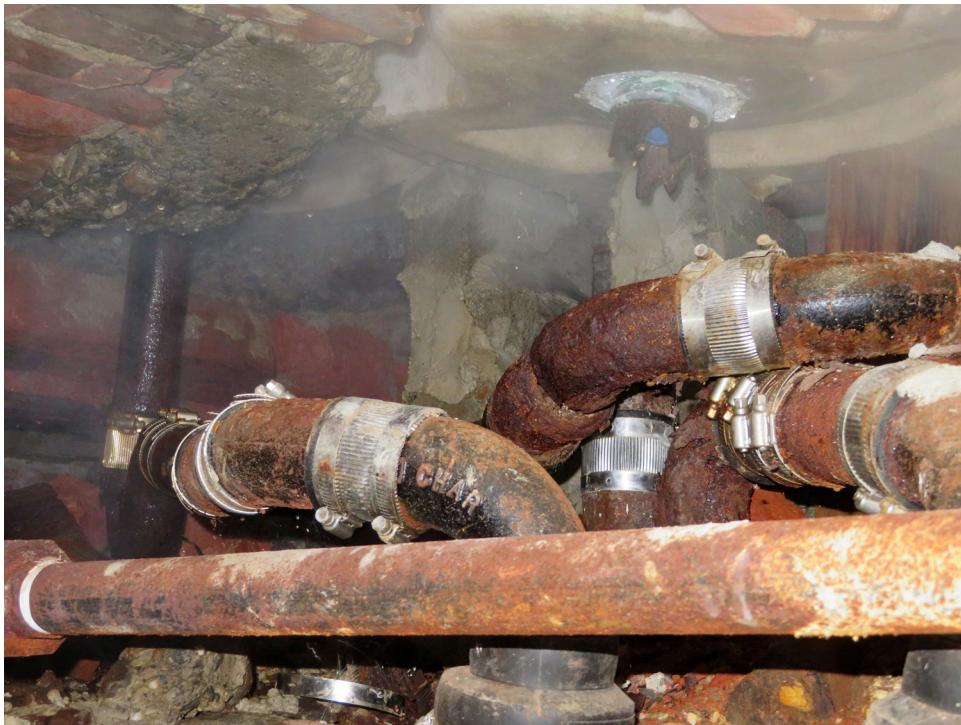
Crawl space below Room 5 (Men's Restroom). Leaking steam heating piping and corroded drain piping. Brick arches have been compromised by holes for piping, and some have partially collapsed. JGWA, 2020.

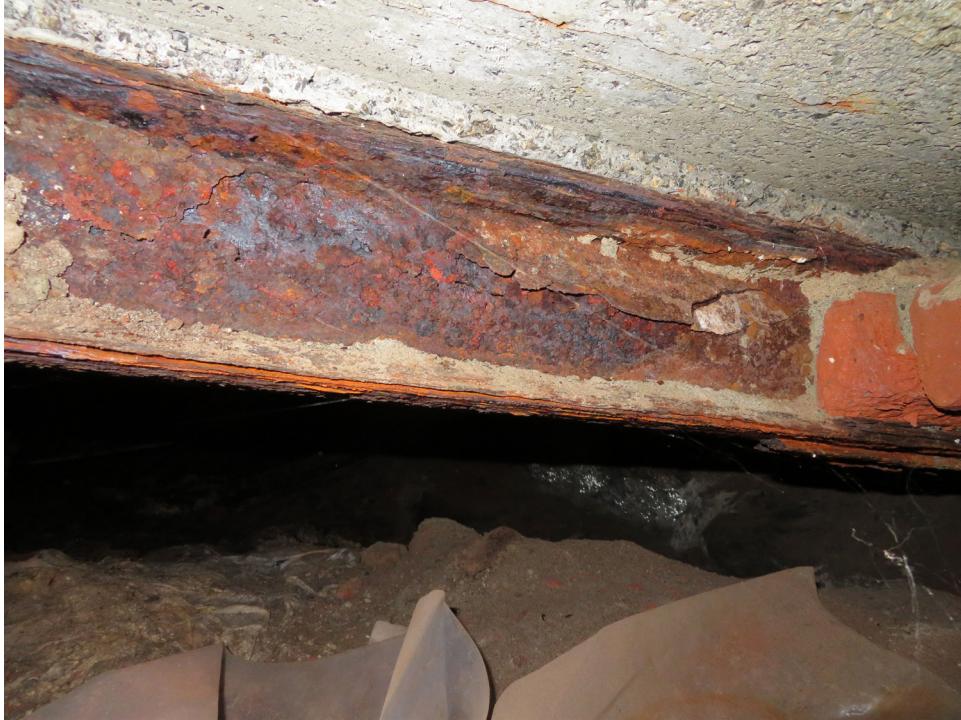
Crawl space below Room 11 (Building Permit Storage). Severely corroded floor beam. The individual brick at the right of the image is from a collapsed brick arch that originally supported the floor. JGWA, 2020.

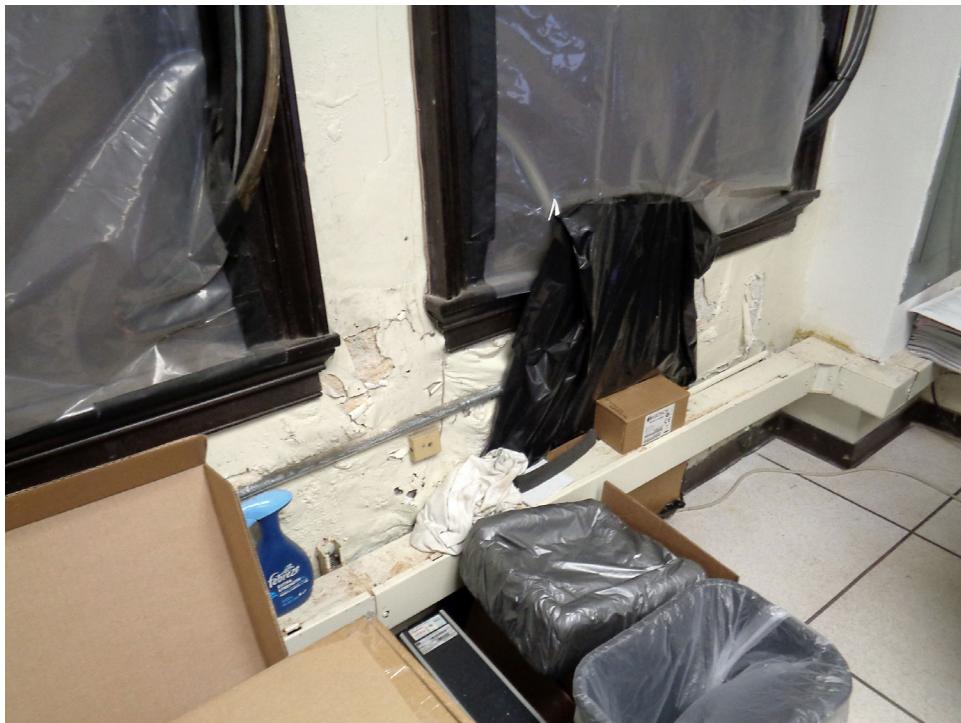
(Above) Room 91 (Server Room). Deteriorated plaster under windows. JGWA, 2020.

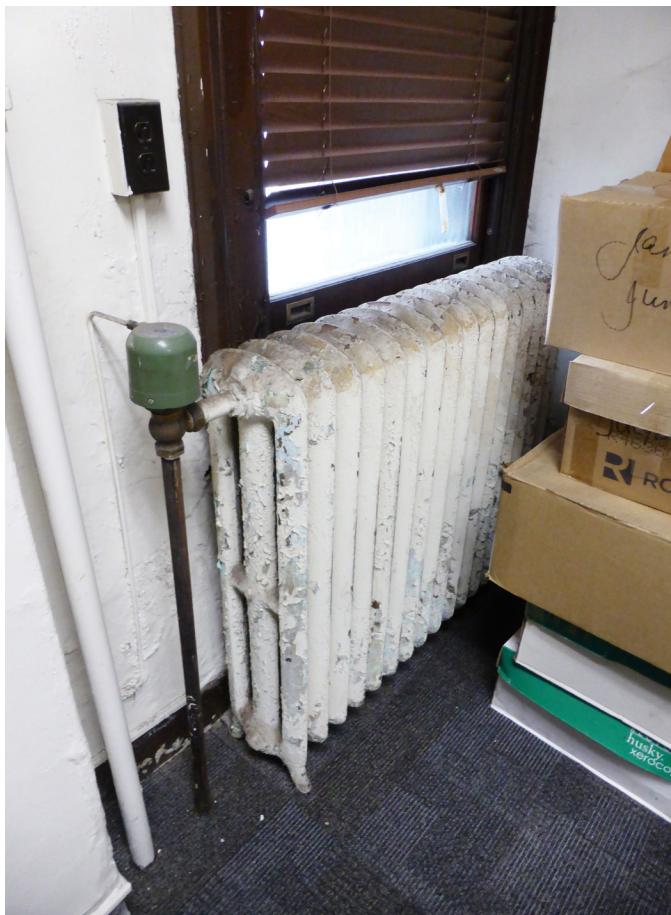
(Left) Room 99A (File Storage). Peeling paint on radiator. Plaster damage behind radiator. JGWA, 2020.

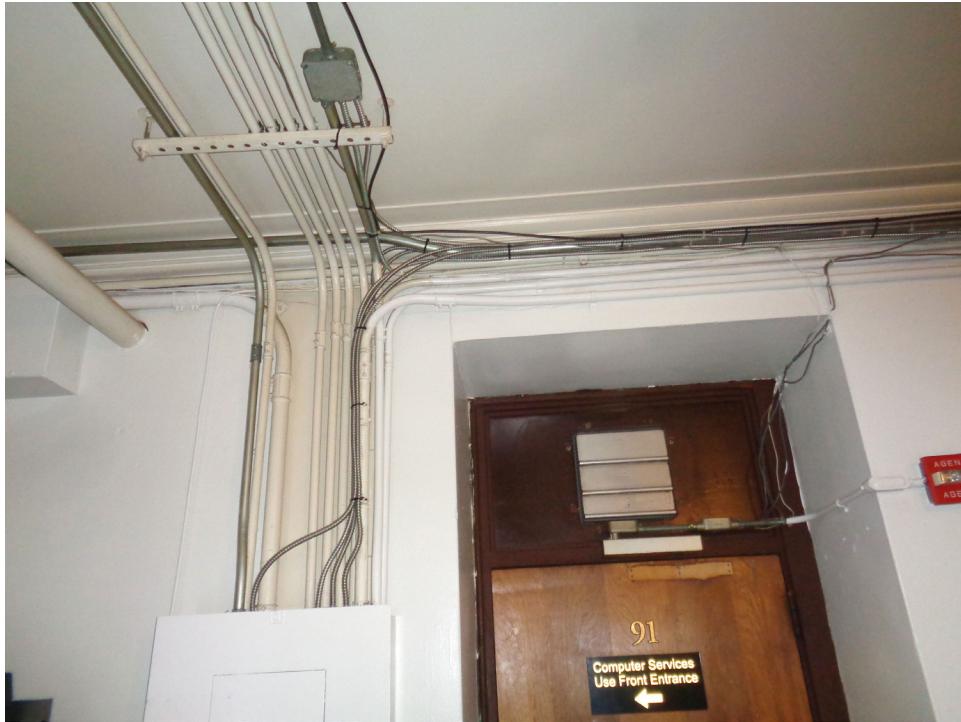
Room 9 (outside Room 91). Wiring secured with cable ties. Unsecured wiring. JGWA, 2020.

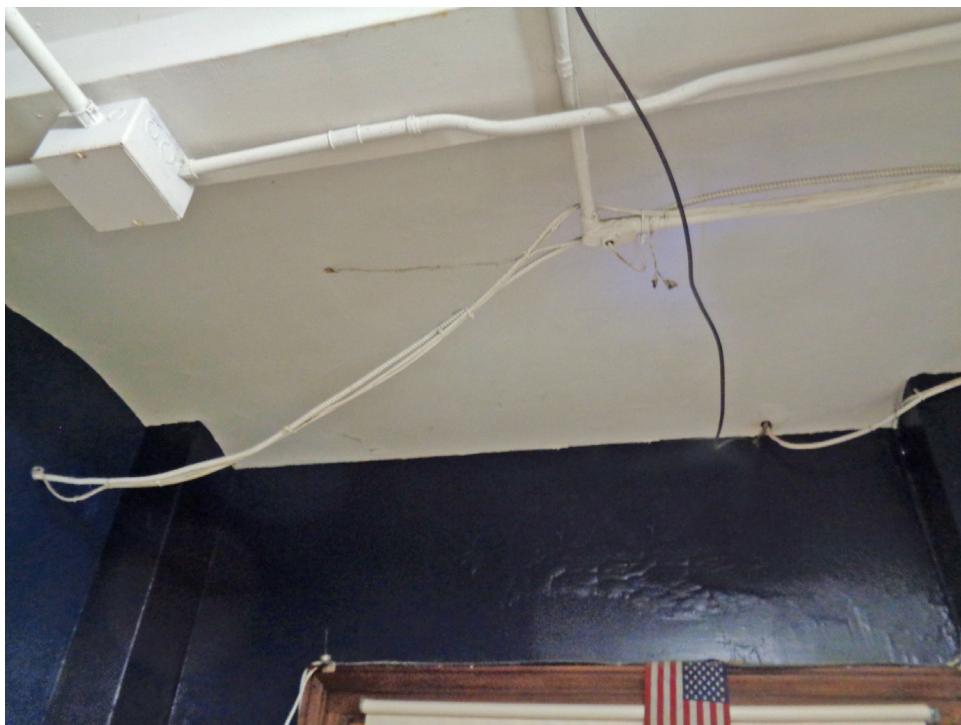
Room 90 (Maintenance). Poorly installed electrical conduit and unsafe exposed electrical wiring. JGWA, 2020.

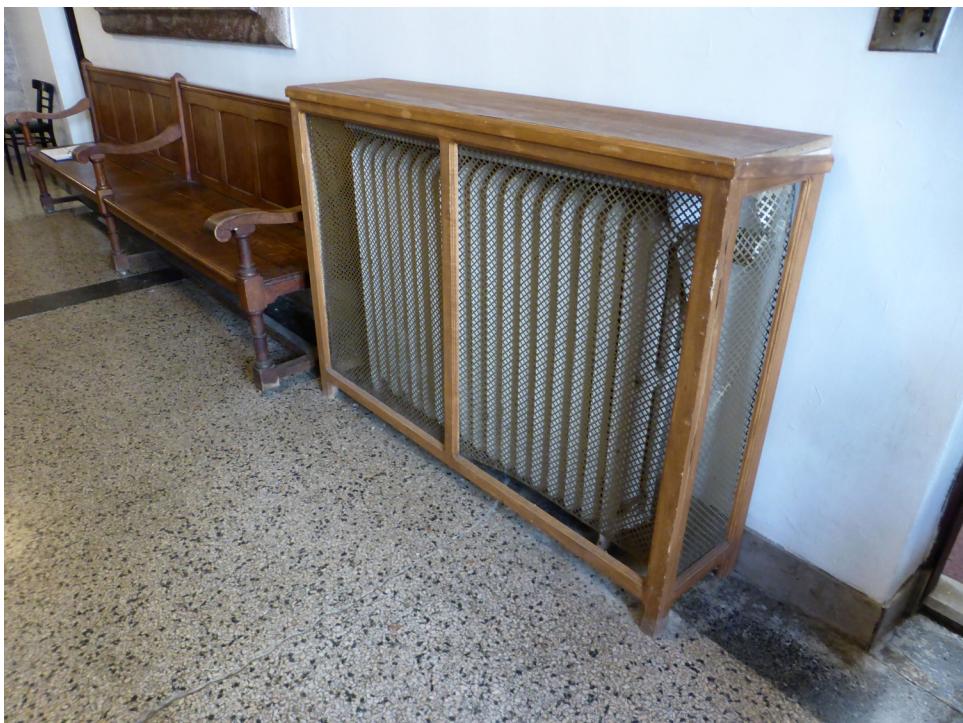
(Above) Room 4 (North Entry Hall). Modern radiator cover does not match surrounding architecture. JGWA, 2020.

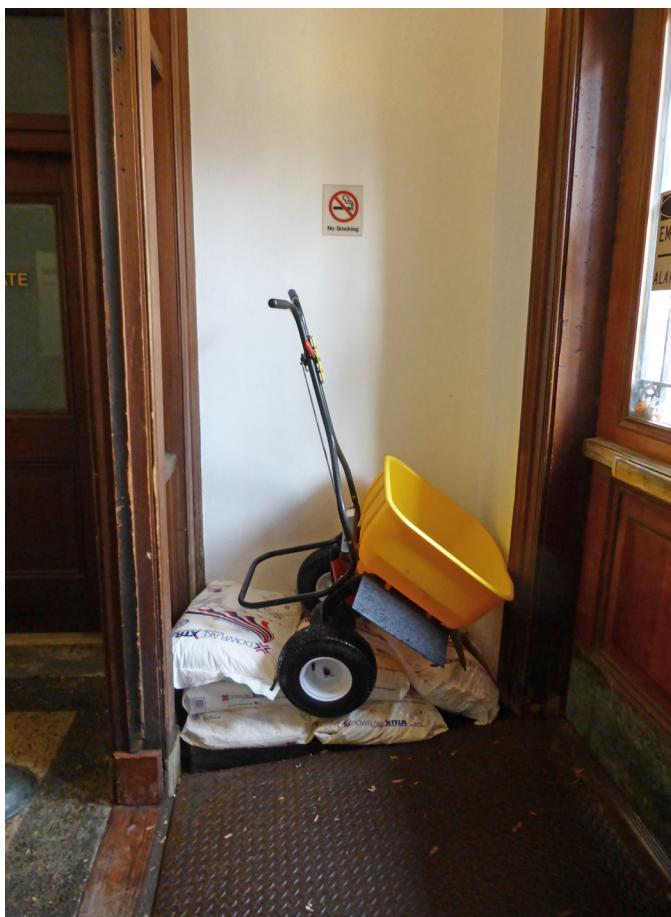
(Left) Room 4 (North Entry Hall). Salt bags and spreader stored in vestibule.

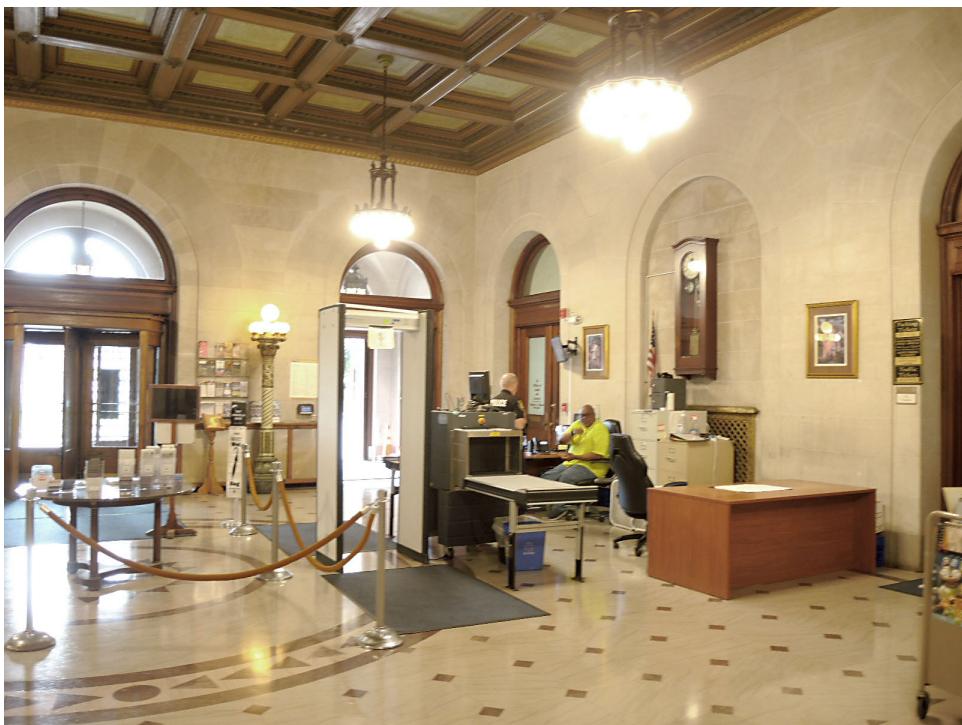
Room 113 (Main Lobby). Historic space with overly large and makeshift security station. JGWA, 2019.

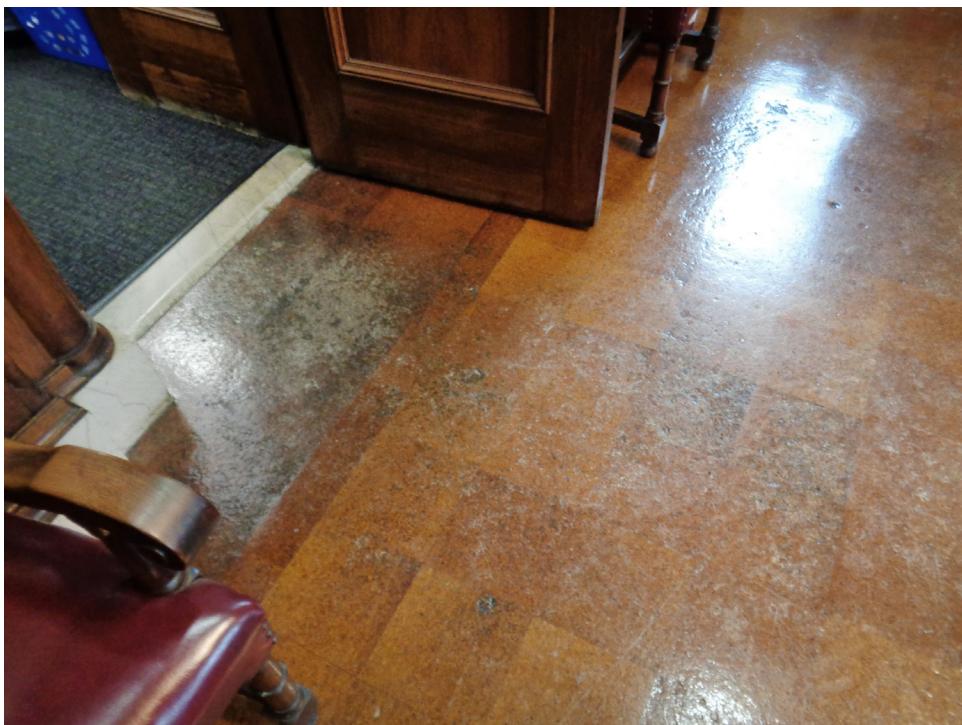
Room 100 (Mayor's Office). Original but worn cork flooring. JGWA, 2020.

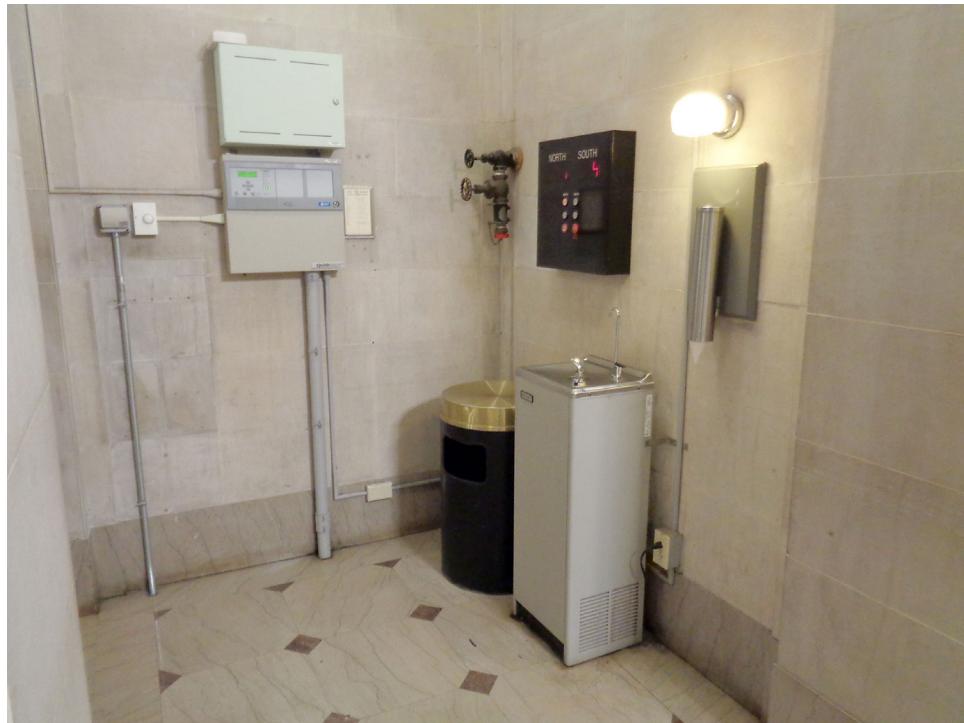
(Below) Room 114
(Atrium). Haphazard
installation of devices
and fixtures in a highly
visible area. JGWA,
2020.

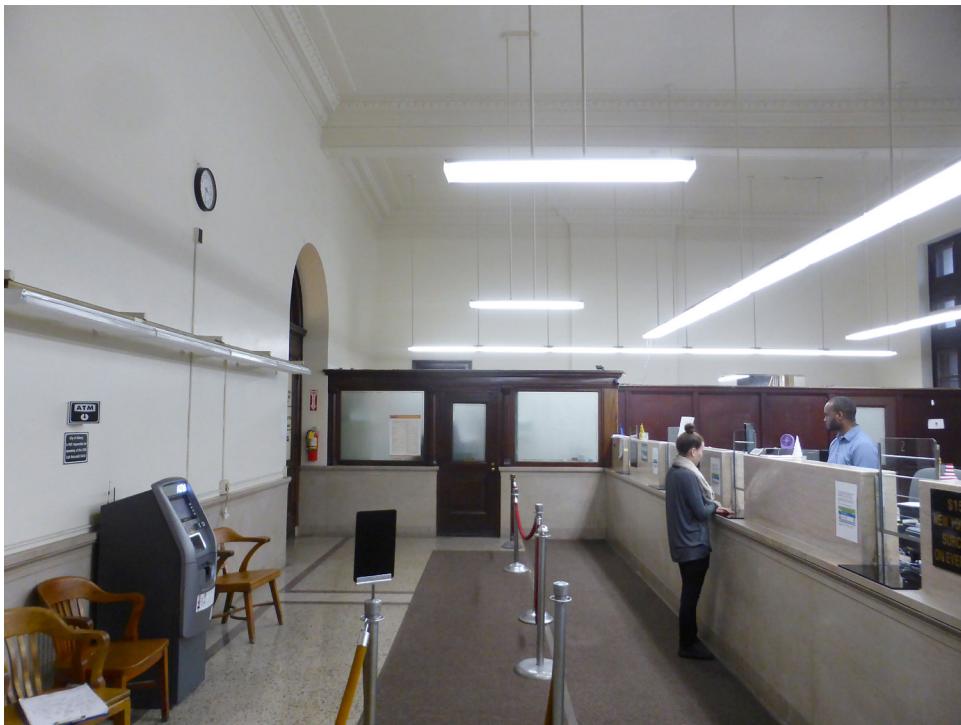
Room 110 (City Treasurer). Inappropriate lighting and paint scheme obscure the architectural qualities of the room. JGWA, 2020.

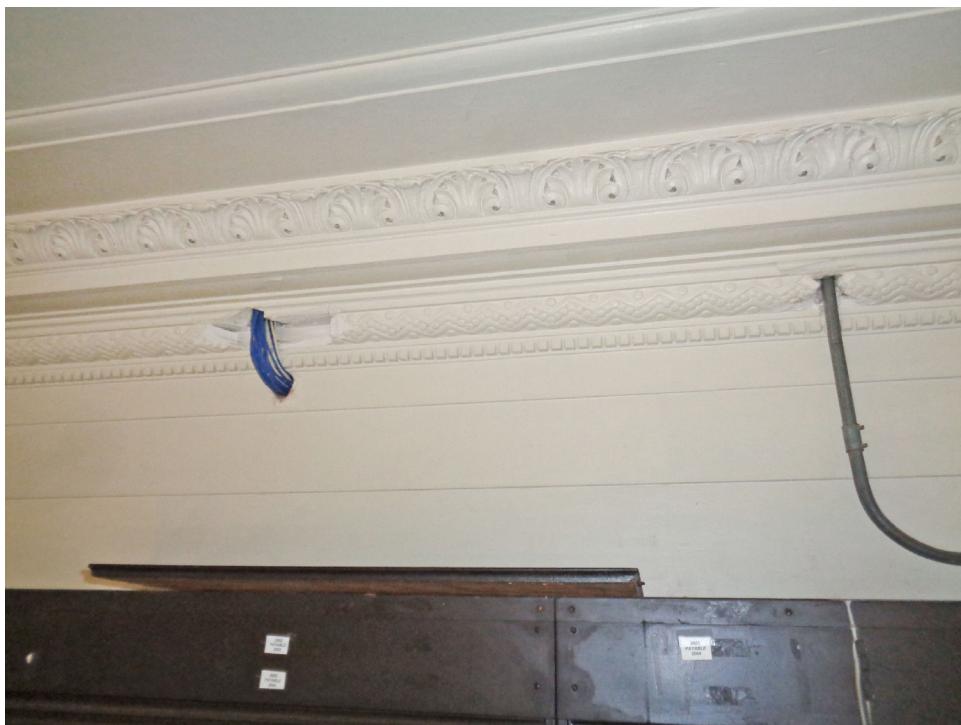
Room 150 (City Treasurer Mezzanine). Decorative plaster cornice damaged by wiring installation. This space is highly visible from publically-accessible Room 110. JGWA, 2020.

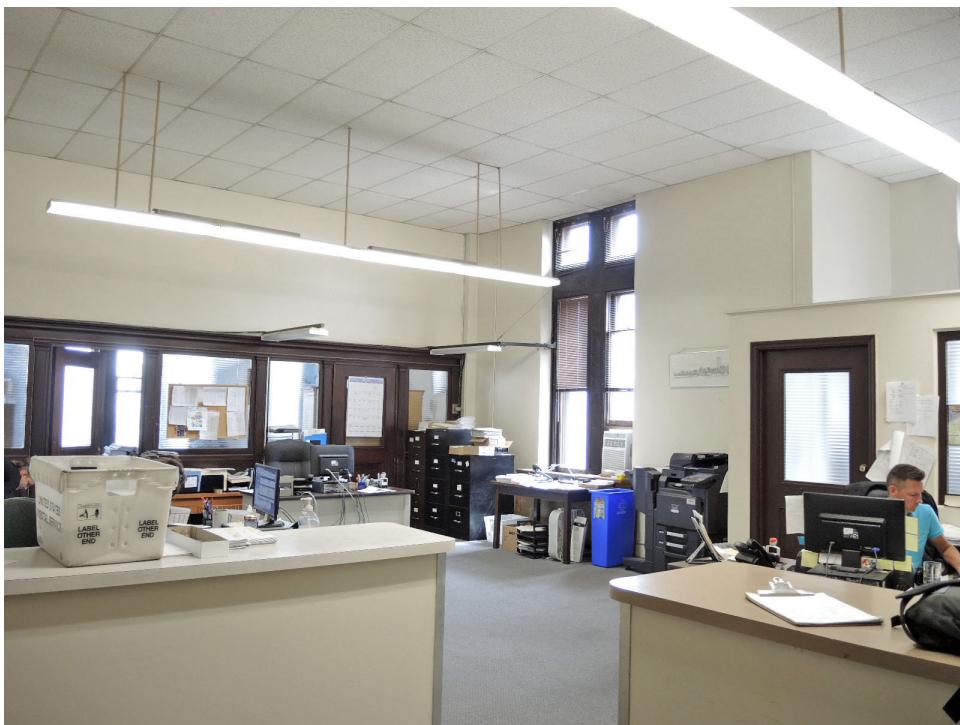
Room 109 (City Treasurer). This historic space could be restored by removing the dropped ceiling and inappropriate and inefficient lighting. JGWA, 2019.

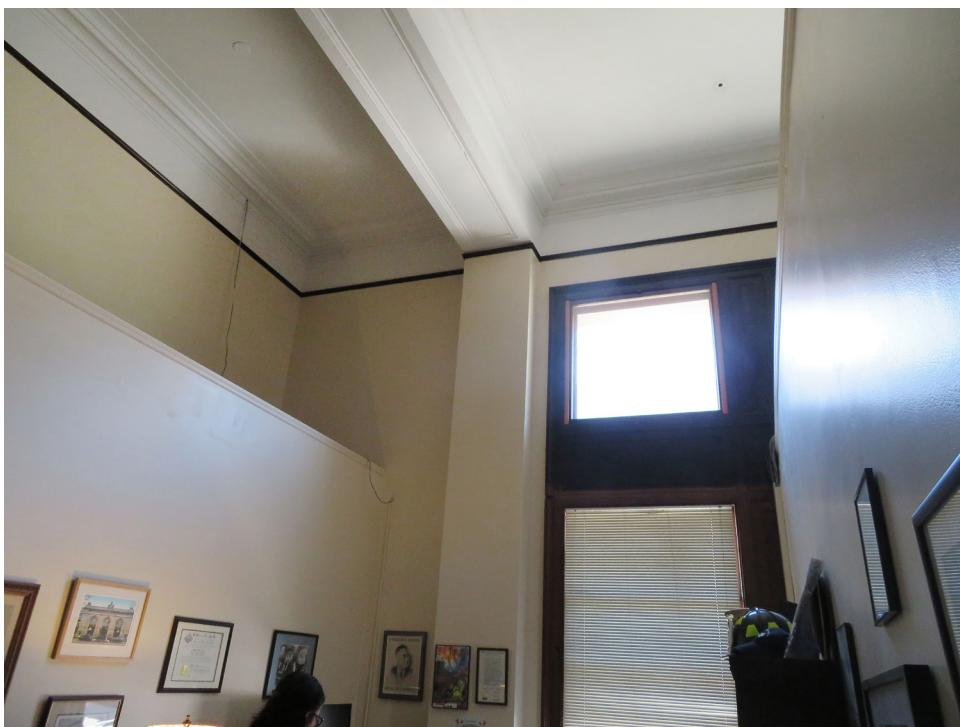
Room 105D (Office). Awkward ceiling configuration caused by the addition of modern partitions in this large historic space. JGWA, 2019.

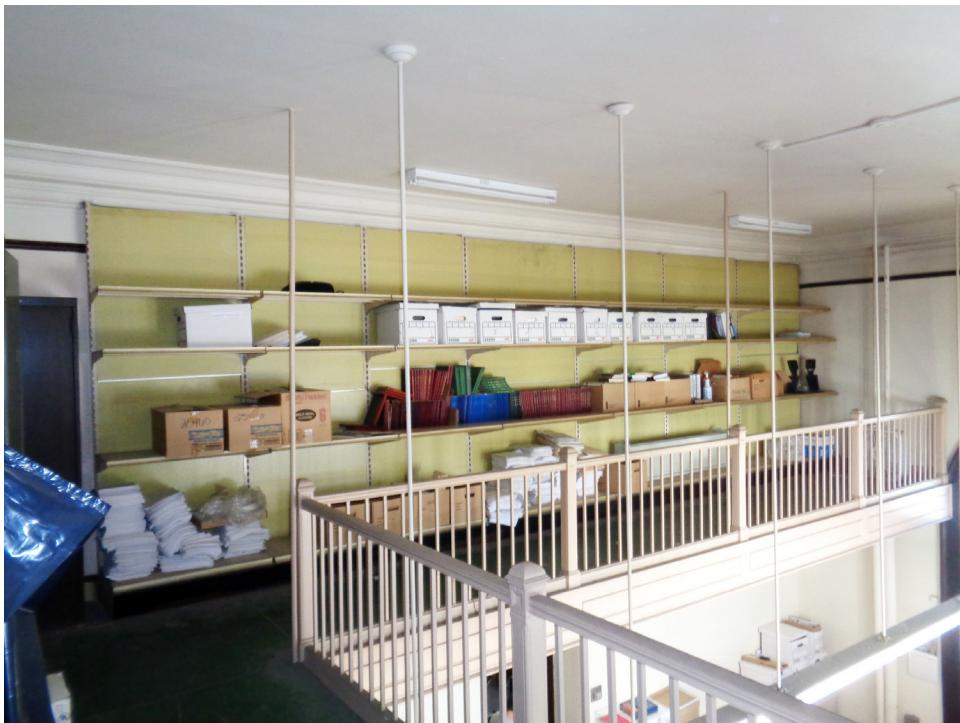
Room 151 (Audit Office Mezzanine). Typical of underutilized storage space. JGWA, 2019.

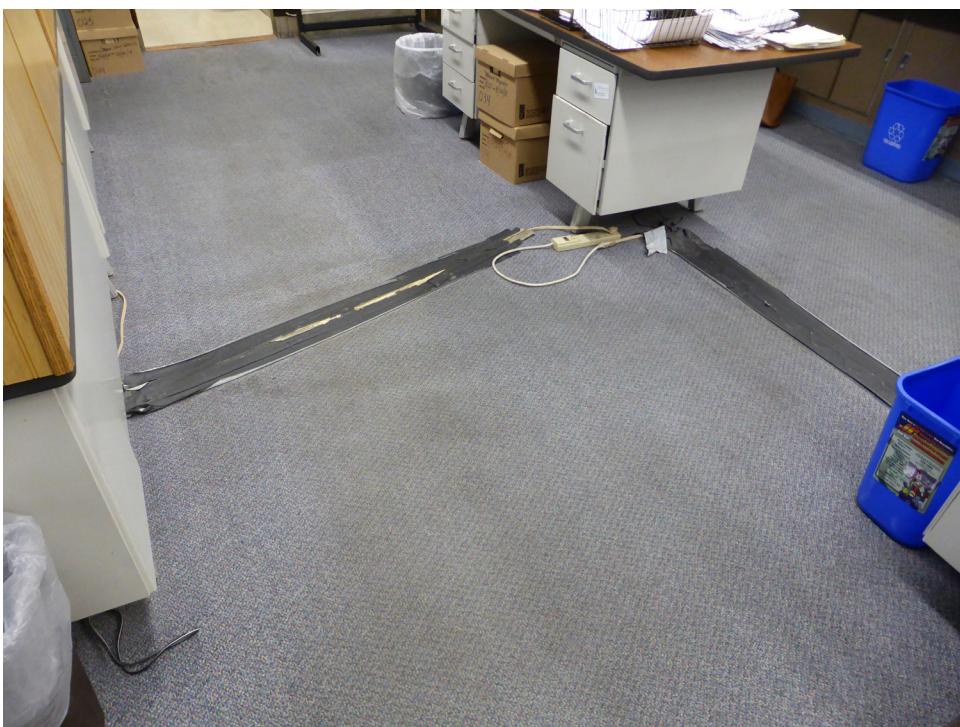
Room 111A (Audit Office). Extension cords taped to worn carpet. Typical in many offices. JGWA, 2020.

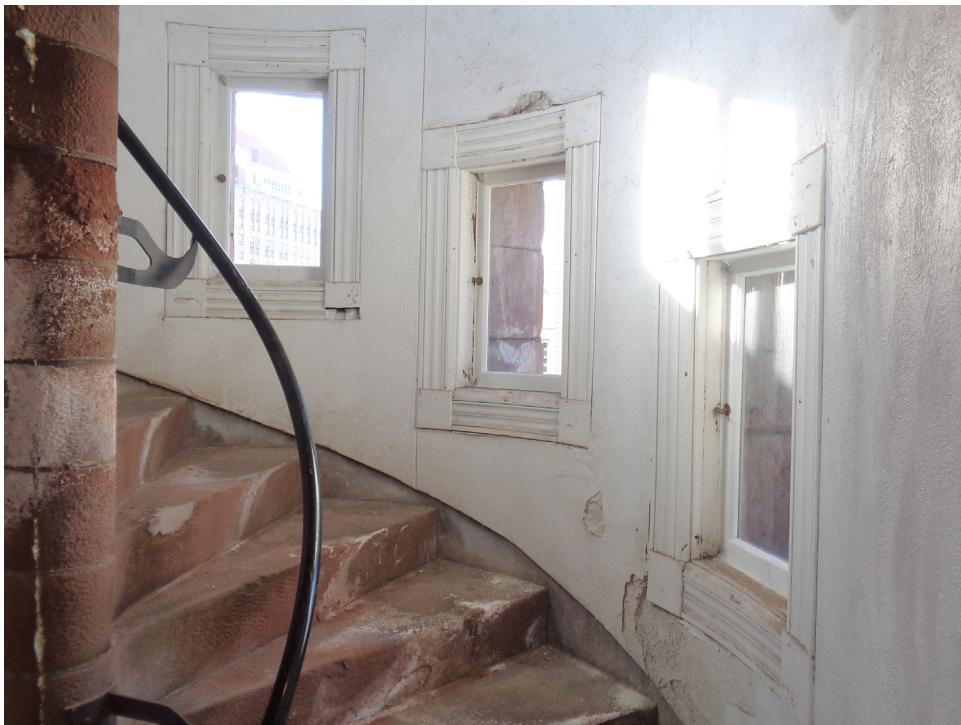
Stair 154C. Plaster damage and evidence of water infiltration on stone stairs. JGWA, 2019.

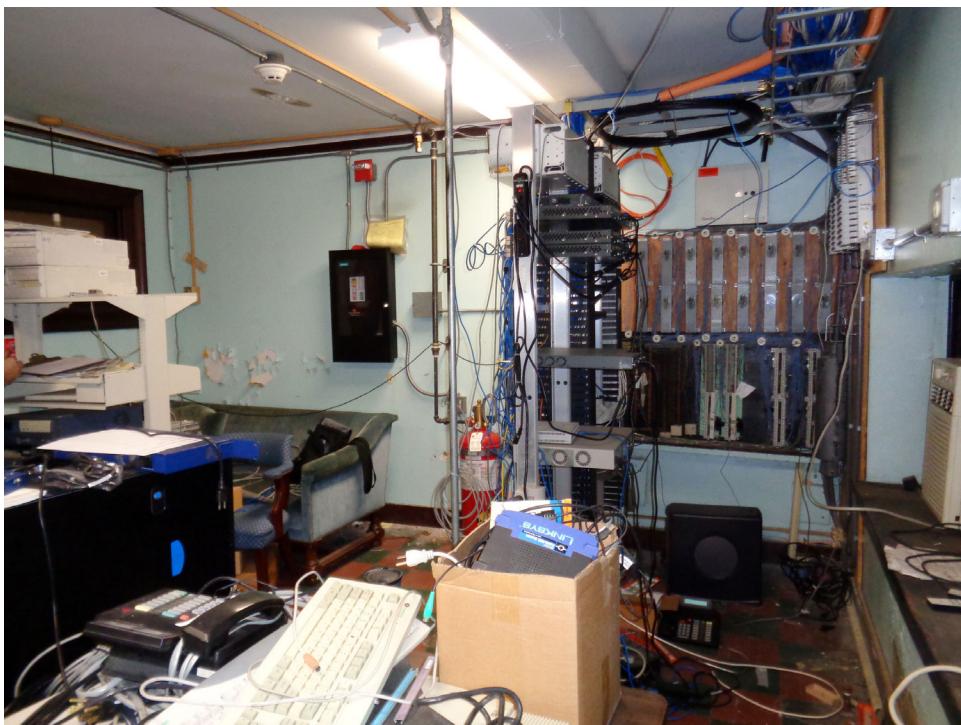
Room 158 (IT Room). Disorganized storage and haphazard wiring. JGWA, 2019.

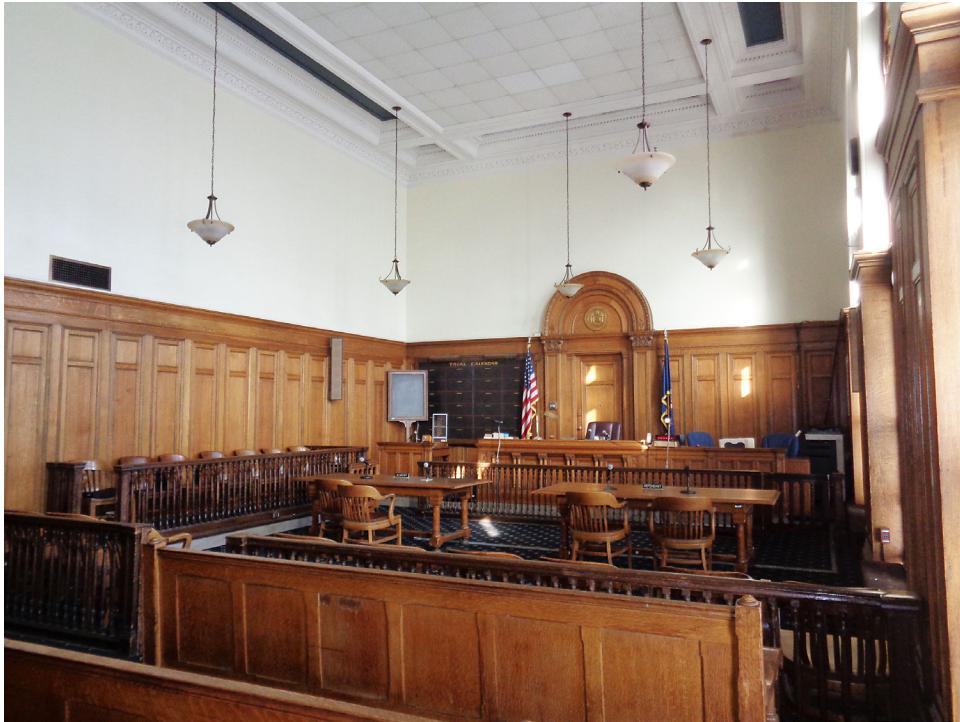
Room 210 (Courtroom). Largely intact historic space that could be fully restored with new finishes and more appropriate fixtures. JGWA, 2019.

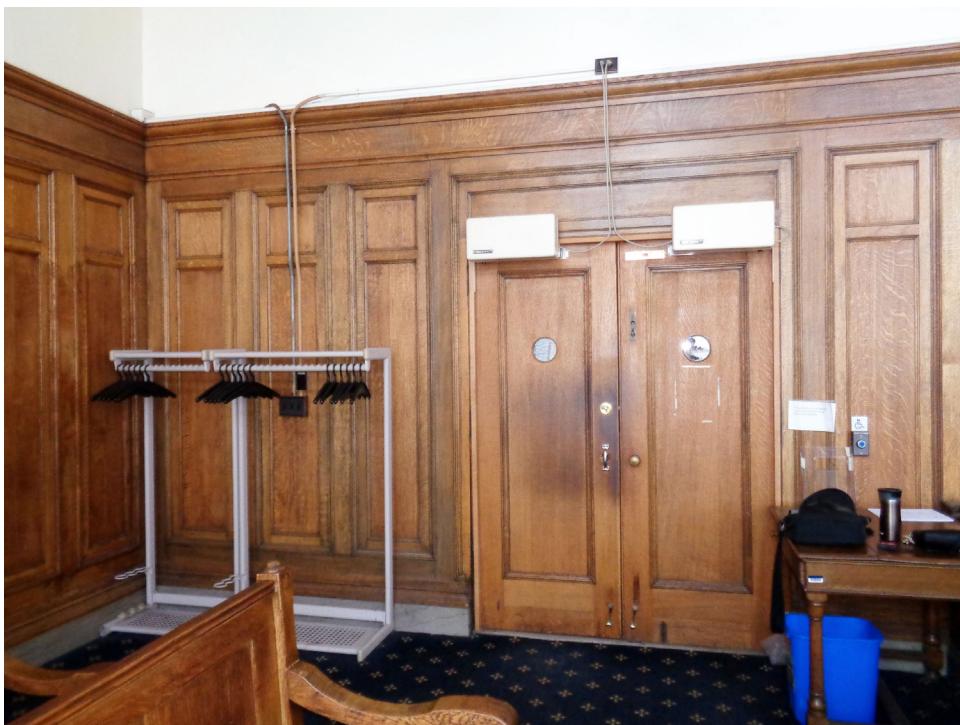
Room 210 (Courtroom). Worn finish and disused tape on doors. Surface-mounted wiring and equipment should be designed to minimize visual impact. JGWA, 2019.

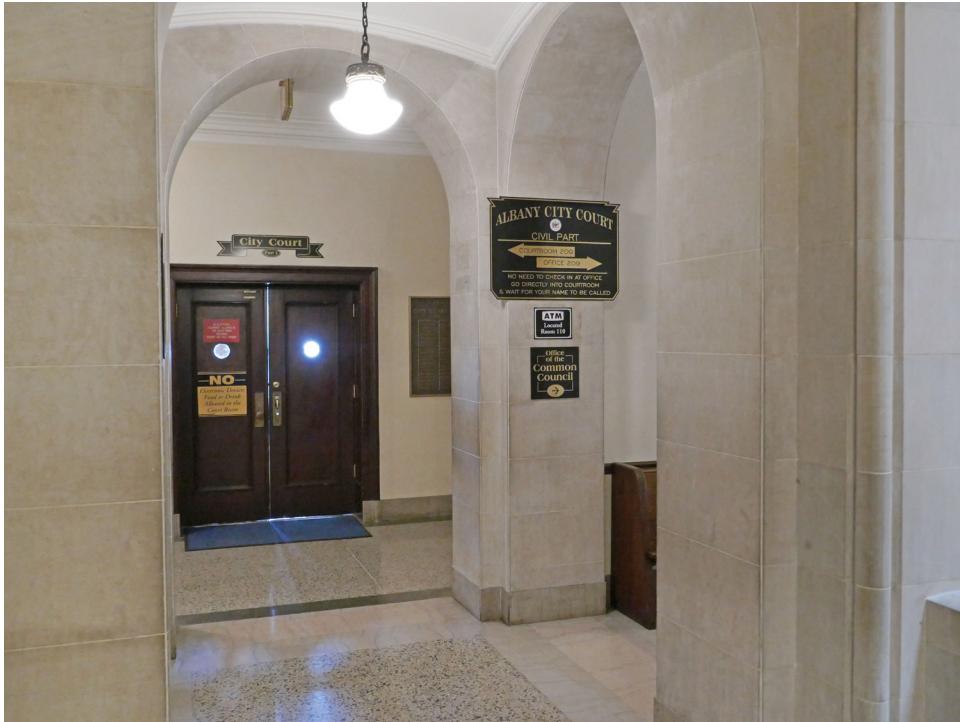
Room 218 (Atrium). Multiple generations of signage that do not correspond to the architecture. JGWA, 2020.

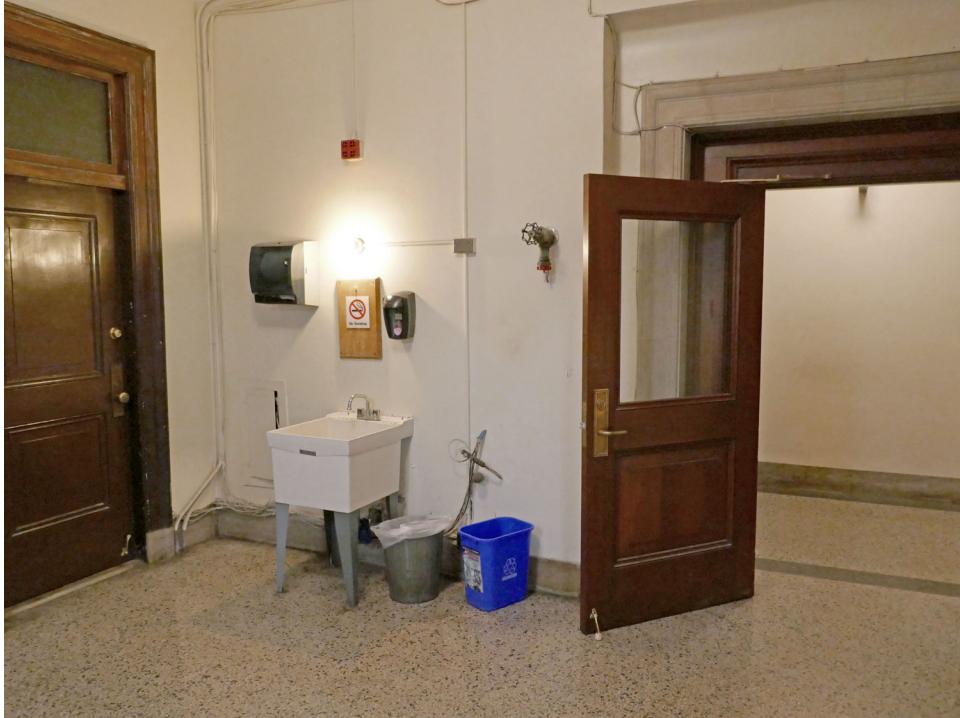
Room 261 (Second Floor Mezzanine South Stair). Janitor's sink in a highly used public corridor. New spaces for janitorial equipment should be incorporated into remodeled bathrooms. JGWA, 2020.

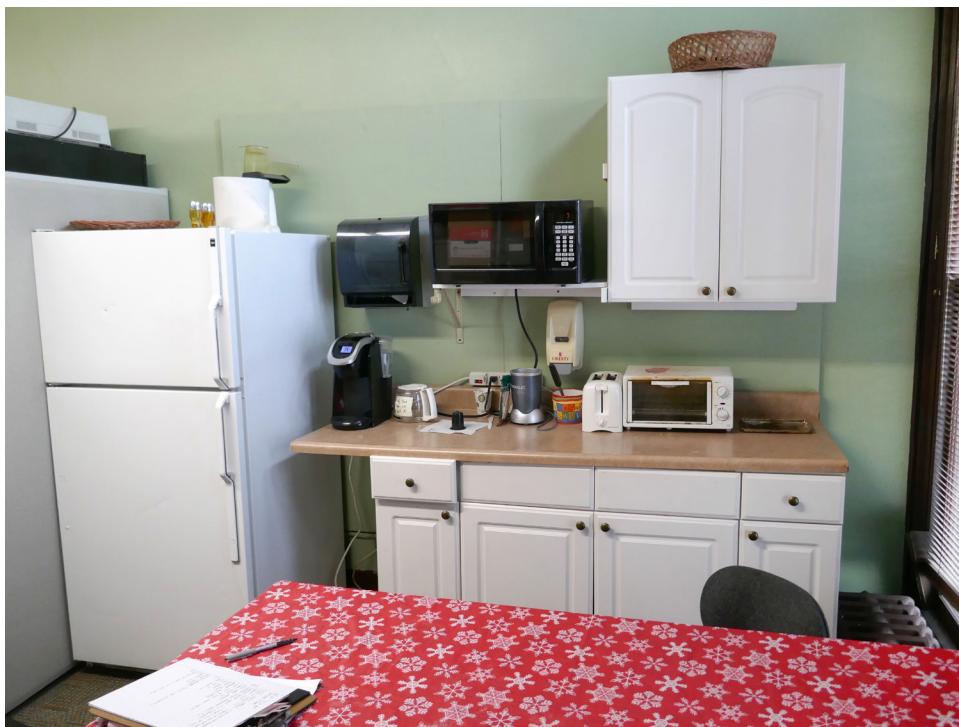
Room 210A (Judge's Chambers). Typical existing kitchenette. When redesigned, only one shared kitchenettes should exist per floor. JGWA, 2020.

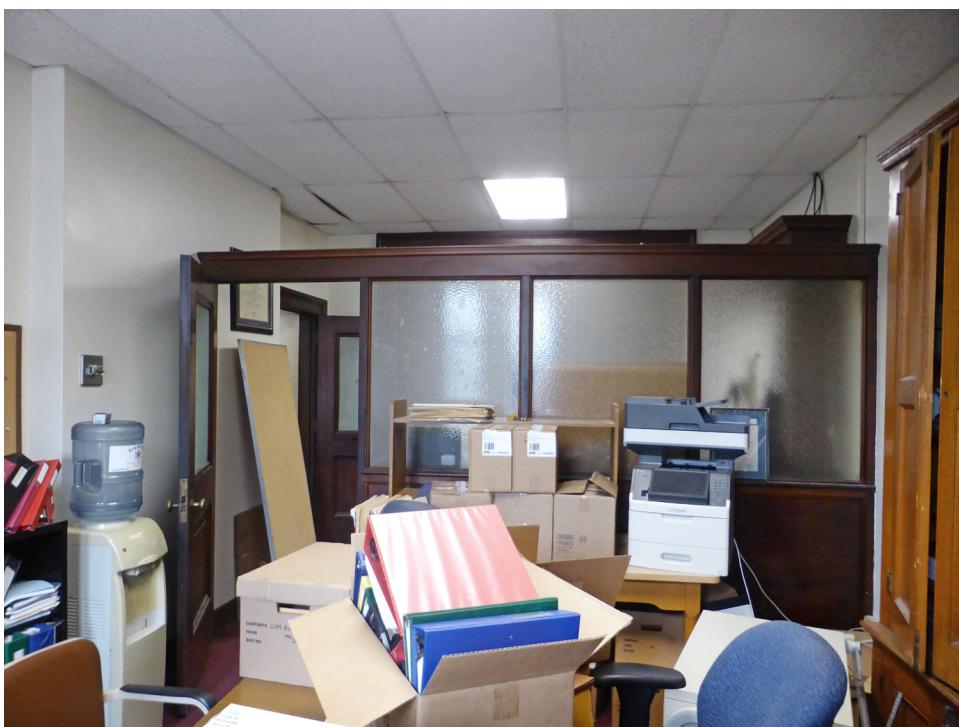
Room 302B (Assessor's Office). Historic wood and glass partition below modern dropped ceiling. Room filed with stored items.
