ALBANY CITY HALL MASTER PLAN

100% DRAFT: AUGUST 2020

John G. Waite Associates, Architects PLLC
384 Broadway, Albany NY 12207
64 Fulton Street, Suite 402, New York, NY 10038

EXTERIOR CONDITIONS ASSESSMENT

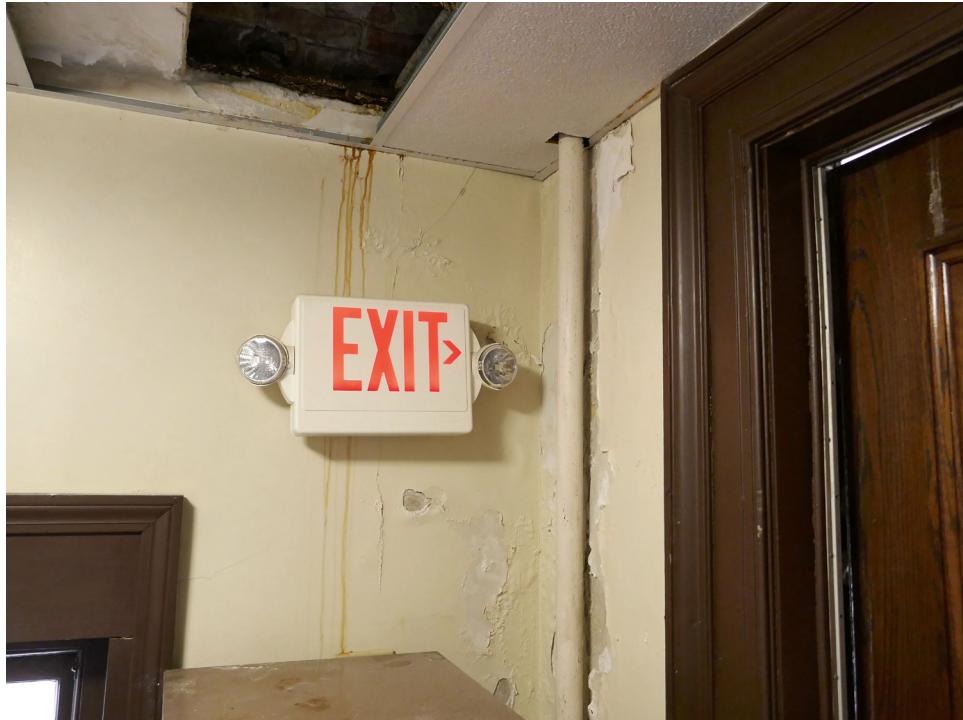
(Above) Room 205E (Office). Water staining and damage from leaking masonry-built roof. JGWA, 2020.

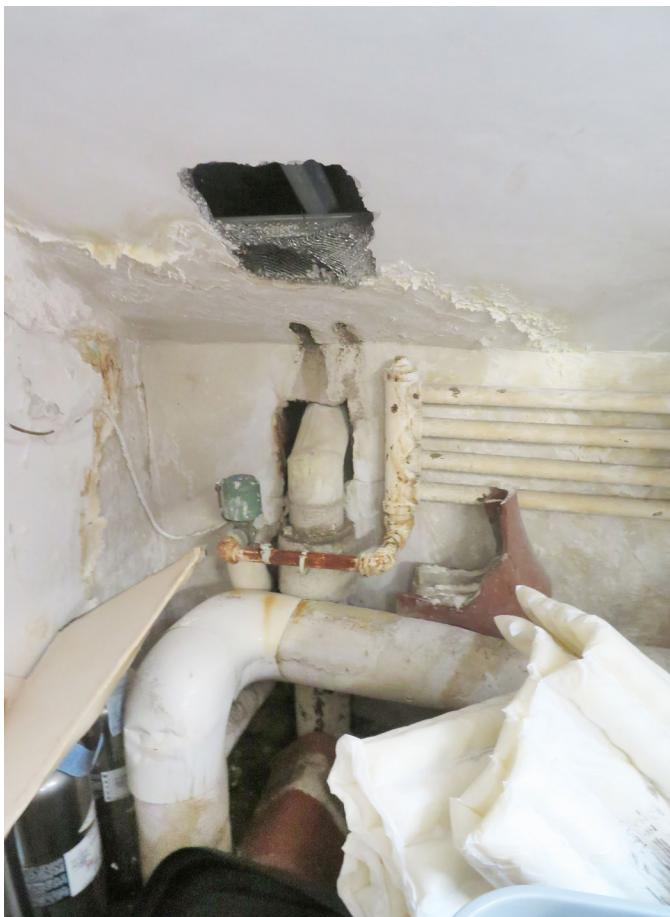
(Left) Room 312 (Storage). Water damage at leaking roof leader piping. JGWA, 2019.

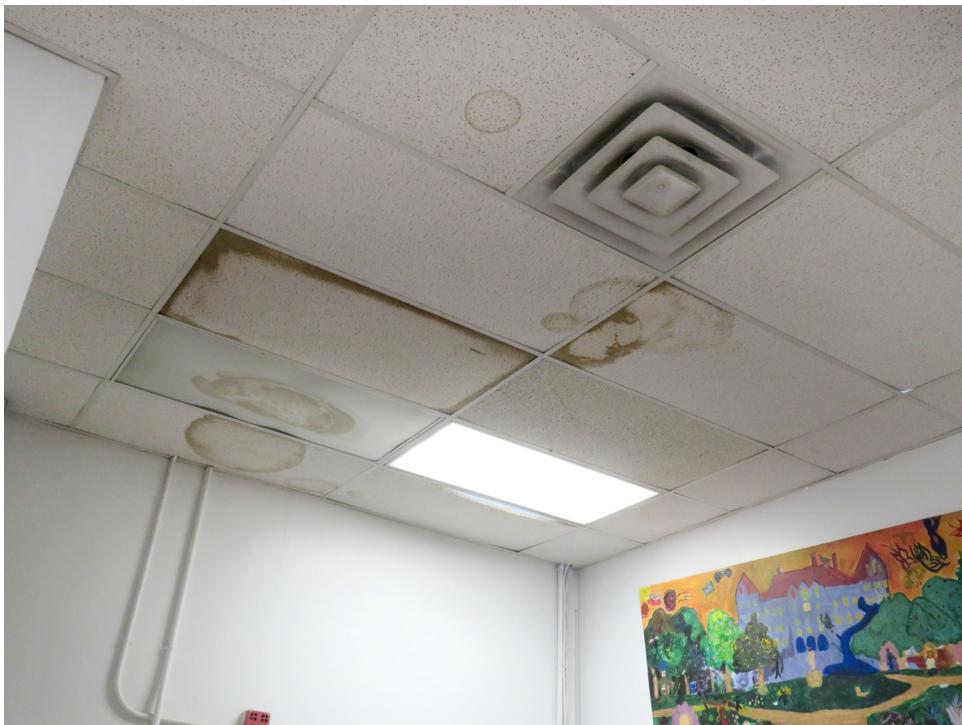
(Below) Room 407
(Lobby). Water damage from leaking skylight above. The historic skylight is completely obscured from view.
JGWA, 2020.

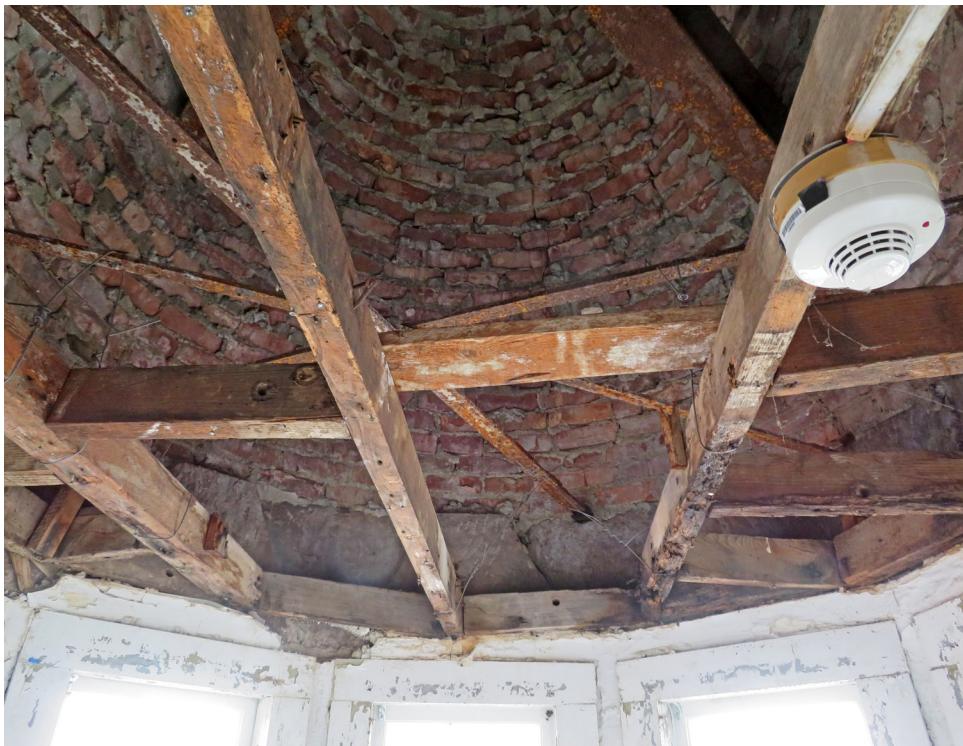
(Above) Tower Stair.
Plaster ceiling missing.
Steel tie rods rusted
and broken. JGWA,
2020.
