ALBANY PUBLIC SAFETY BUILDING

FEASIBILITY AND PLANNING STUDY

SEPTEMBER 2020

ALBANY PUBLIC SAFETY BUILDING
Feasibility and Planning Study
SEPTEMBER 2020

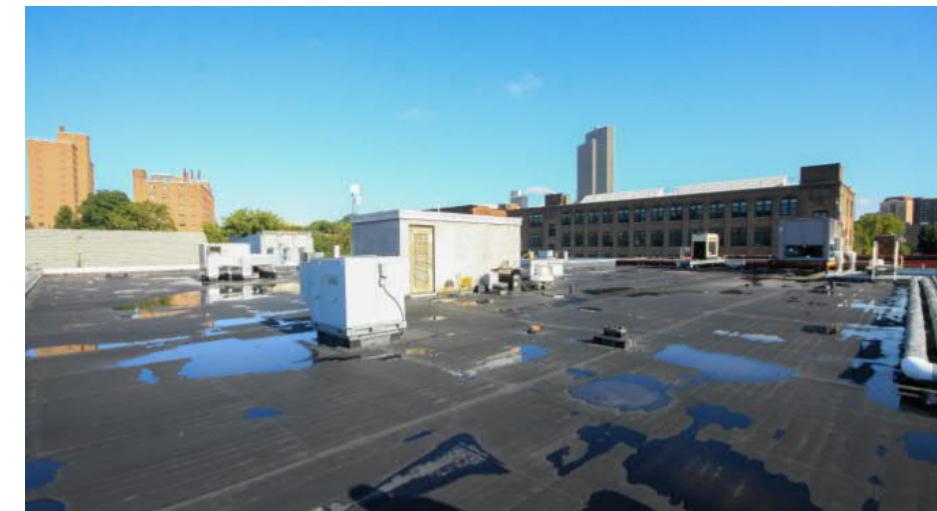
The roof is almost entirely made up of rubber membrane (EPDM) roofing. Despite many points of penetration for vents, mechanical systems units, and dunnage, it is generally in fair condition with some distinct but isolated areas of deterioration. The roofing over the entire facility is within 5-10 years of the end of its useful lifespan, with the exception of the roof over the northern portion of South Station, which was replaced three years ago and is in good condition as a result.

View of Morton Ave. EPDM roof.

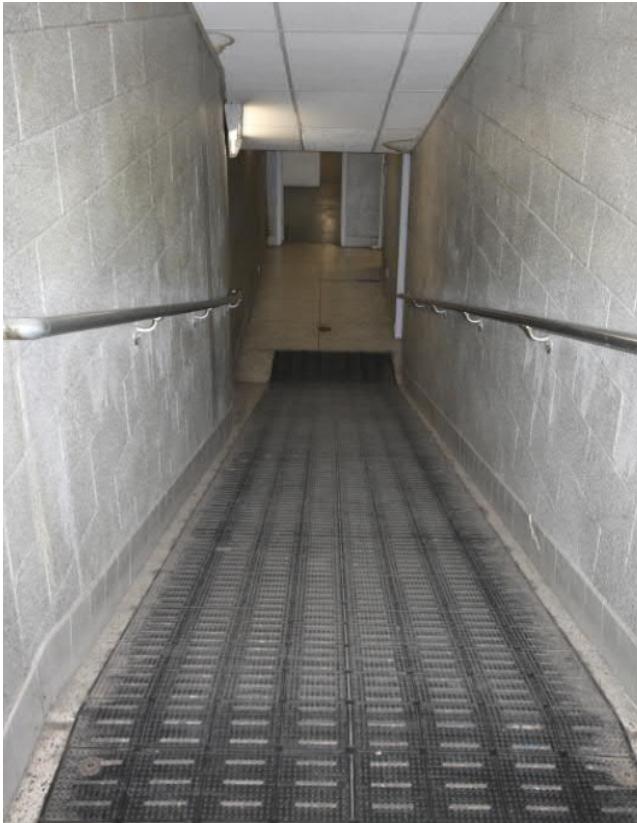
View looking down the ramp that leads from the holding cells on Level 1 to the court rooms on Level 2.

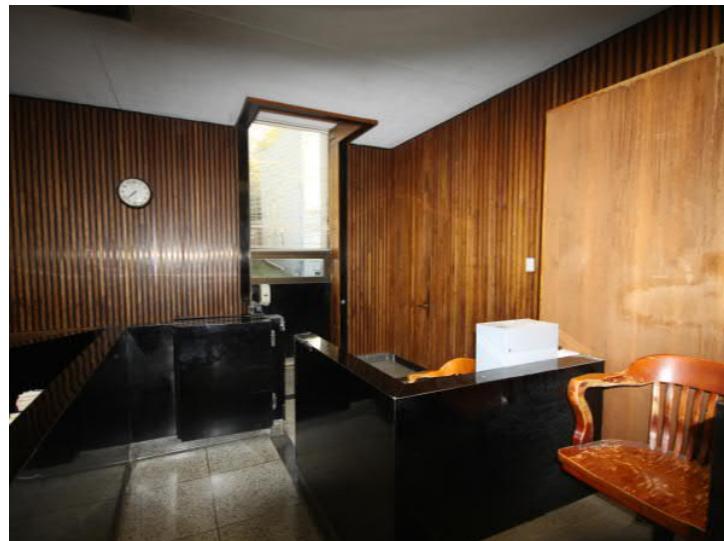
Wood paneling wall finish, suspended ceiling, and terrazzo flooring in courtroom #1.

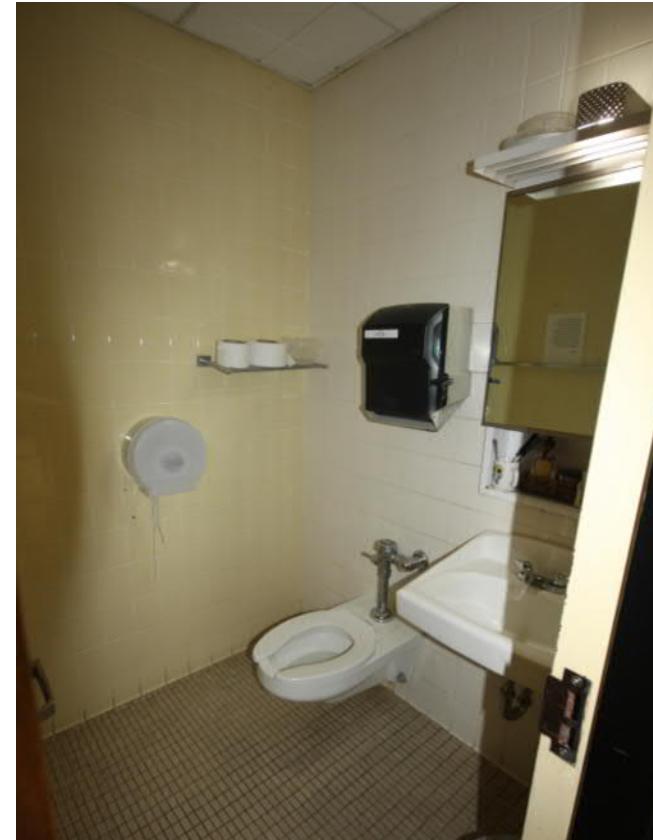
The condition and code compliance of restrooms varies throughout the facility, but they are generally in fair and operable condition. Only the newly-renovated judges and jury restrooms are ADA compliant, all other restrooms appear to be non-compliant with current ADA standards. None of the restrooms at South Station are ADA compliant.

One of many existing restrooms throughout the building that is not ADA compliant.

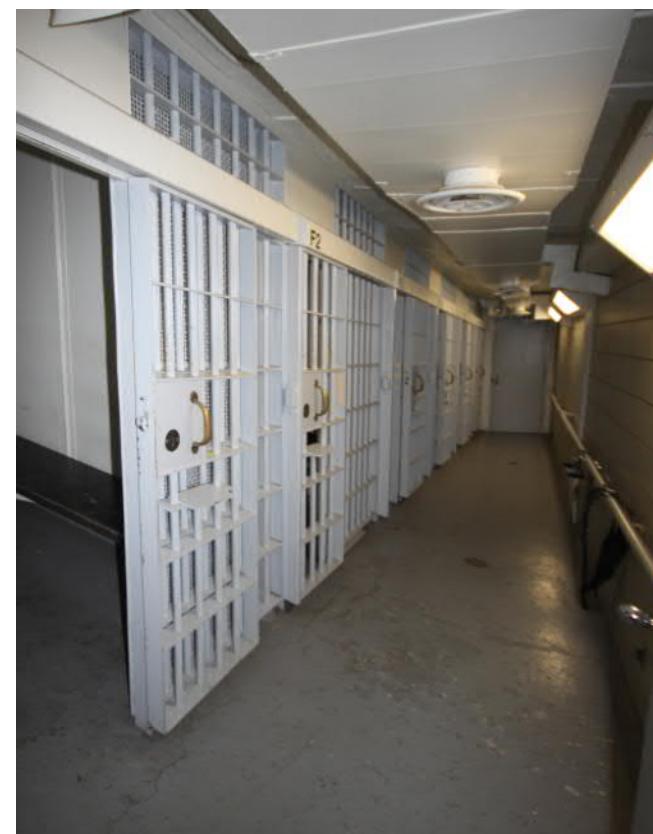
The original holding cells are in good condition and apparently grandfathered in their current configurations, but from a code and OCA standpoint they do not meet current building code and OCA guidelines. Wood benches are in fair condition, worn paint, and scratches on the surface. The plumbing fixtures appear to be operational and in fair condition.

Original holding cells and terrazzo tile floors.

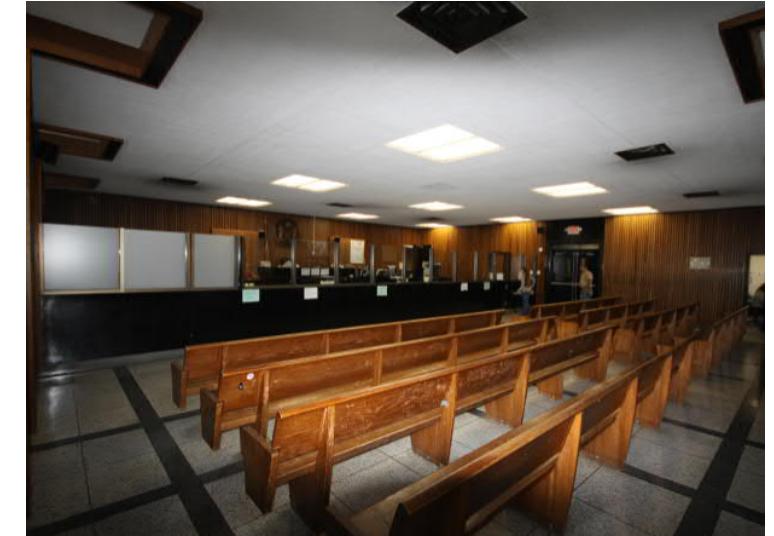
Operationally, the courtrooms appear to be in fair but worn condition; but Courtroom #1 in particular poses significant issues of non-compliance with ADA. Examples include the inability of wheelchair-bound people to pass through the gate into the court space, and there are risers separating the witness stand from the pit and surrounding spaces. In addition, the public areas of the court rooms is generally smaller than what OCA guidelines suggest.

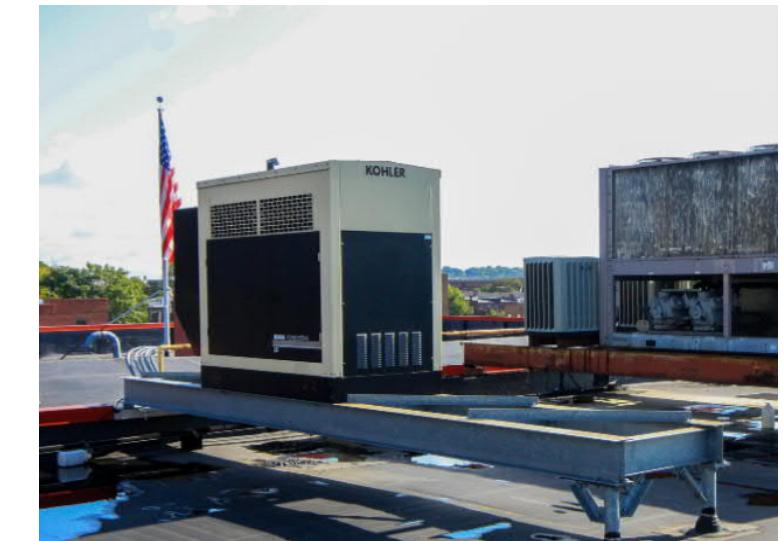
Back-up/Emergency power generator on the roof.

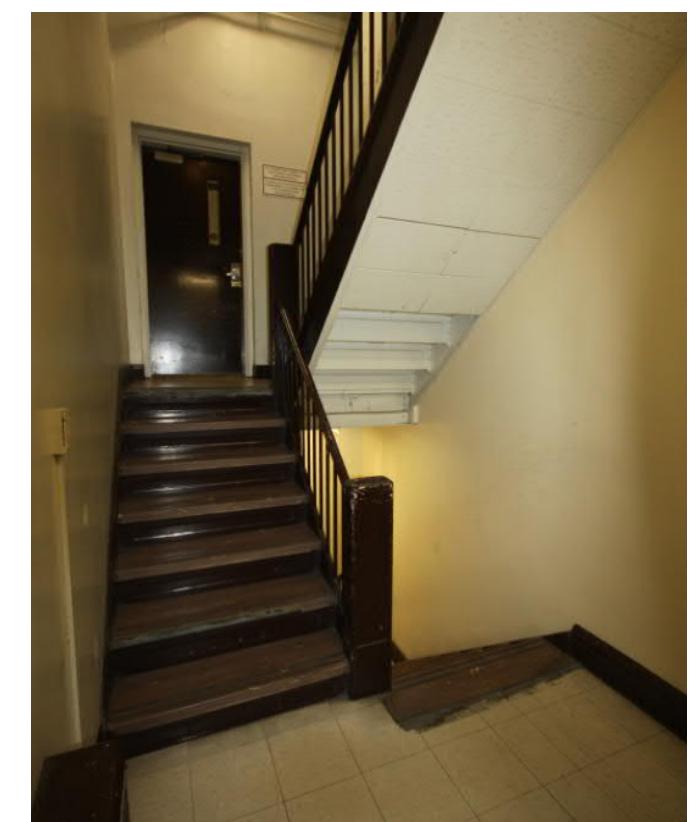
One of the many stairs within South Station. This creates inaccessible pathways to primary functions of the police department.

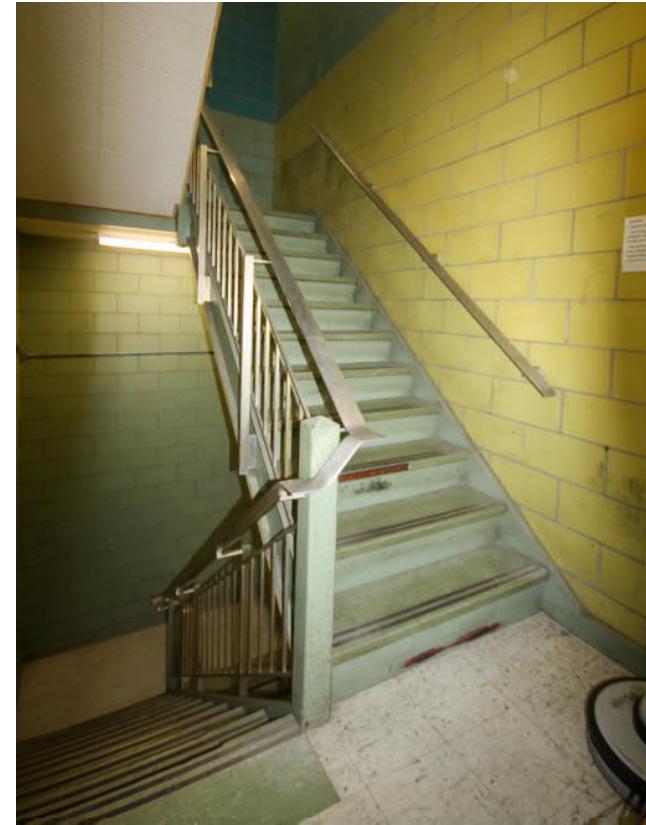
Throughout the building there are many stairways without proper sized areas of refuge for egress stair landings to serve the building's upper floor occupant loads.

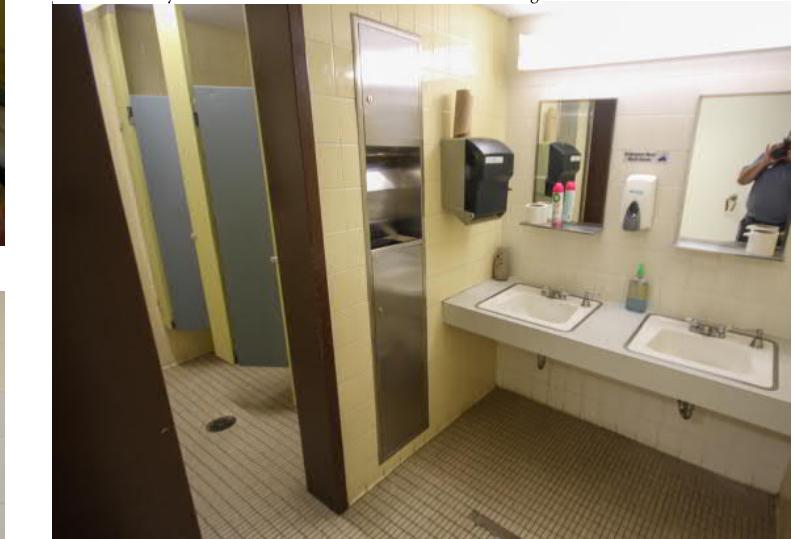
View of the existint public women's restroom. This bathroom does not meet ADA compliance, failing to have a handicap stall and does not have proper sizing for turnaround clearance.

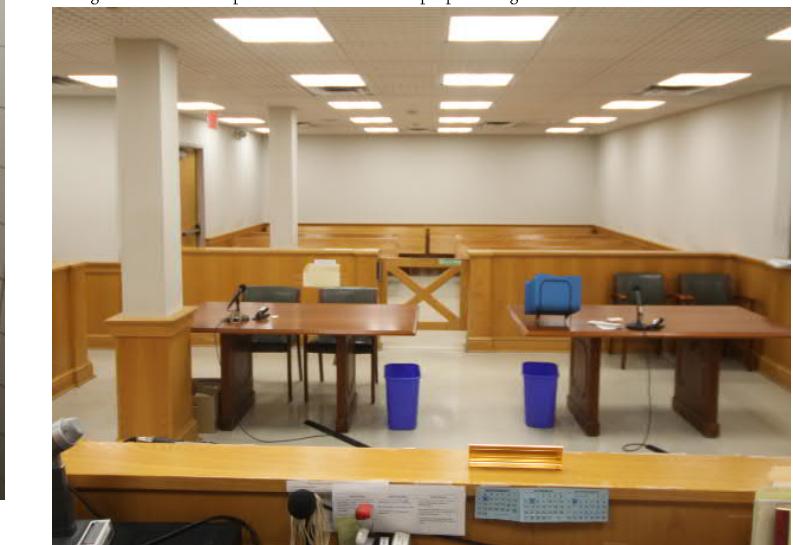
The gate between the benches and seating area is not ADA compliant, making the bench inaccessable to persons in a wheelchair. This does not hold up to the OCA standards of courtrooms.

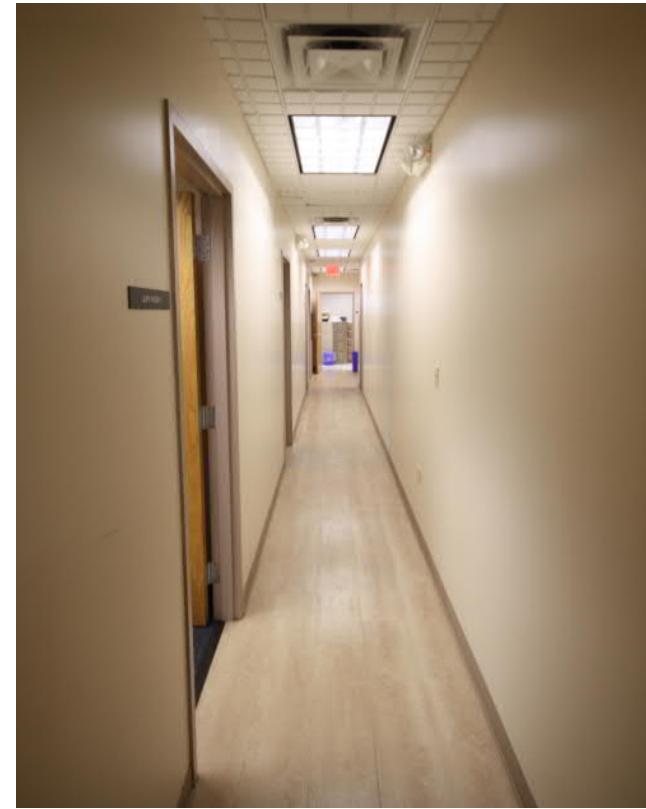
This existing hallway is used by court personnel and the public jury. OCA requires separate pathways for each user including prisoners.
