2. Existing Conditions

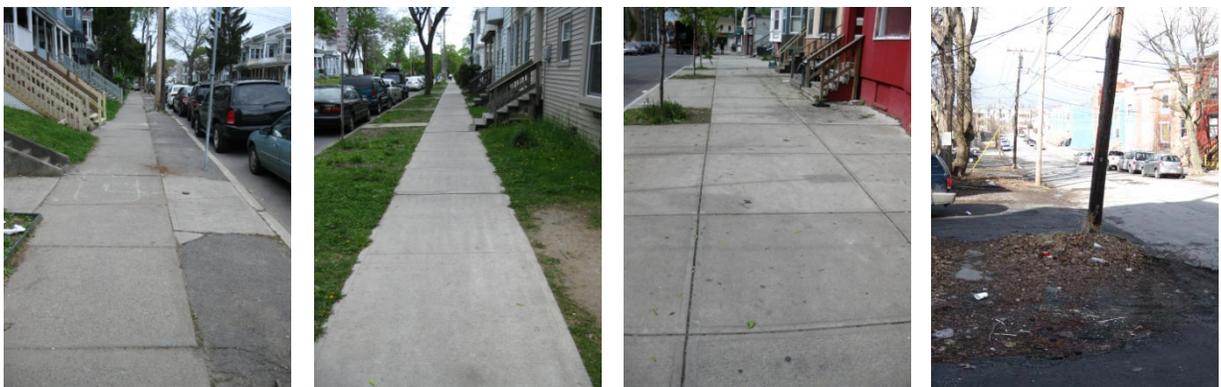
Type A - Consists of a four to five foot wide City of Albany standard concrete sidewalk with a four to five foot wide asphalt maintenance band. The band may or may not include such amenities such as trees, signs, utility poles, and mail boxes.

Type B - Similar to Type A only the band is comprised of grass instead of asphalt.

Type C - Walkway and maintenance bands are uniform concrete pavement from the right-of-way line to the curb. The band area may or may not include amenities such as tree pits, signs, utility poles, telephone booths and mail boxes.

Type D - No sidewalk present.

Typical Sidewalk Types A, B, C, and D respectively.

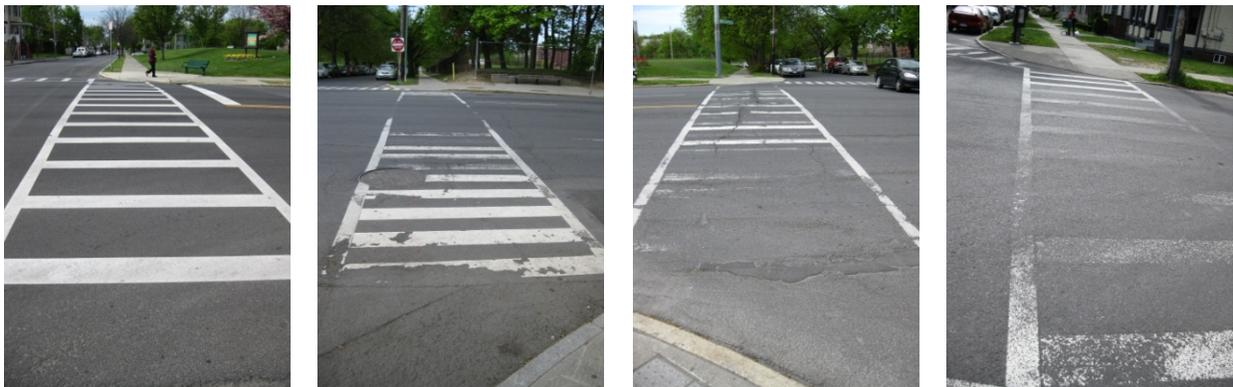
Crosswalks primarily consist of a standard eight foot-wide painted NYSDOT Ladder-style crosswalk, typically located at the north-south street intersections of Madison Avenue, Western Avenue and Washington Avenue. There is evidence of wear in some locations while others appear newly re-installed.

Crosswalks on Washington and Western Avenues in good to poor condition.

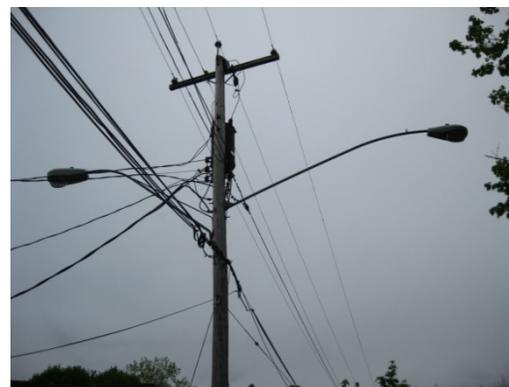
The primary light source for the District are Cobra Head luminaries installed and powered by National Grid (NG). Figure 10 illustrates the locations of these lamps. The lamps and support arms are typically mounted on wooden utility poles approximately 25 to 30 feet above grade and spaced approximately 80 to 140 feet apart. Most are in a single mount configuration while others are double mounted. Wattage ranges from 70 to 1000 watts. Higher intensity lamps of 250 watts are located along the east-west collector streets of:

National Grid Cobra Head Light Fixture

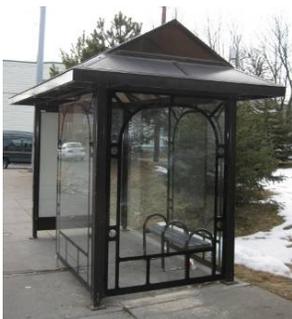
CDTA Bus Shelter

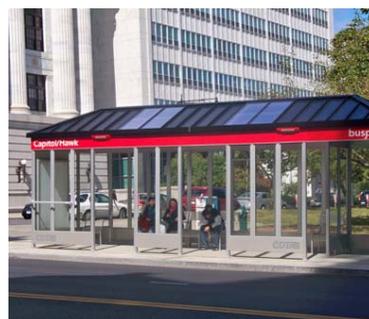
City bus shelters are owned and operated by the Capital District Transportation Authority (CDTA). There are several types of shelters located throughout Albany, some are vintage while others are the newer Brasco International shelters. CDTA, with approval from the City, is replacing old shelters with the newer Brasco shelters on a case by case basis. Installation is predicated on a point system as described in CDTA's Bench and Shelter Program, see Appendix D-2. CDTA is proposing a Bus Rapid Transit (BRT) line for Washington or Western Avenue (route alignment to be determined). For branding purposes, this system uses a different shelter, seen below. The Washington/Western line will have its own color scheme. In the future, a number of shelters along Washington or Western Avenue within the District will be replaced with BRT shelters.

CDTA Brasco BRT Bus Shelter

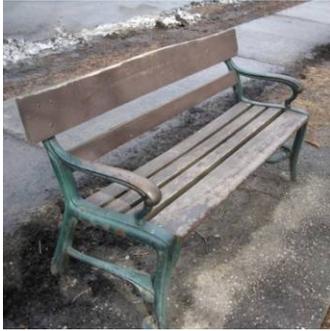
Existing Benches in the Education District

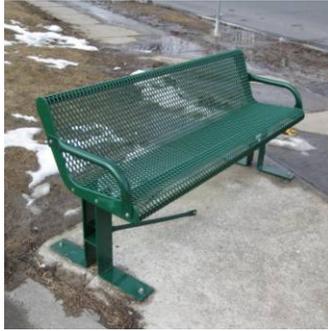
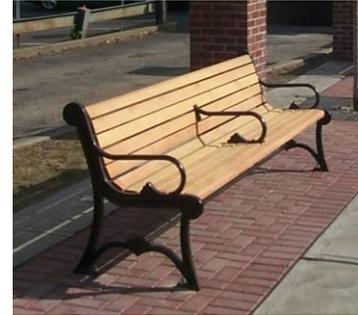
There are several different types of benches used throughout the District from metal to wood and metal/wood combinations. It is noted that the while City of Albany uses a standard bench, the DuMor model 57PL wood and metal bench, none are located in this area of the District. The DuMor bench has an eight foot length with an arm rest in the center to minimize vagrant loitering.

The DuMor Bench 57 on New Scotland Avenue

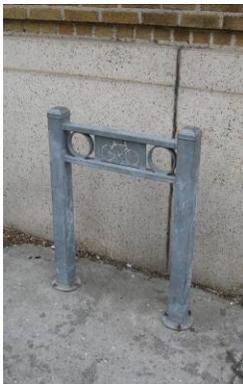
The City of Albany has recently changed the model of its standard bike rack. Previously, the Creative Pipe's model FH-2-F, was placed throughout the City. In many instances these racks have been installed incorrectly such as the one shown below on Madison Avenue. Albany's new standard hoop racks and hitch posts are being installed throughout the City. Numerous new racks are being located within the District. Many of which have been placed using a grant program developed and executed by CDTA.

Poorly Installed
Creative Pipe bike rack

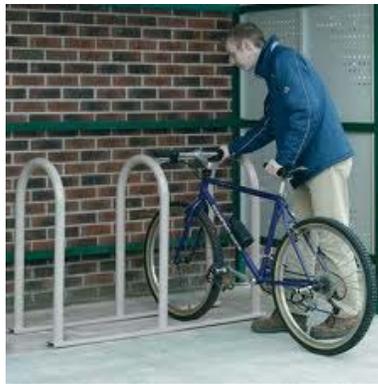
The City's new standard bike rack models, seen in the second and third photos below, are consistent with the City of Albany Bicycle Master Plan.

Standard Hoop Rack

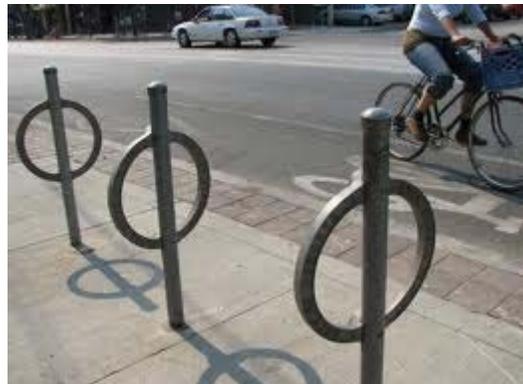
Standard Hitch Post

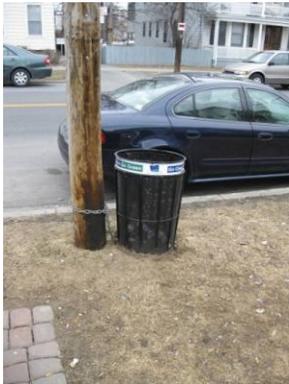
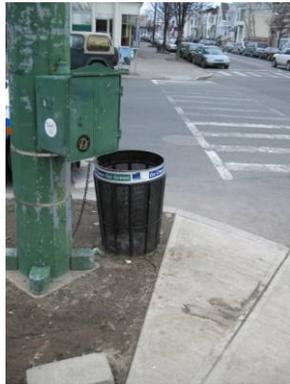
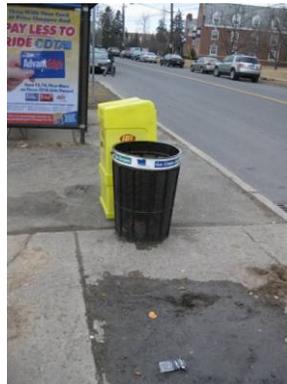
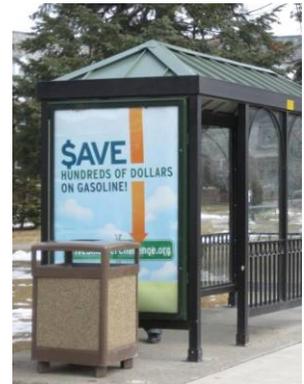
Public trash receptacles consist of DGS's standard metal retainer chained or bolted in place and generally located at collector and connector street intersections. Corrosion is evident on most of the receptacles. There are also trash receptacles adjacent to bus shelters consisting of a metal frame with aggregate stone side panels. As of the completion of the study, no Big Belly solar trash compactors have been located within the District.

City of Albany Trash Receptacles and other Trash Receptacles.

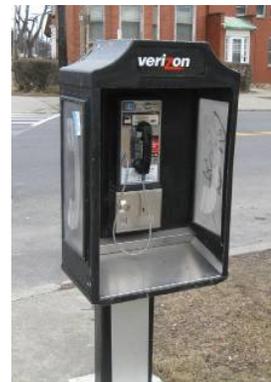
There are several telephone booths located in the study area. These phones are owned and operated by Verizon Communications, Inc. and currently are not profitable for the company. Selected phone booths are being removed as they fall out of service and are not being replaced.

Verizon Telephone Booth

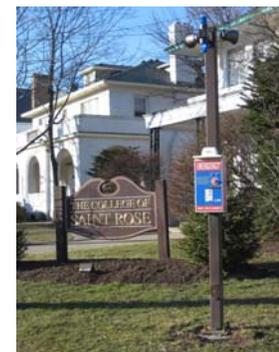
The College and University have installed emergency call boxes in various locations on their campuses. These boxes are installed so that students, staff and visitors can contact campus security in the event of an emergency.

Emergency Call Box
