ALBANY PUBLIC SAFETY BUILDING

FEASIBILITY AND PLANNING STUDY

SEPTEMBER 2020

ALBANY PUBLIC SAFETY BUILDING
Feasibility and Planning Study
SEPTEMBER 2020

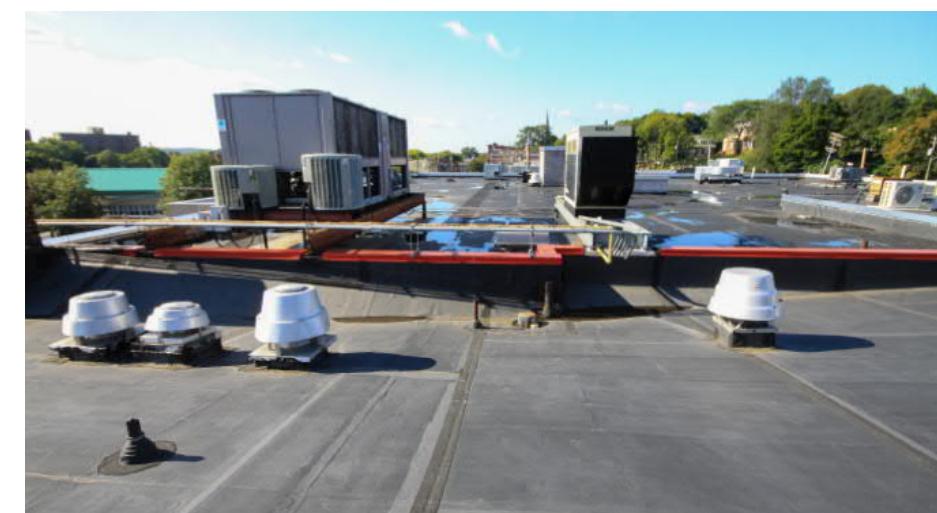
Transition between South Station sloped roof and Morton Ave. EPDM roof.

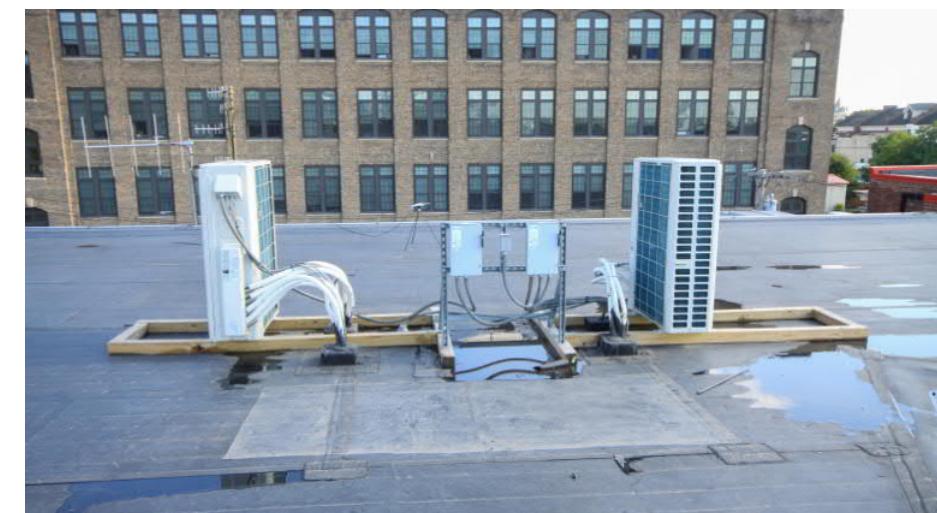
Wood curbing placed directly on top of the roof membrane.

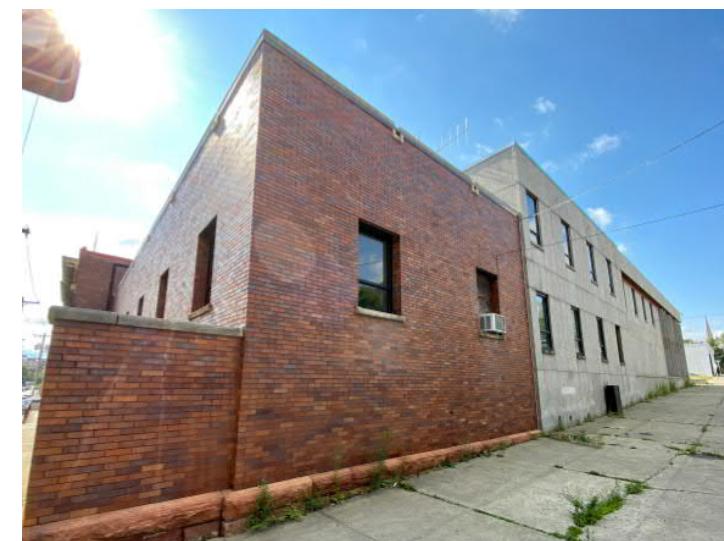
- The historic brick exterior walls and brownstone water table of the South Station building exhibit isolated areas of mild deterioration, chipped and stained stone and brick surfaces, cracked mortar joints and minor settlement issues are generally minor; however, the higher exterior masonry wall at the northeast corner of the station is leaning more significantly and should be investigated further for structural stability.

Historic brick exterior and brownstone water table of the South Station building, joining with the granite cladding of the Morton Ave portion of the building.

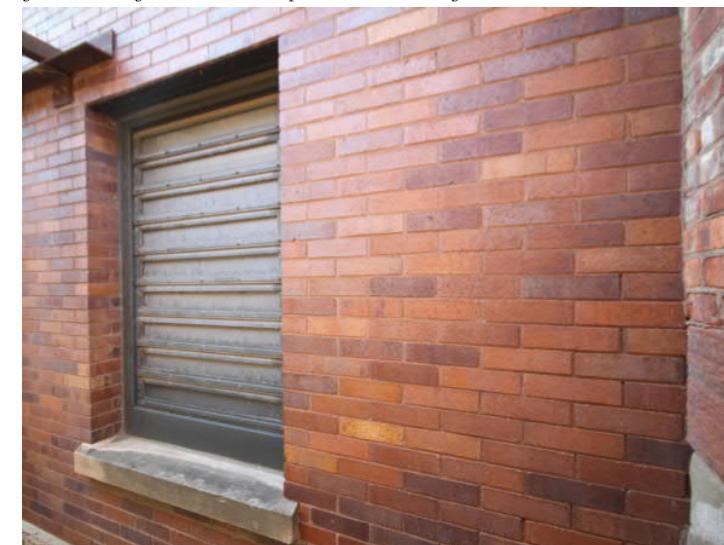
Close up of historic brick of South Station facade.

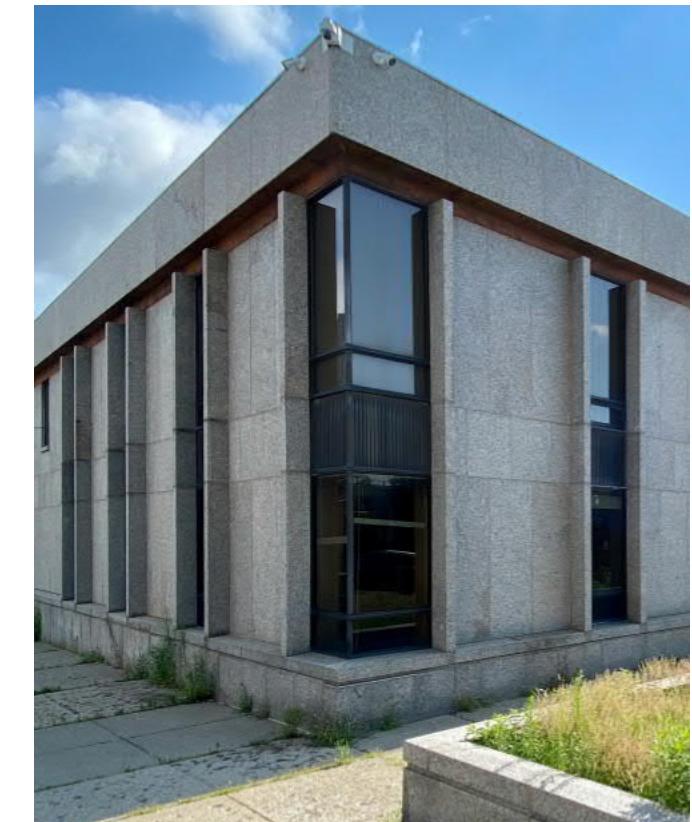
Corrosion can be seen from the exterior side of the frames. Evidence of water infiltration can be seen on the interior gypsum header and jambs, and some window sash had broken or otherwise compromised vacuum seals between panes at the insulated glazing panels. None of the glass fenestration appears to be bulletproof or otherwise rated for impact-resistance.

Existing windows of the Morton Ave courthouse section of the building.

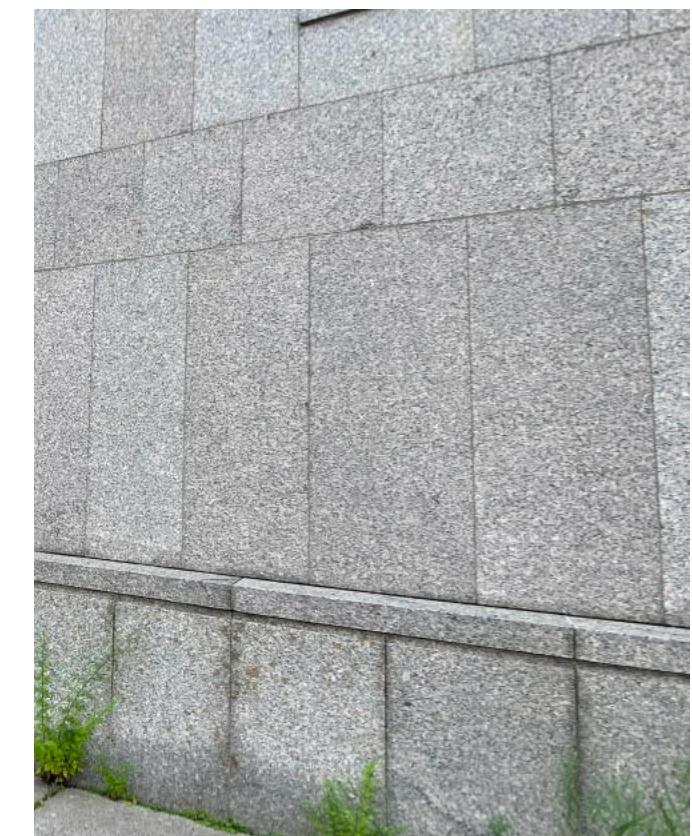
- The granite cladding comprises the majority of the remaining façades, and while the panels themselves are in relatively good condition, the mortar joints between them on the east and west facades have cracked, and/or broken its bond from the surrounding stone panels. In 2015, a campaign to repair the west end (main entrance façade and short returns on the east and west walls) was conducted, utilizing sealant in the joints, since the panels exhibited significant movement. Some of these sealant joints have separated but the majority of the work is intact.

Granite cladding of the Morton Ave portion of the building.

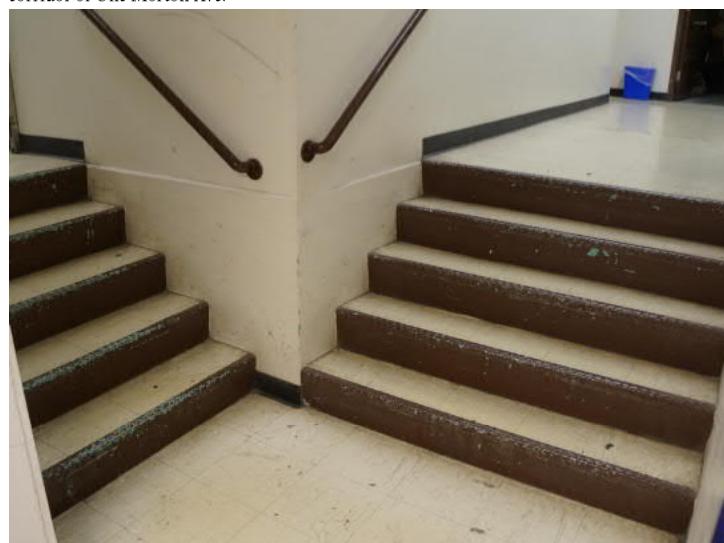
Stairs throughout the facility are in fair condition, but do not appear to meet code requirements. Many of the stairs are open and unprotected with a rated enclosure and do not serve as a proper fire stair. Original steel stairs with slate tread appear to be in good condition, with typical wear that can be seen in the surface of the slate tread. Rubber tread and riser covers have been installed over select stair runs and appear to be loosely fitted and could cause a tripping hazard.

One of many convoluted areas of the building where stairs are installed due to multiple renovations to the interior of the structure creating mid levels.

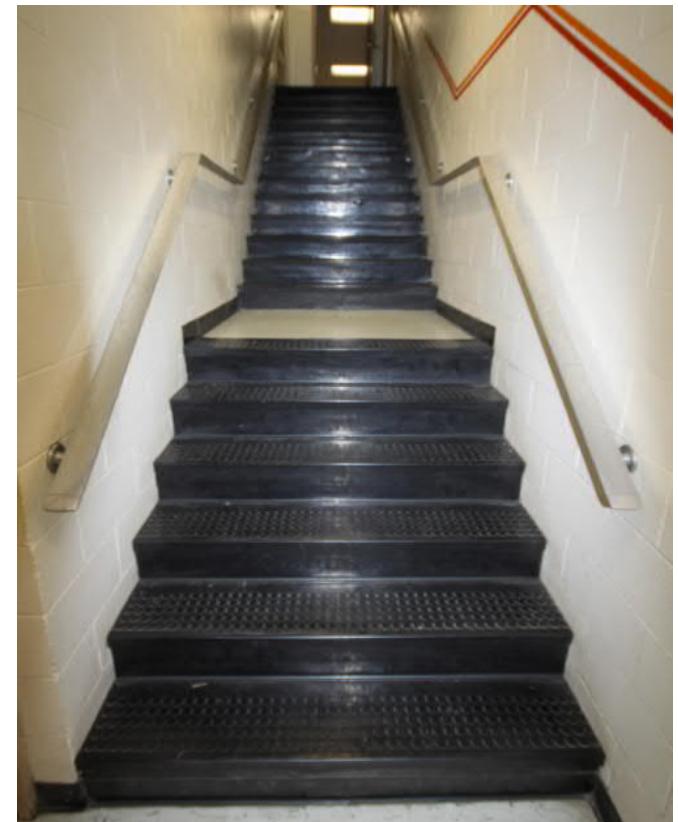
Rubber tread risers and covers installed over stair.

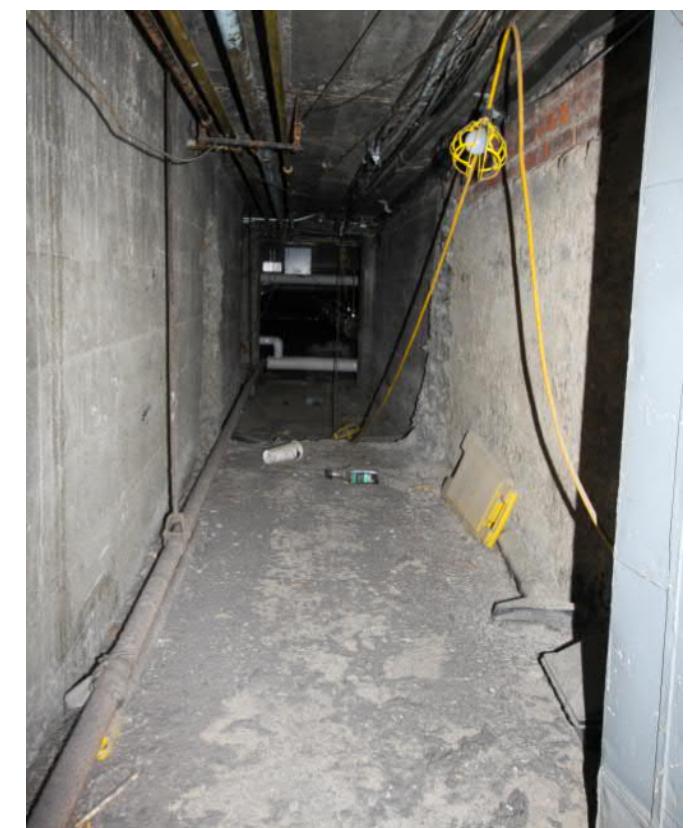
Crawlspace on Level 0 beneath the holding cell area of South Station section of the building.

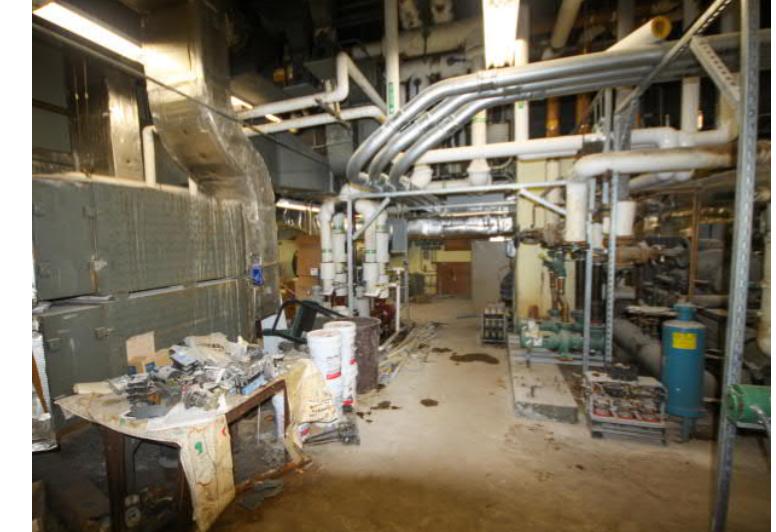
Mechanical room on Level 0 is crowded with currently used and abandoned equipment and parts.

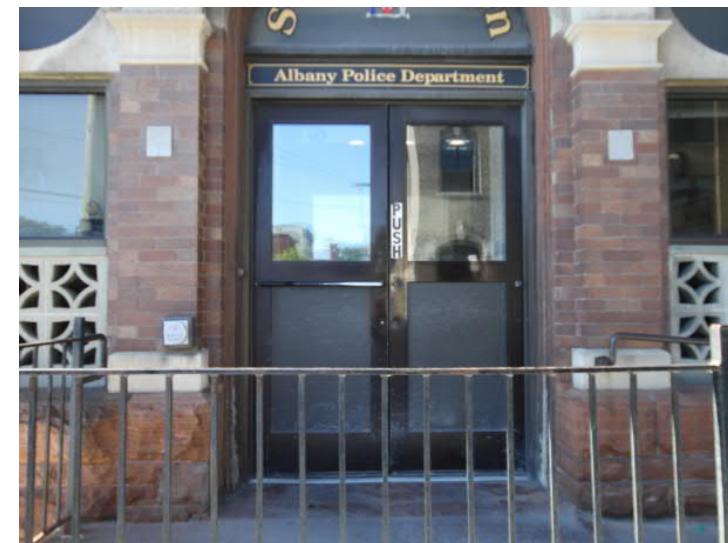
The Arch Street entrance to the South Station Police Department has a double pair of inward-swinging doors. As part of the path of egress, these doors should swing out, and changes thus should be made to the accessibility hardware to the door and actuators to accommodate this change. The exterior concrete ramp and landing with guard rail otherwise appear to provide code-compliant, accessible entry to the police station.

At the entrance of South Station, the double doors swing inward, which to code should swing outward since it is a means of egress.

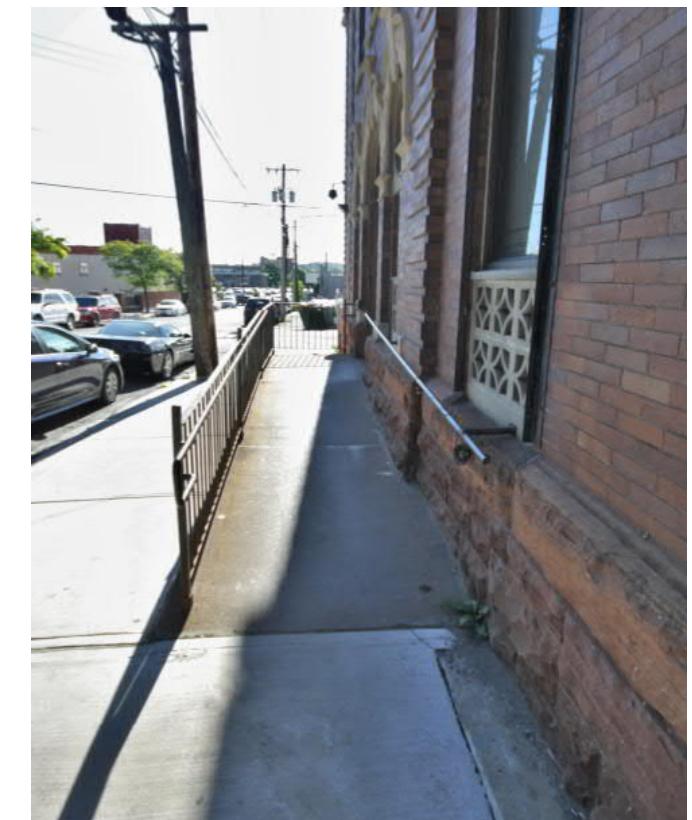
Existing ramp at the entrance of the South Station, providing an accessible route into the main lobby of the police station.

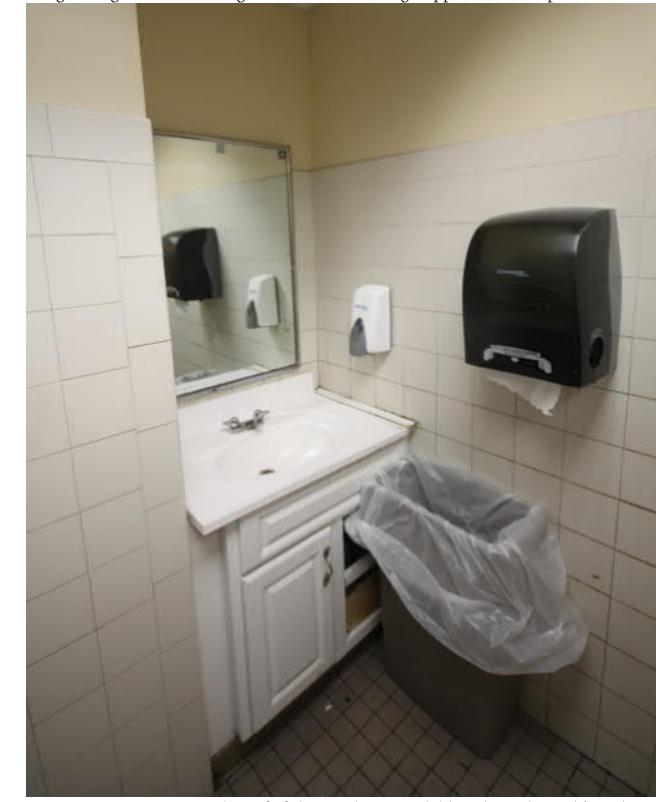
Existing restroom on Level 1, off of the South Station lobby. The sink would not be accessible to a person in a wheelchair, as well as the soap dispenser, and the paper towel dispenser should be mounted high to prevent someone in a wheelchair from hitting their head while approaching the sink.

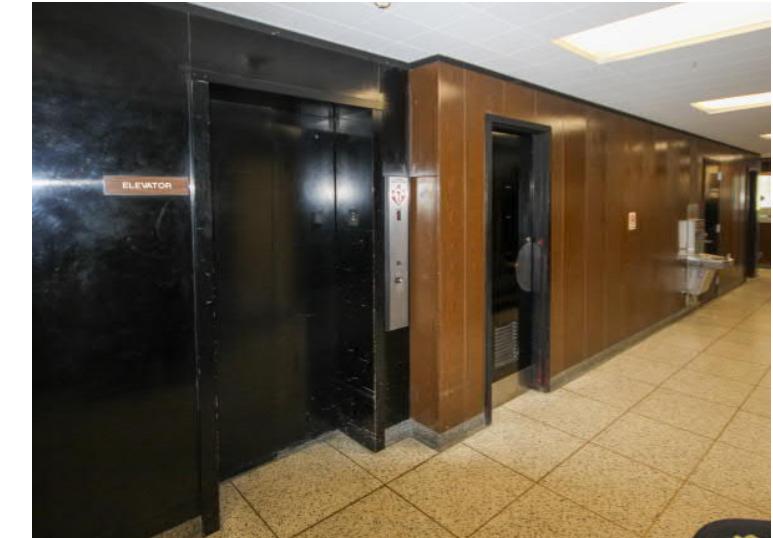
Existing elevator located in the lobby of the Morton Ave section of the building on Level 2 that only serves three out of the four levels of the building.

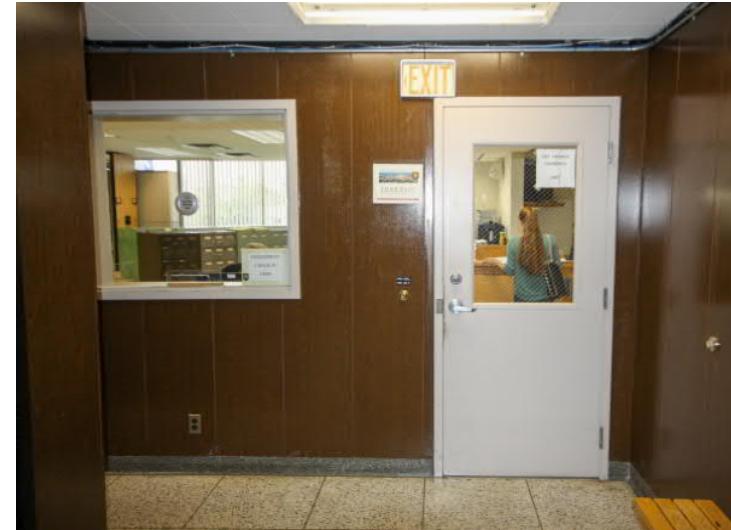
10. Court clerk windows for transactions with the public are not ADA-compliant. The existing clerk counter is above the required height of 2'-6". It is recommended at least one counter be lowered to accessible height.

County clerk's existing transaction window does not meet ADA compliance.

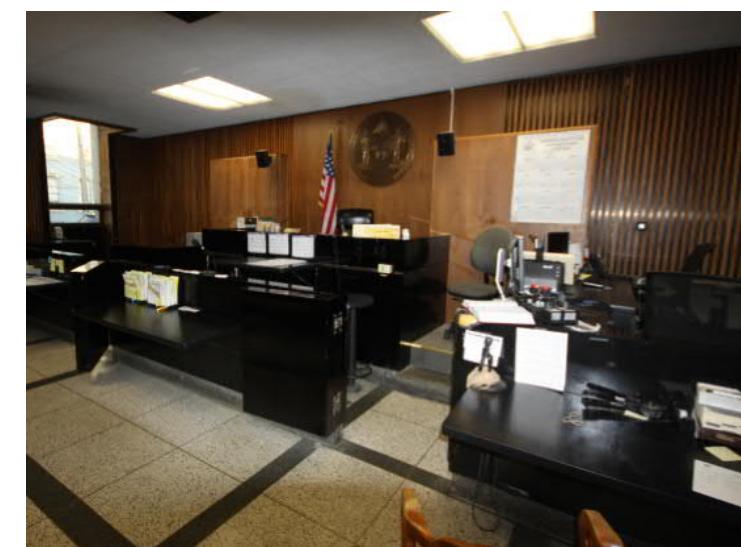
- f. The defendant box is not accessible. It does not provide the required clear floor space or compliant approach to enter or exit the box; and
 - g. The judge's bench is not accessible.

Raised defendant's box does not allow handicap persons to access the box, along with approach clearances.

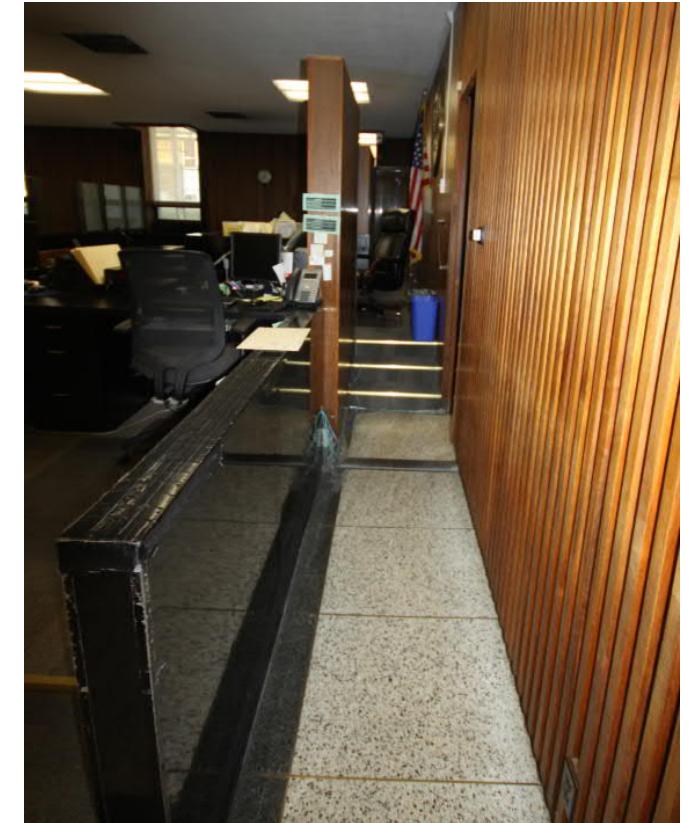
Existing judge's bench in Courtroom #1 is not accessible.

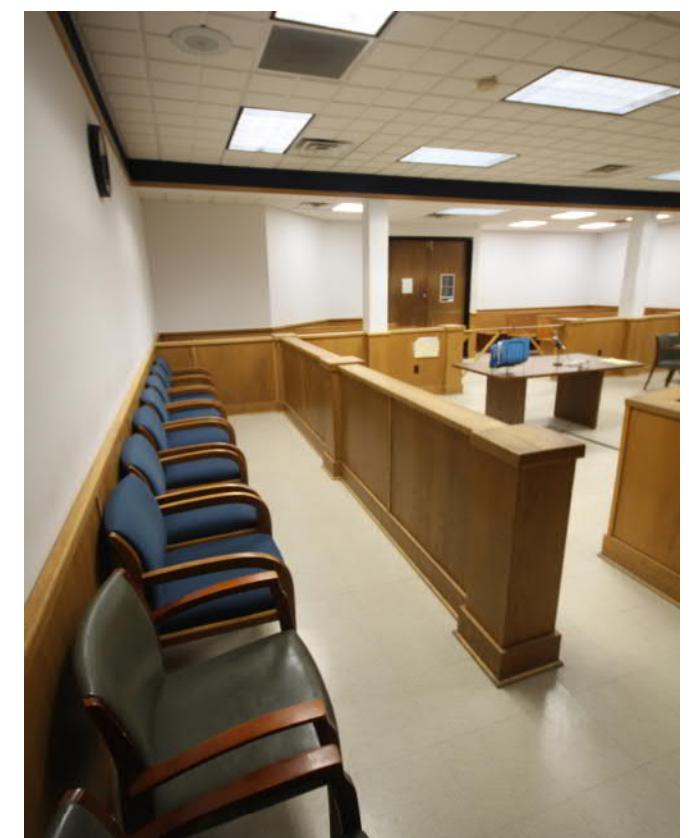
In-accessible jury box in Courtroom #2.

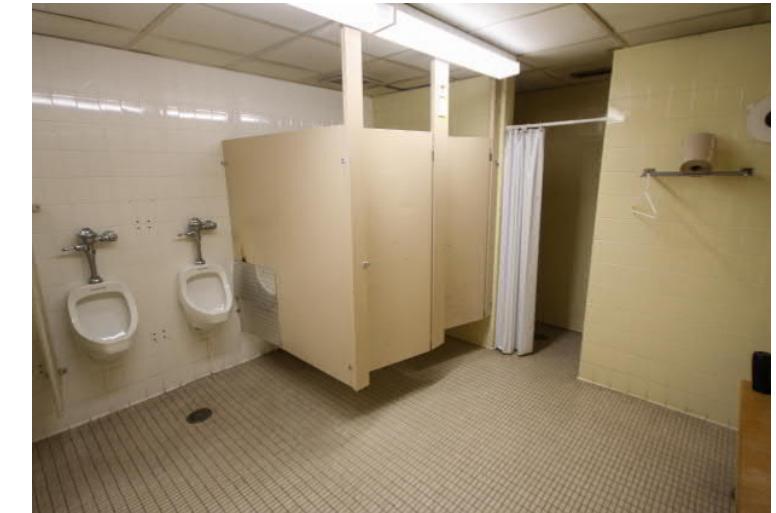
Outdated fixtures and finishes, along with non-ADA compliant urinal, stalls, and shower.

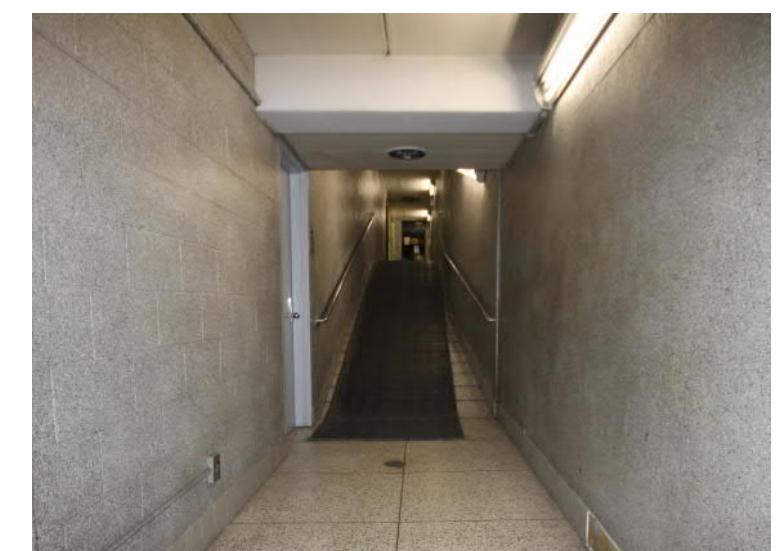
The existing ramp leads from Level 1 to Level 2, bringing incarcerated persons from the holding cells up to the courtrooms. The ramp is not accessible and should contain a landing.

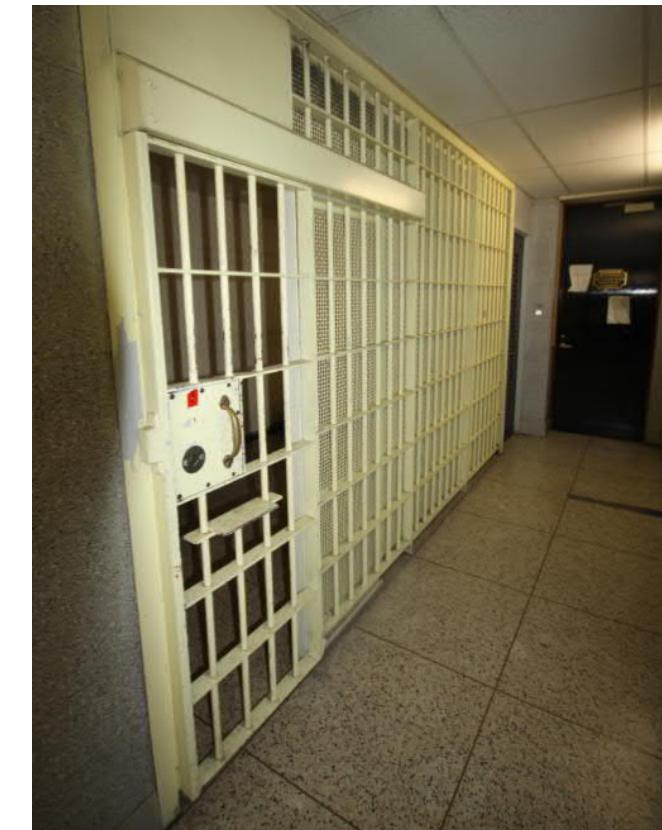
Hallway at the top of the ramp where prisoners are held until they enter the courtrooms. This hallway is the only access point for judges to enter courtroom #1.

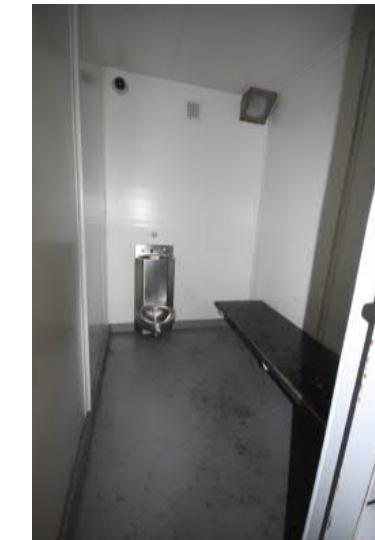
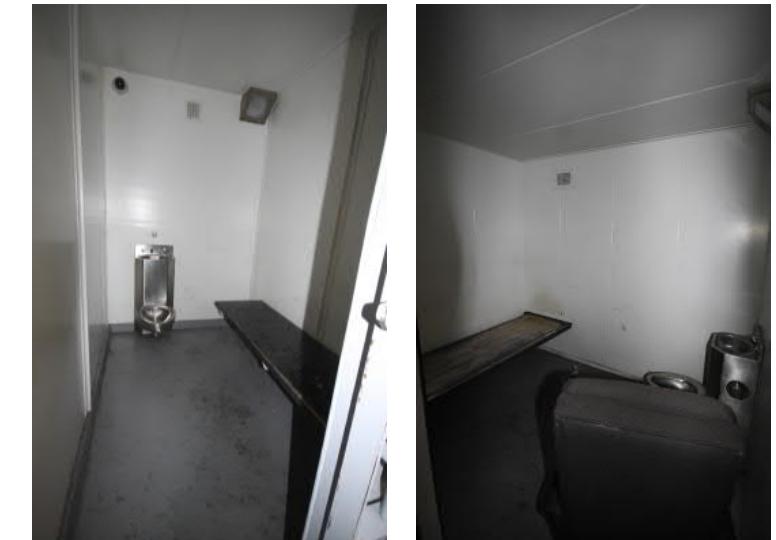
12. There are several considerations that should be made for the lack of dedicated, ADA-compliant accommodations for holding cells. At least one or otherwise 2% of the total number of cells shall be provided with mobility features complying with 807.2 of the ADA 2010 Standards. Further study is needed to determine if existing holding cells are otherwise compliant.

Both photos show views of the interior of a holding cell. This is the typical layout for all of the existing holding cells, with no consideration toward ADA accessibility.
