ALBANY CITY HALL MASTER PLAN

100% DRAFT: AUGUST 2020

John G. Waite Associates, Architects PLLC
384 Broadway, Albany NY 12207
64 Fulton Street, Suite 402, New York, NY 10038

EXTERIOR CONDITIONS ASSESSMENT

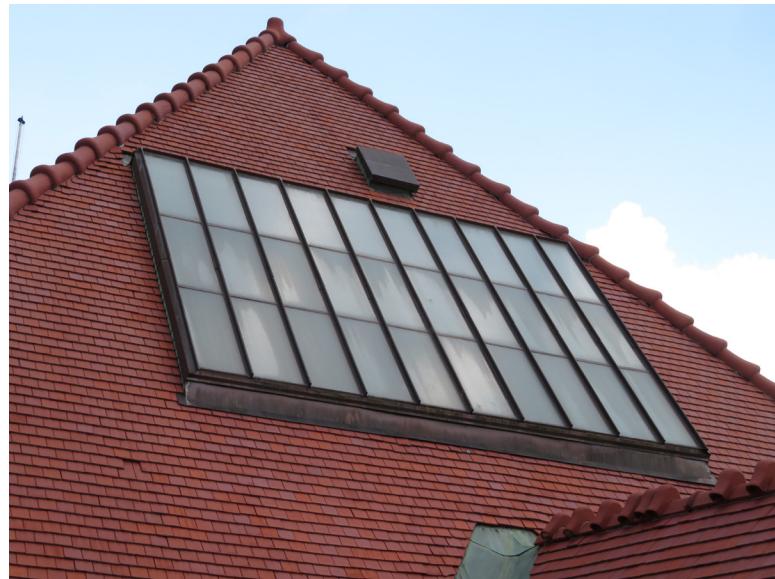
Restored rotunda skylight. The base flashing between the skylight and the roof was not replaced. JGWA, 2019.

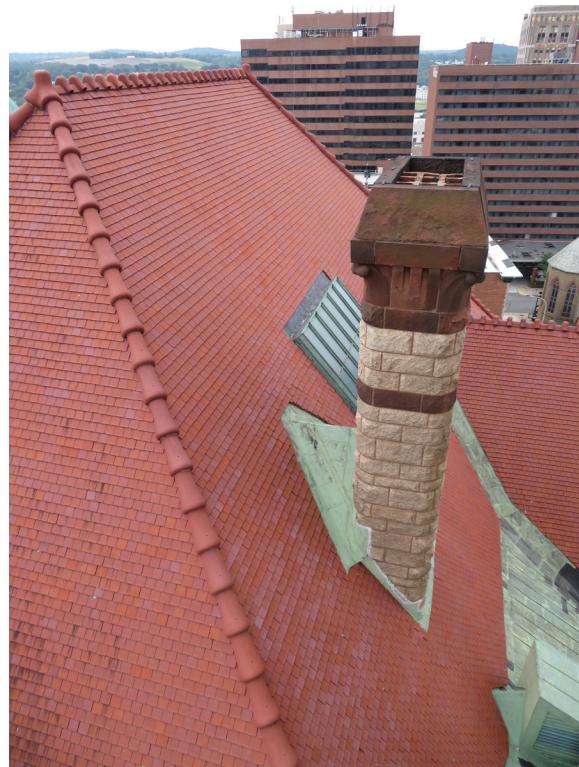
Overview of south slope of roof with chimney, skylight, and large copper-lined valley. JGWA, 2019.

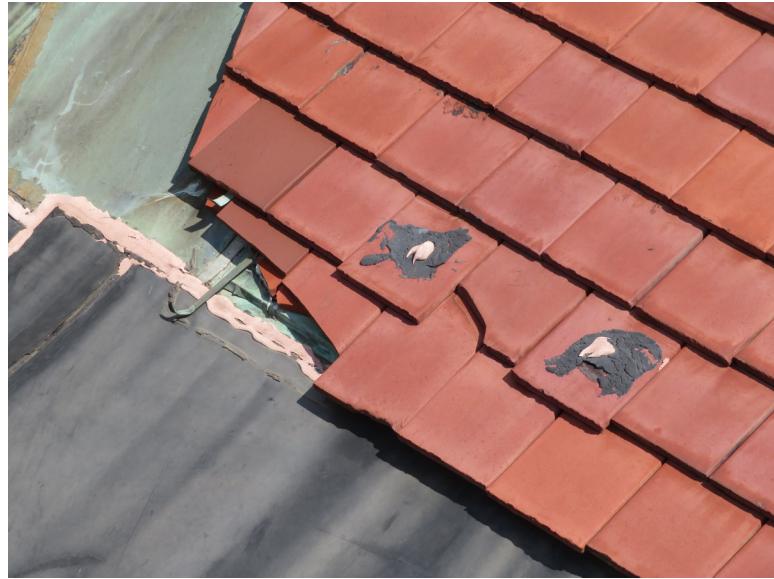
Broken and patched terra cotta roof tiles and membrane patch on top of worn copper roofing. JGWA, 2019.

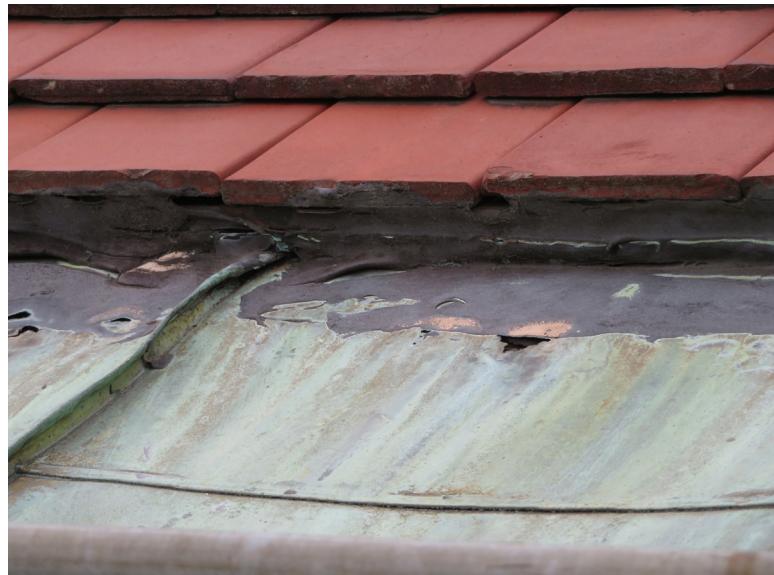
Scoured copper with visible holes where thinned copper has lifted. Mastic has been coated to the bottom of the adjacent tiles in an attempt to stop leaks. JGWA, 2019.

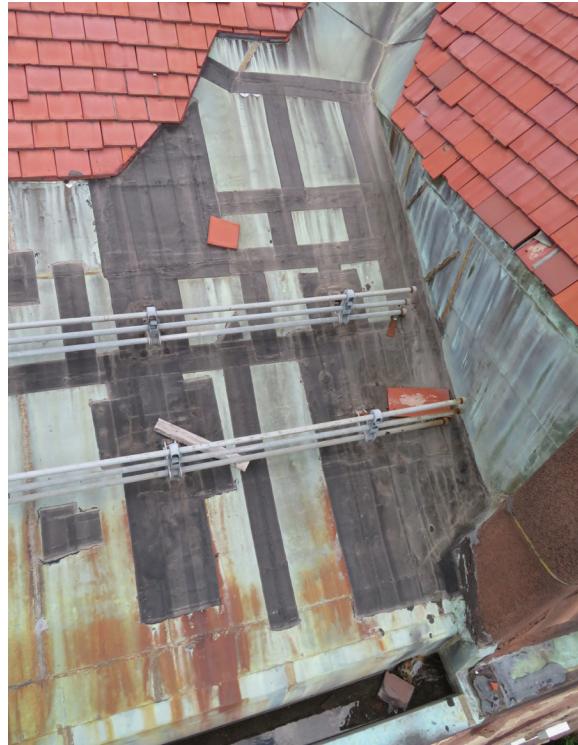
Multiple membrane patches over deteriorated copper at east elevation. Broken terra cotta tiles can be seen on the gutter and behind the snow guards. JGWA, 2019.

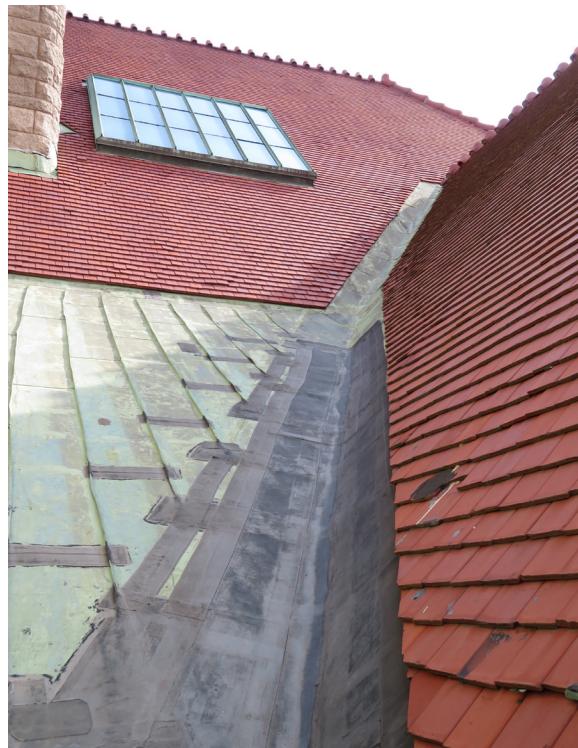
Large membrane patch at valley with smaller patches at seams and damaged tiles at south elevation. JGWA, 2019.

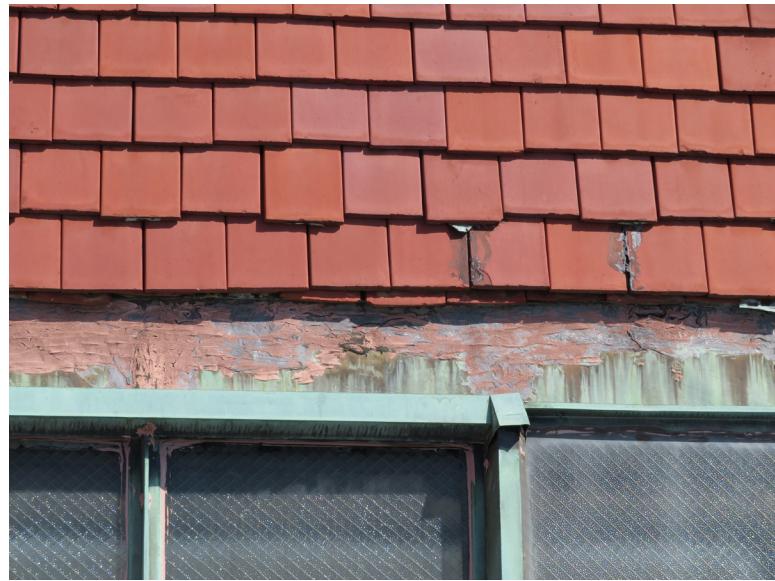
Mastic and missing cap flashing at head of south-facing skylight. Several terra cotta tiles have dropped out of position. JGWA, 2019.

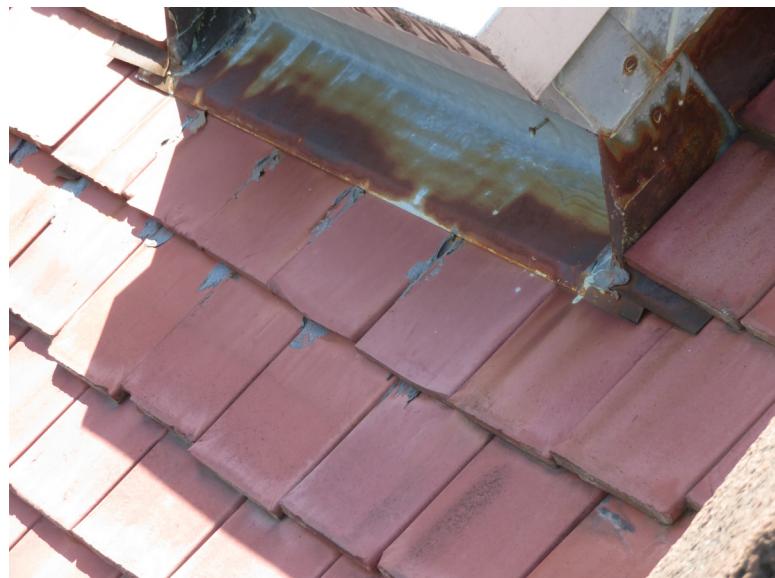
Loose anchors, galvanic corrosion, and loose tiles at base of skylight. JGWA, 2019.

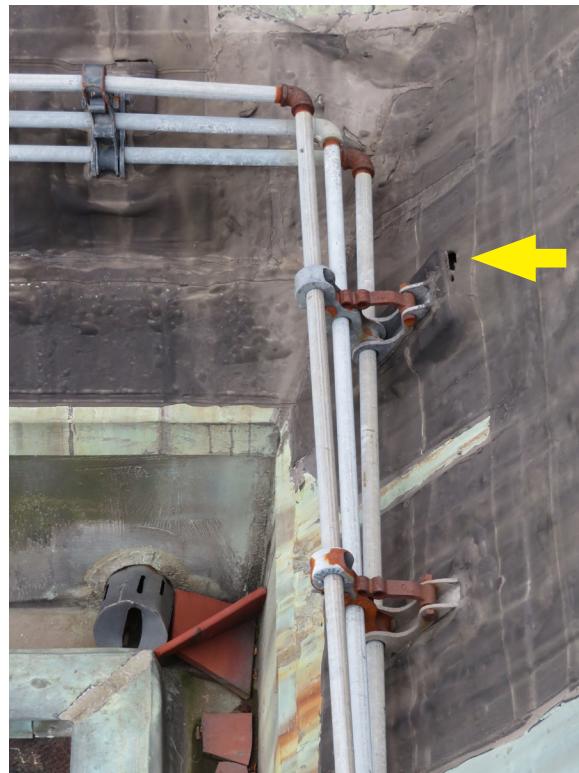
Membrane torn around lifted base plate of displaced snow guard on north elevation. JGWA, 2019.

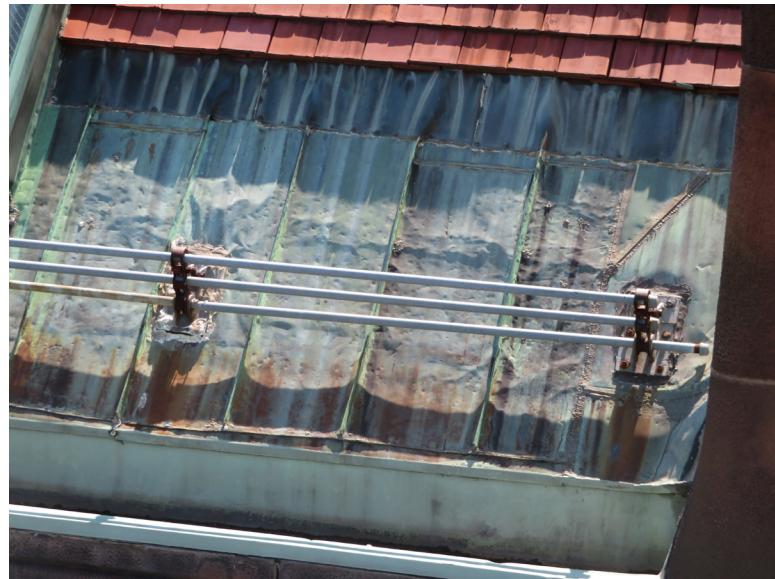
Thin copper deformed by wear and impact damage. Base plates for snow rail provide an access point for water. JGWA, 2019.

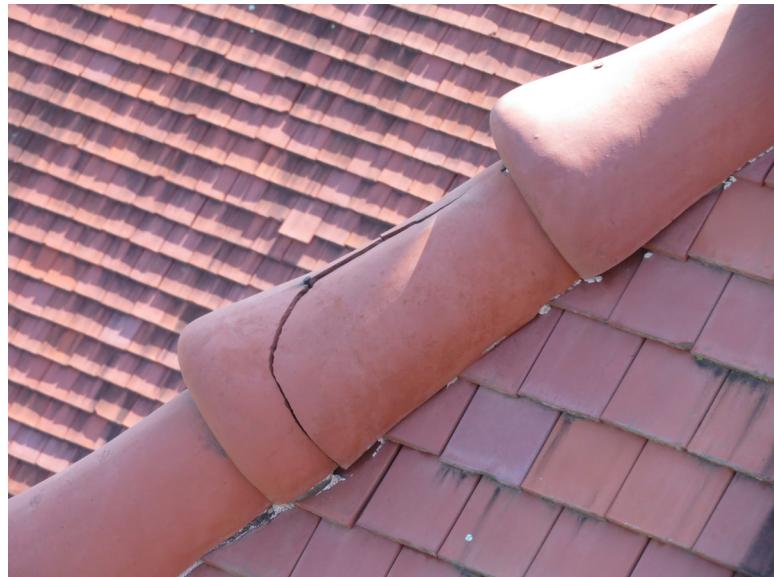
Badly cracked hip tile at northwest hip. JGWA, 2019.

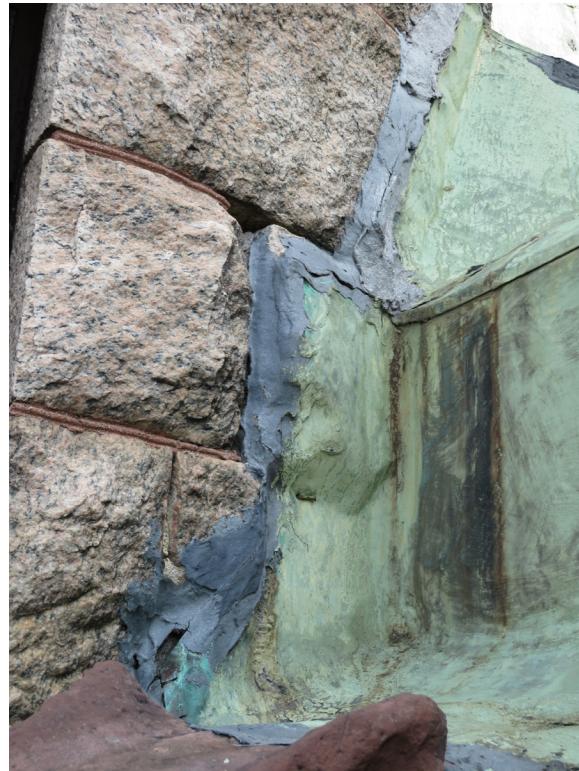
Mastic buildup at the junction of the roof and the east face of main tower and an open mortar joint adjacent. JGWA, 2019.

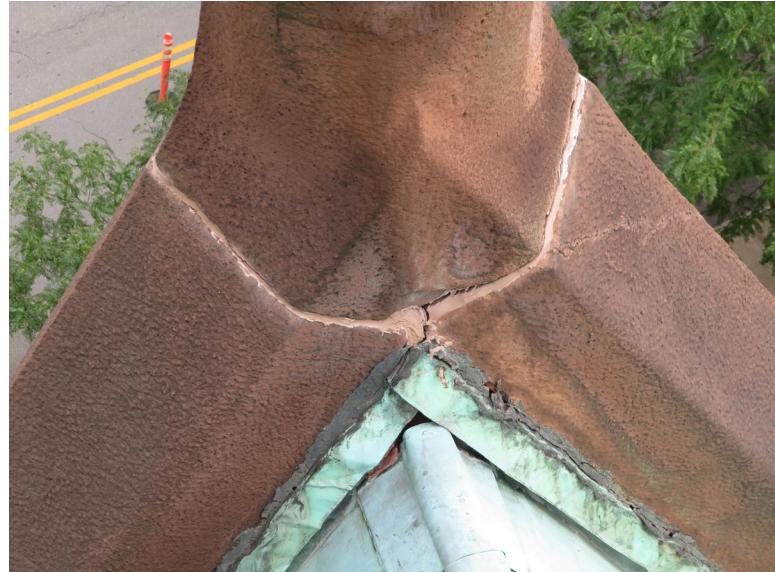
Cap flashings with exposed gap at ridge at north-facing projecting bay. A gap in the sealant and the cracked coping indicate movement. JGWA, 2019.

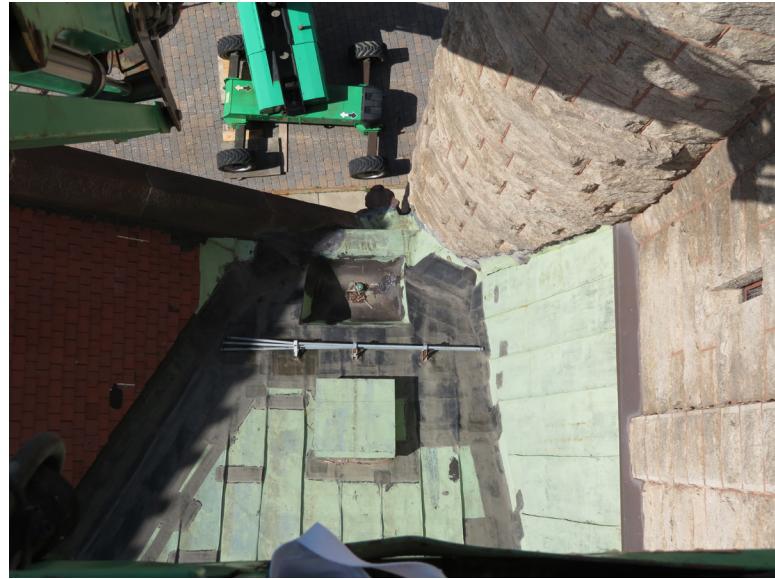
The complex and troubled valley between the main tower and the south gable.
JGWA, 2019.

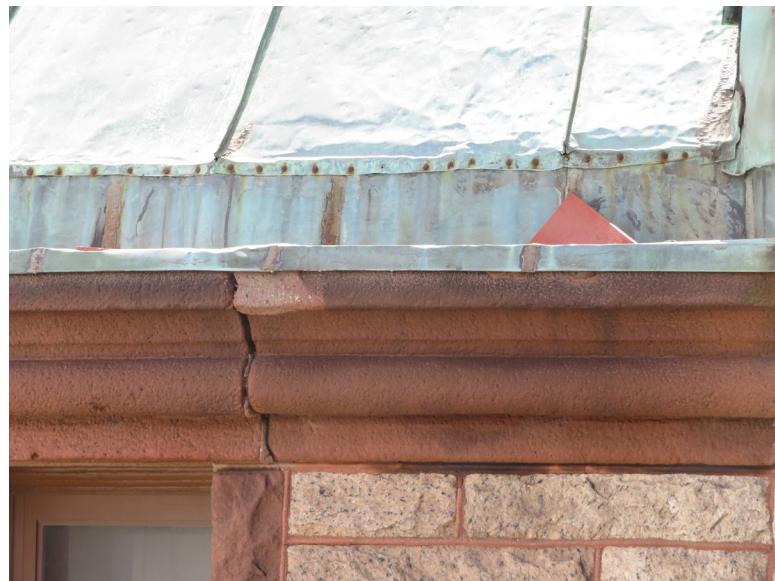
Ferrous nails through face of copper gutter. Roof tile in gutter with patched edge of brownstone below. JGWA, 2019.

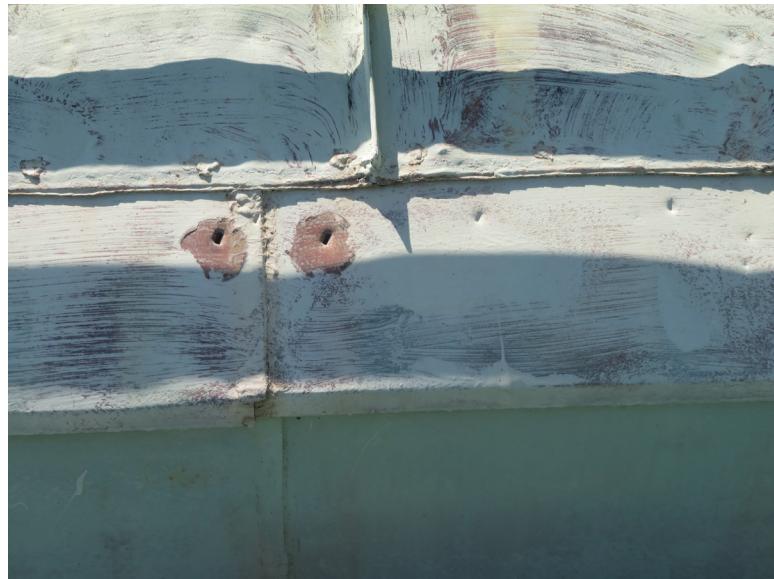
Holes in copper above gutter. JGWA, 2019.

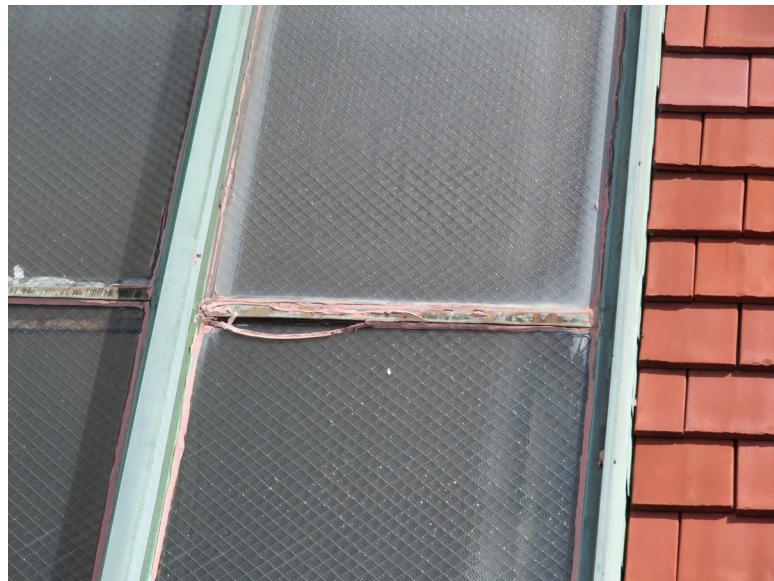
Sealant repairs and sealant failure at south skylight. JGWA, 2019.

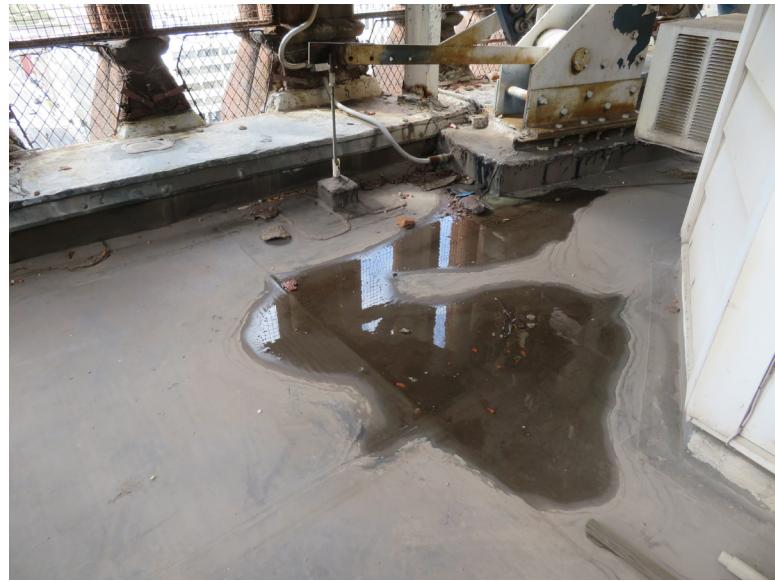
Water collecting at membrane roof at the bell level of the main tower. JGWA, 2020.

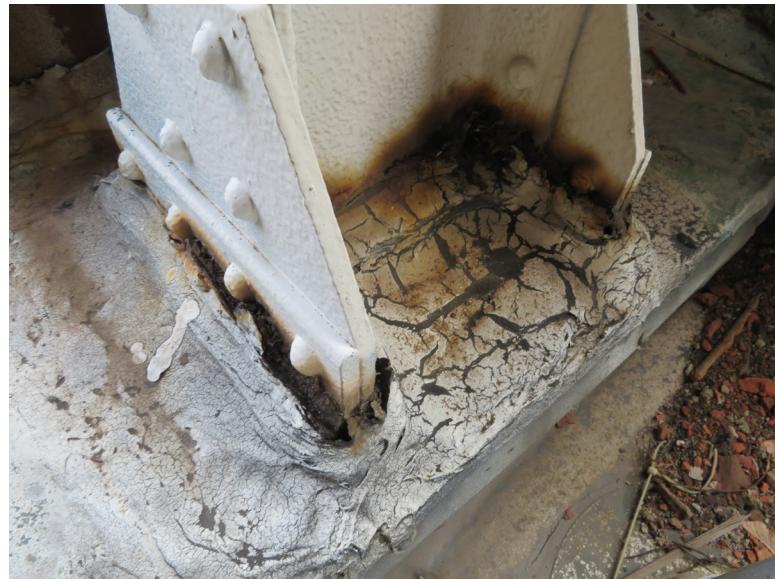
Built up and cracked mastic at base of steel framing bell level of tower. JGWA, 2020.

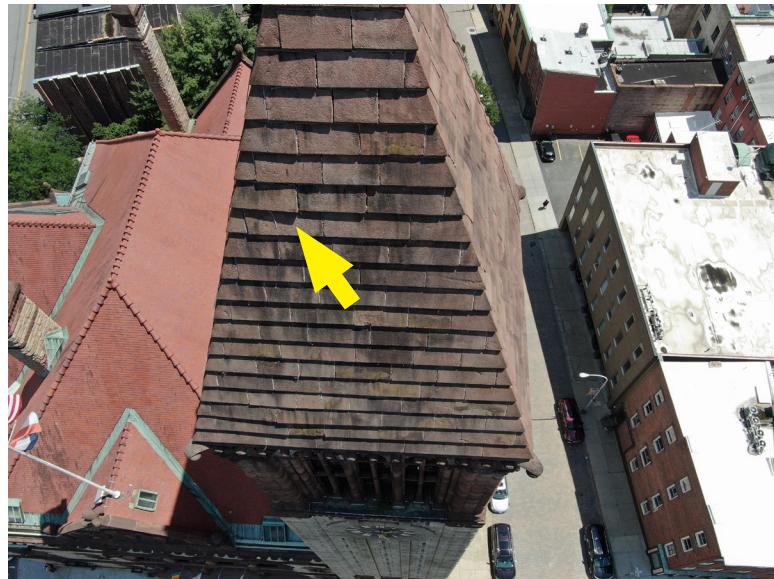
Displaced cladding stones in the west face of the masonry roof of the main tower. Most joints in this roof have failed and provide multiple routes for water ingress.
[Image from Albany DGS/Water Dept.]

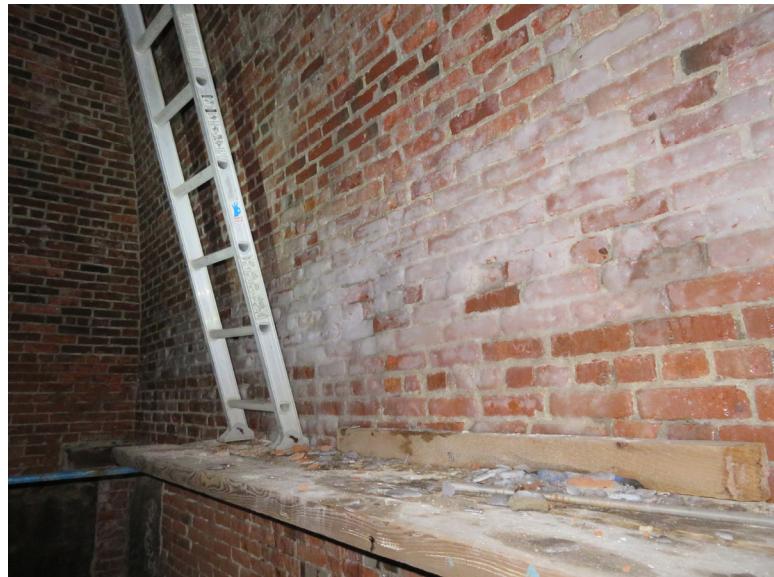
Ice buildup on south face of the interior of tower roof caused by open mortar joints on the exterior. JGWA, 2020.

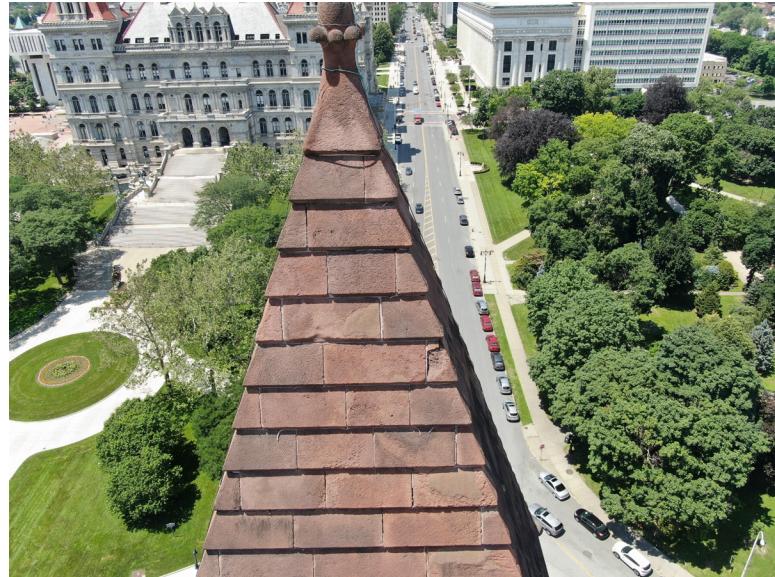
Deteriorated and patched stone work on the top of the east face of the main tower roof. Albany Water Department, 2019.

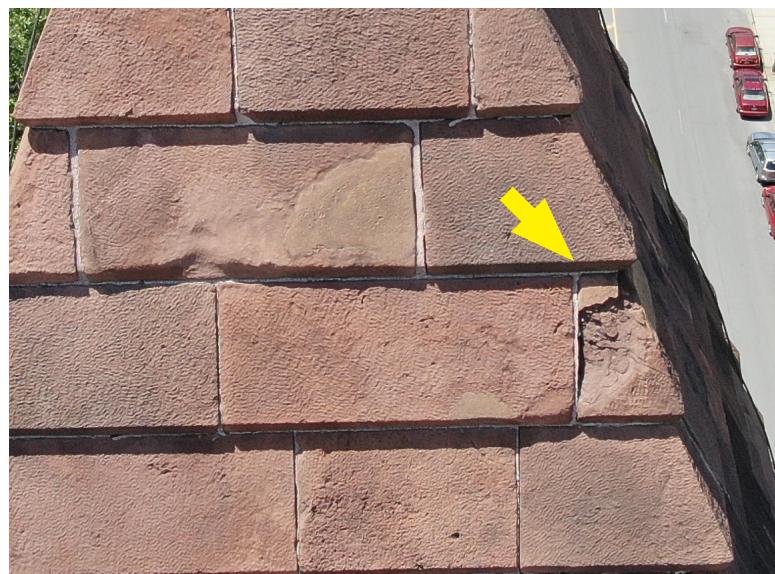
The stone seen above on the east face of the main tower roof has deteriorated badly. A patch from the 1970s work has failed. The surface of the stone to the upper left has eroded substantially. Albany Water Department, 2019.

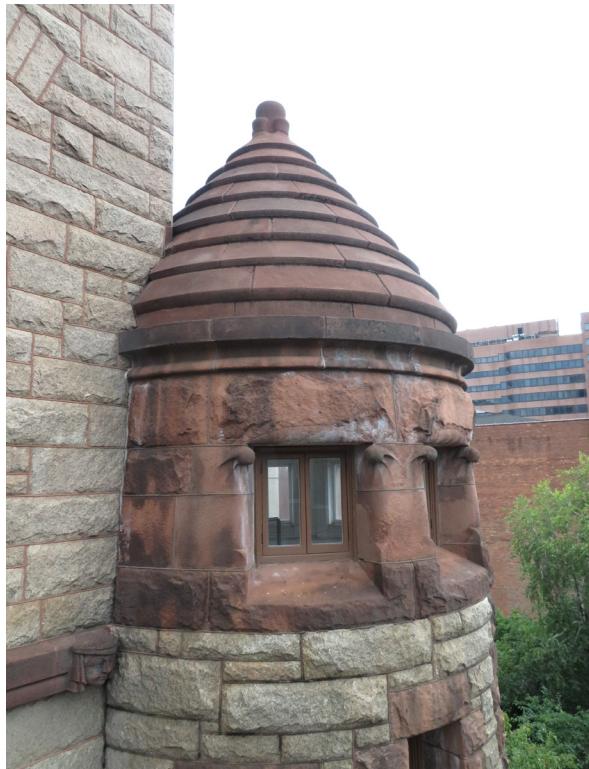
SOUTH ELEVATION

The southeast tower roof with signs of water runoff below the cornice where there is no drip edge. JGWA, 2019.

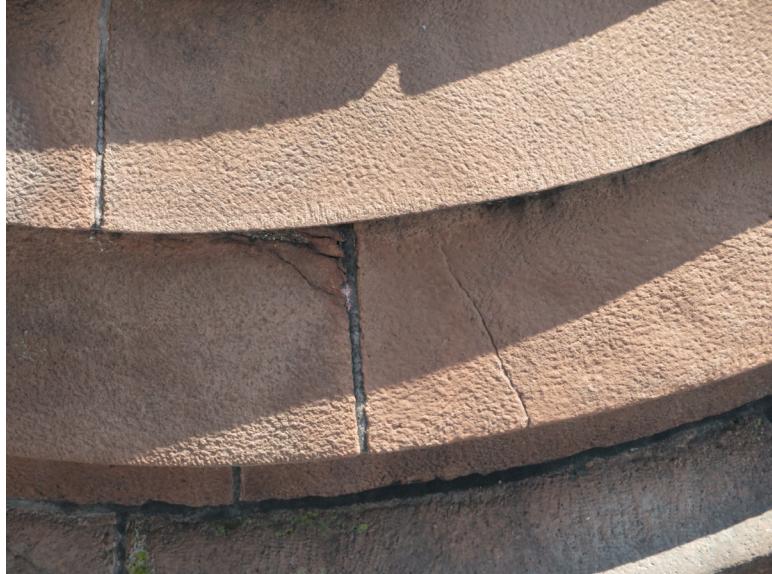
Cracked roof stones and failed joints at southeast tower. JGWA, 2019.

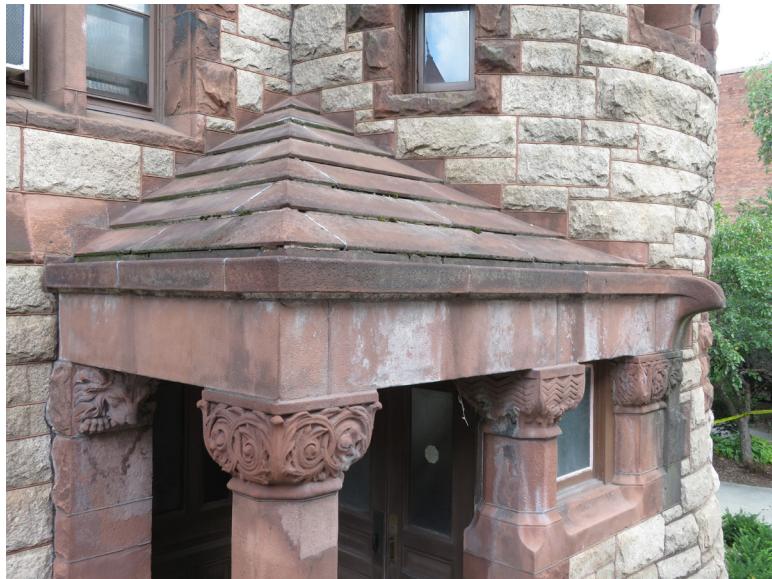
SOUTH ELEVATION

South entry porch roof. Joints have been filled with lead wool in 2006. JGWA, 2019.

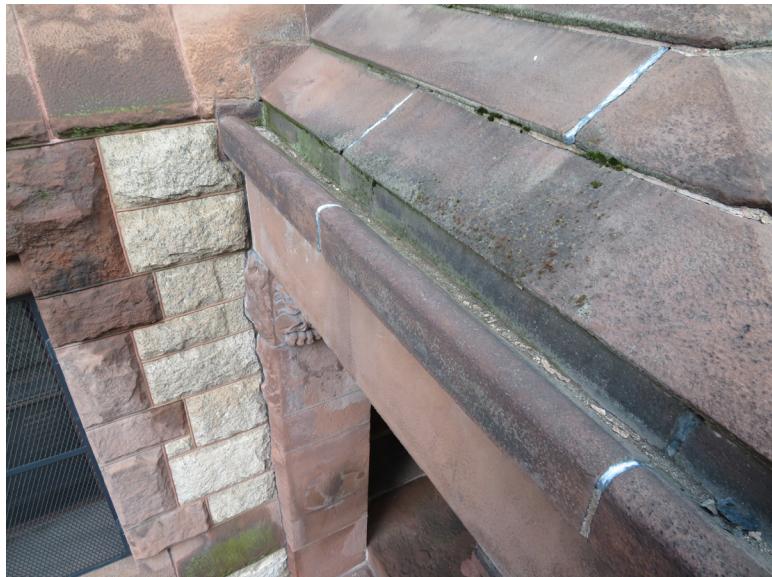
Moss buildup in joints and debris in stone gutter at south entry porch. JGWA, 2019.

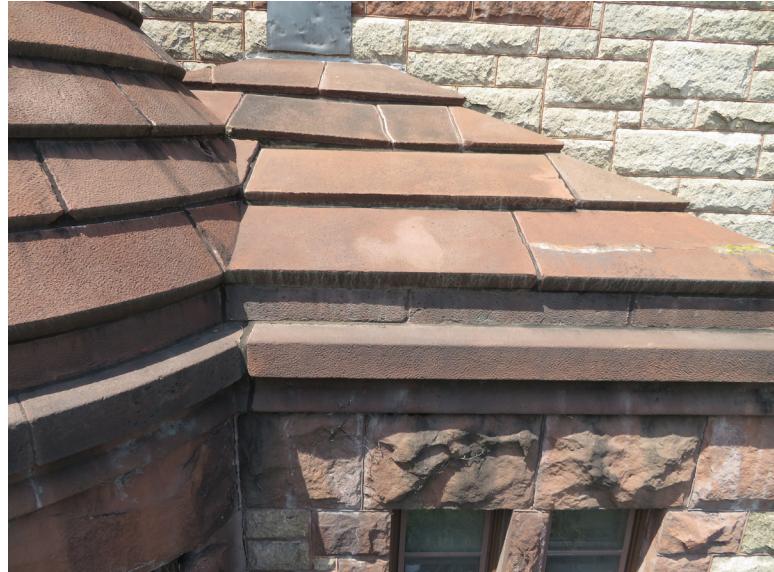
Cracked and displaced stones caused by settlement of the units. The area below was entirely rebuilt in 1916-1920. JGWA, 2019.

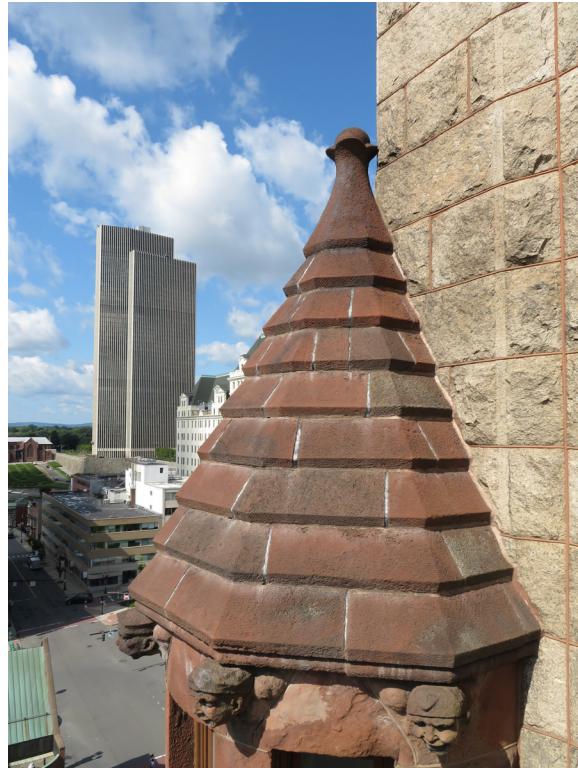
SOUTH ELEVATION

The tower stair roof was repaired in 2006. As part of that repair, lead wool was installed in upward-facing joints. JGWA, 2019.

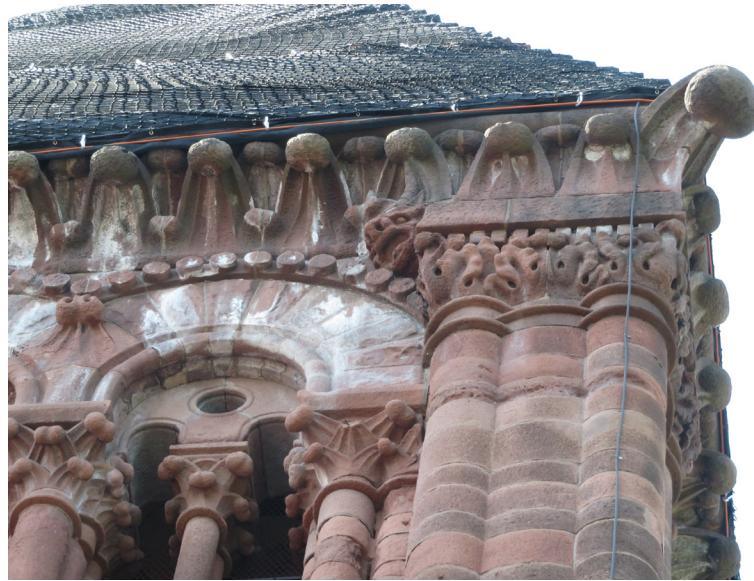
WEST ELEVATION

White staining (lime scale) from deteriorated mortar joints at the tower roof and its substructure. JGWA, 2019.

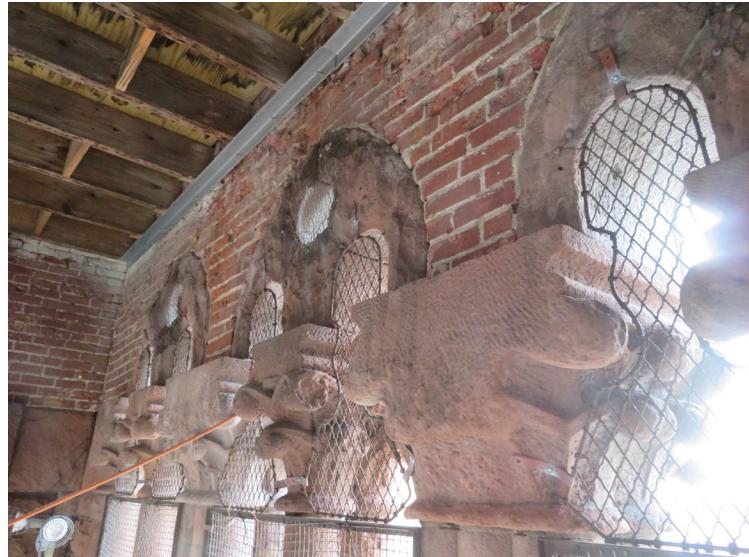
Deteriorated stone in the arches at the top of the main tower. The metal grates are secured with ferrous metal anchors that have caused spalling of the stonework in some locations. JGWA, 2019.

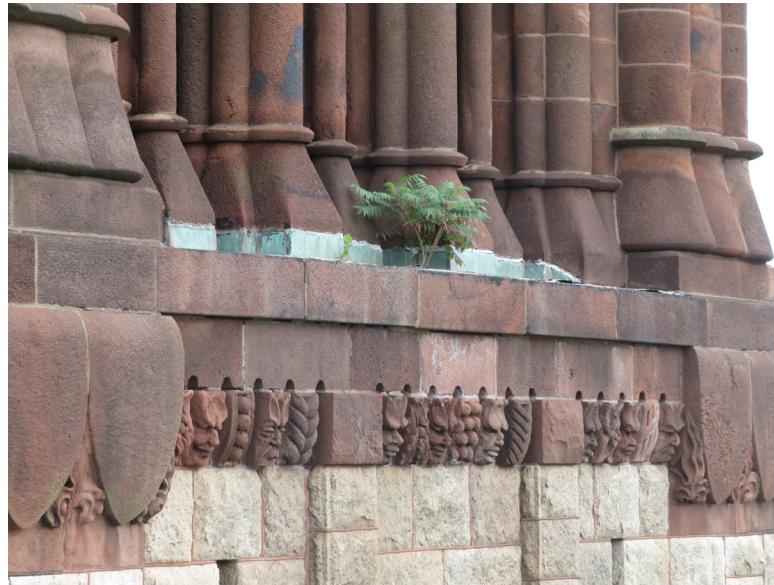
WEST ELEVATION

Where sheet metal roofing stops short of the edge of the stone, a tree is growing on the west elevation of the tower.

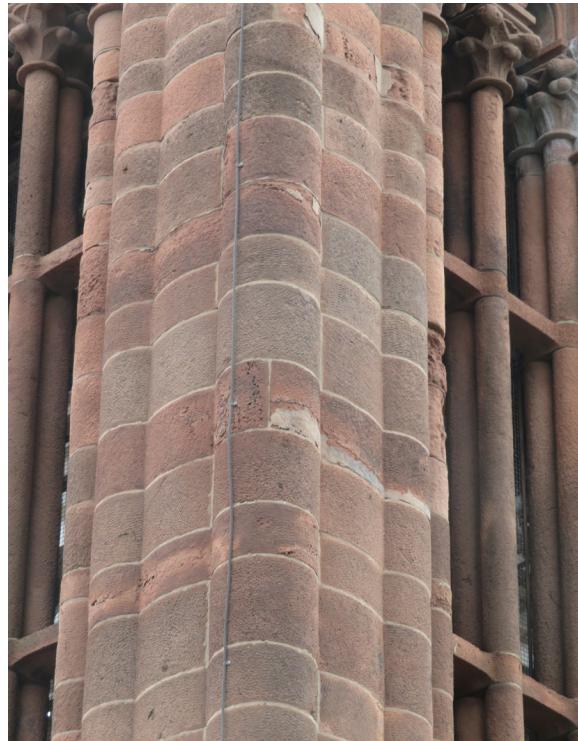
NORTH ELEVATION

Patches and deterioration at the brownstone at the northwest corner of the tower.
JGWA, 2019.

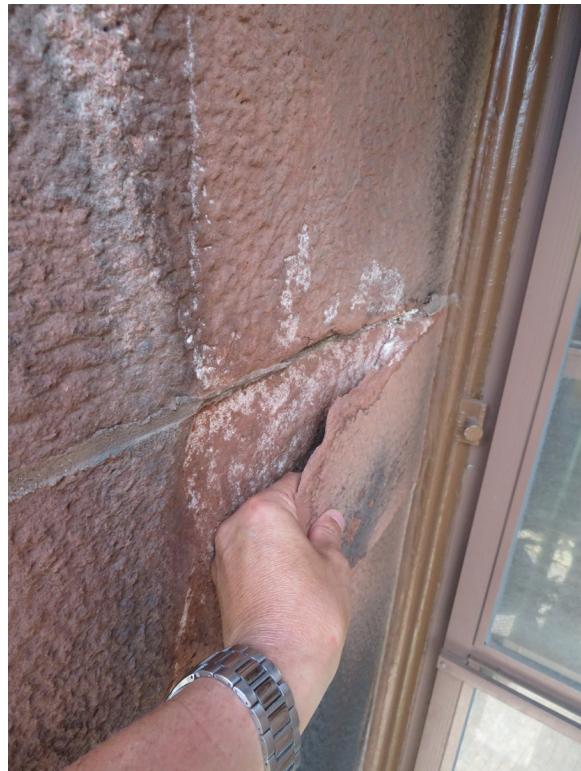
SOUTH ELEVATION

Spalled stone at south-facing window jamb. The loose piece was removed for safety. JGWA, 2019.

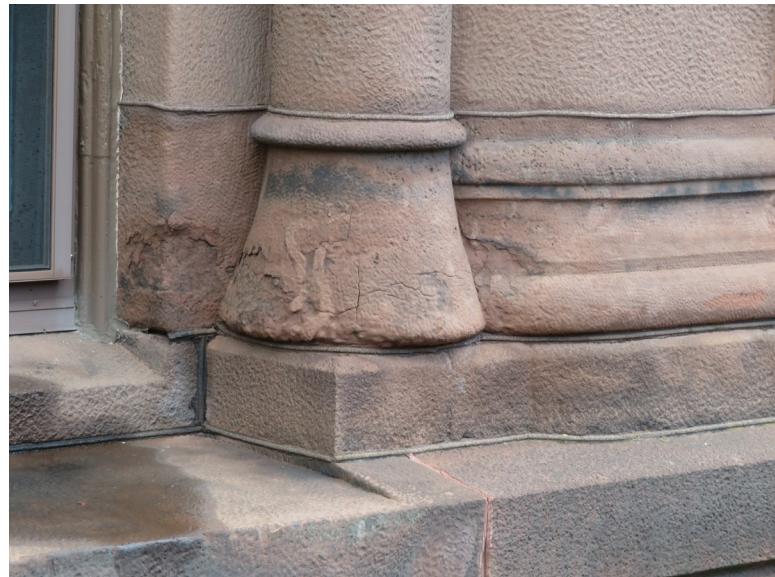
SOUTH ELEVATION

Pitting and deterioration of the decorative brownstone adjacent to a windowsill. The standing water on the left side of the image is from a window air conditioning unit. JGWA, 2019.

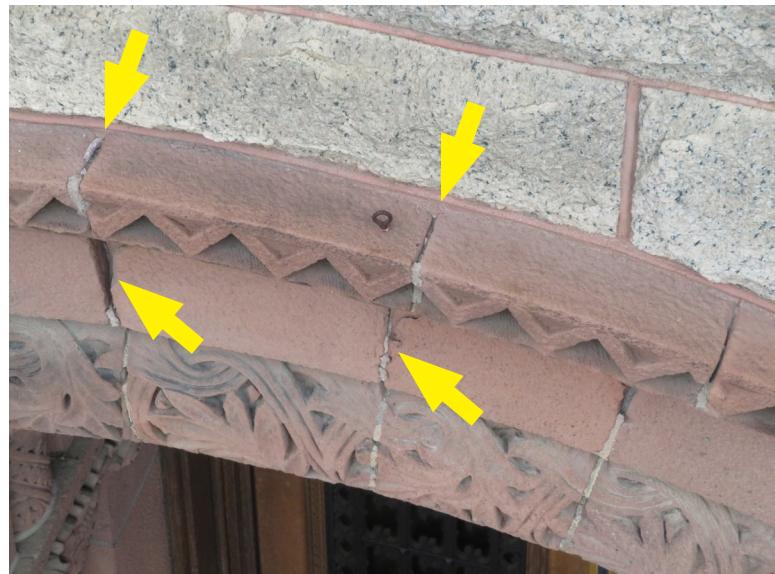
WEST ELEVATION

Deterioration of a stone in the arch above the west entrance caused by open mortar joints above. The rusting metal anchor could cause spalling of the stone if left in place. JGWA, 2019.

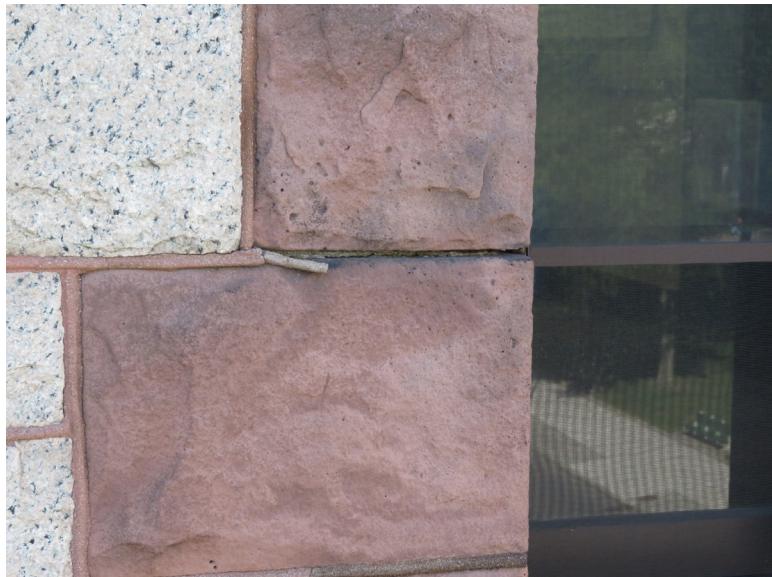
WEST ELEVATION

Mortar failure at mildly deteriorated brownstone. JGWA, 2019.

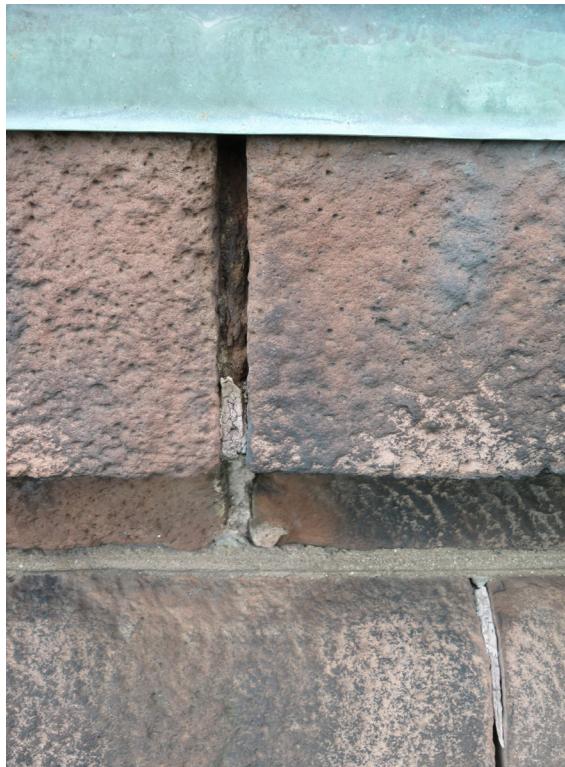
WEST ELEVATION

Sealant and mortar failure adjacent to a gutter. JGWA, 2019.

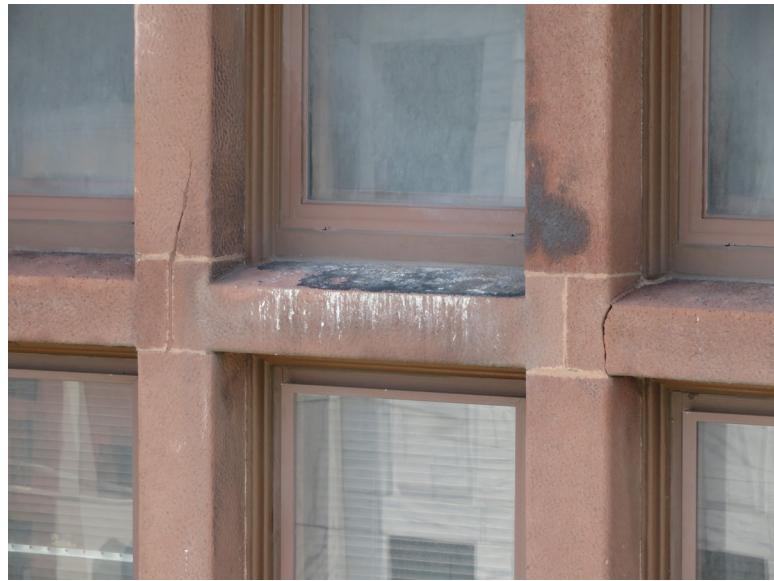
NORTH ELEVATION

Vertical cracks at mullion and transom on north face of building. The crack to the left of this image was caused by an embedded anchor. The crack at right was caused by movement. JGWA, 2019.

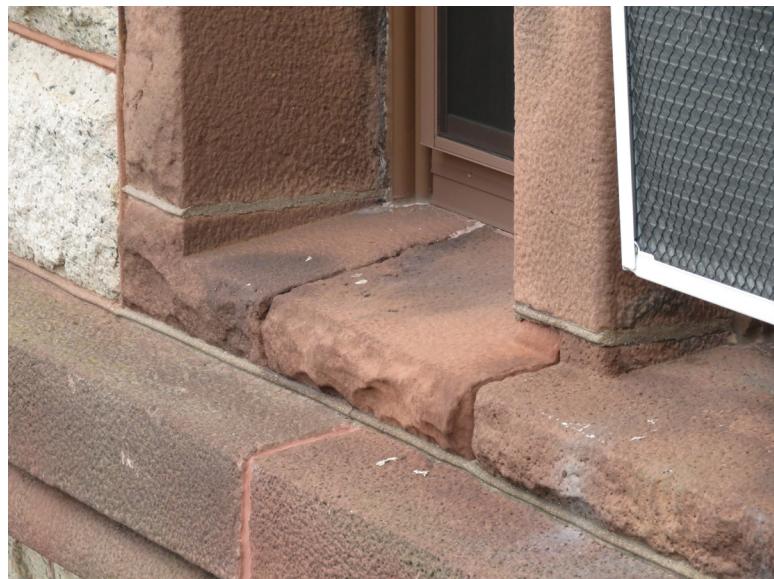
NORTH ELEVATION

A wide crack through a north-facing windowsill is a source of water ingress. The open mortar joint on the right also allows water to enter the wall. JGWA, 2019.

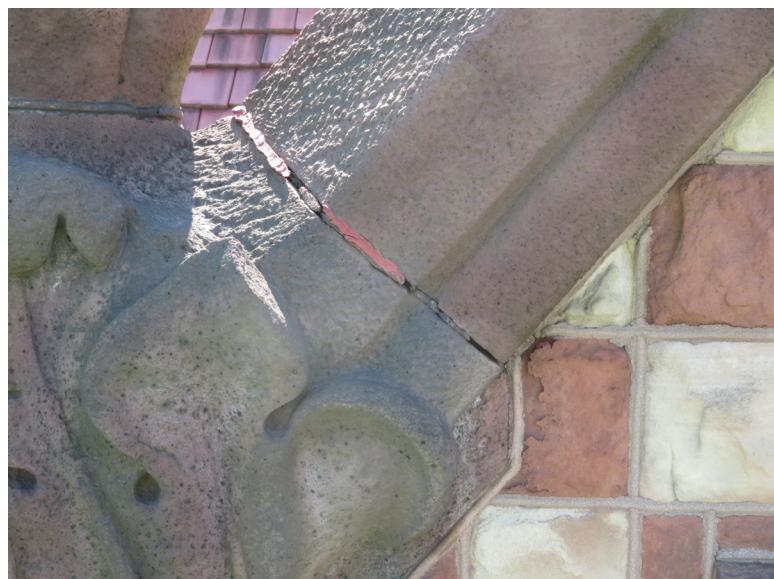
WEST ELEVATION

Open mortar joint and deteriorated stone at the base of the west-facing gable. JGWA, 2019.

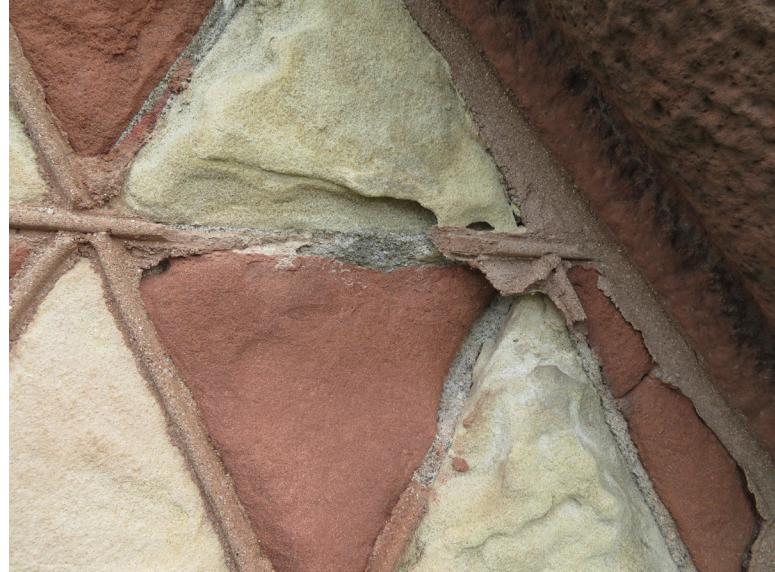
WEST ELEVATION

Detail of the stone at the west gable, eroding away from hard 1970s-era mortar.
JGWA, 2019.

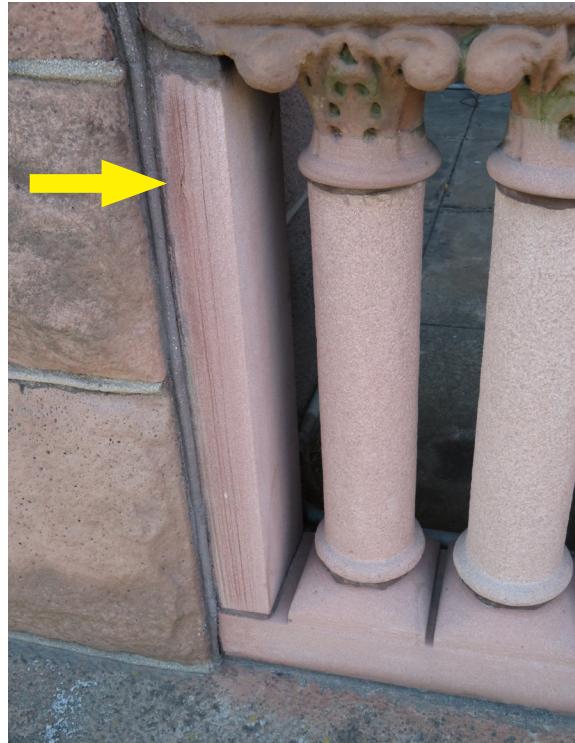
WEST ELEVATION

Deterioration along the bedding plane of new stone at loggia balustrade. JGWA, 2019.

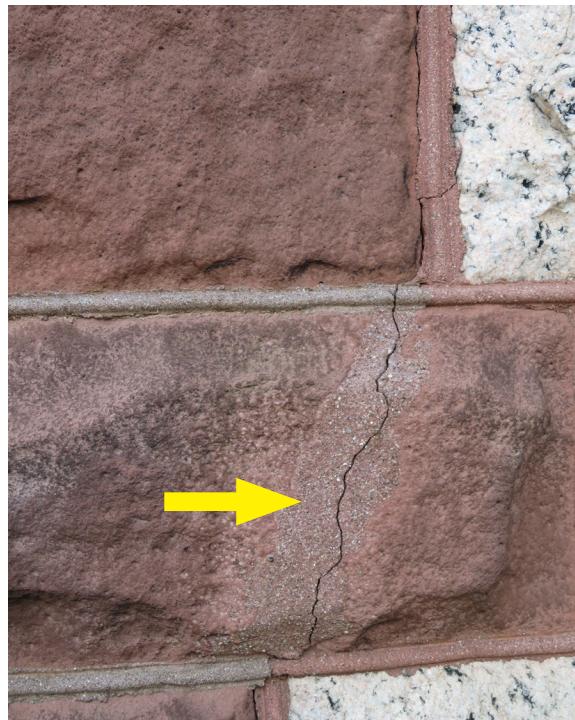
EAST ELEVATION

A new crack through an area of repaired brownstone from the 1970s. JGWA, 2019.

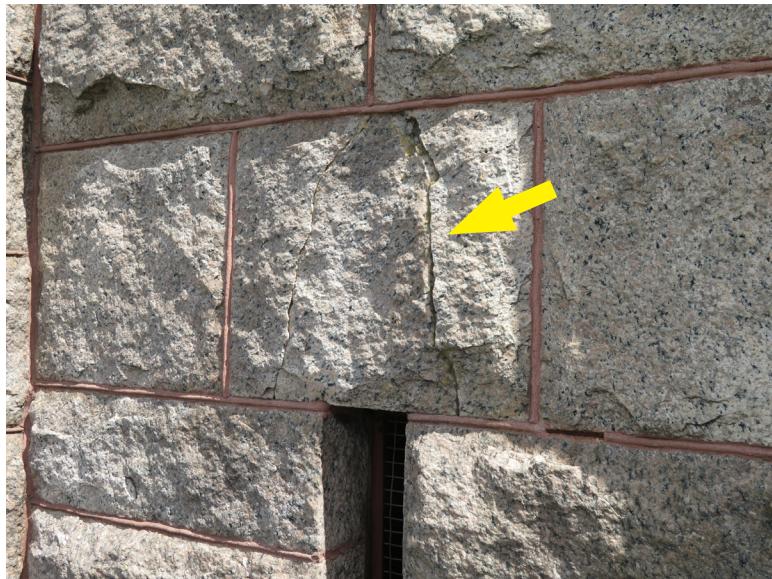
SOUTH ELEVATION

Two cracks, and epoxy repairs, at a granite lintel of a south-facing tower window. JGWA, 2019.

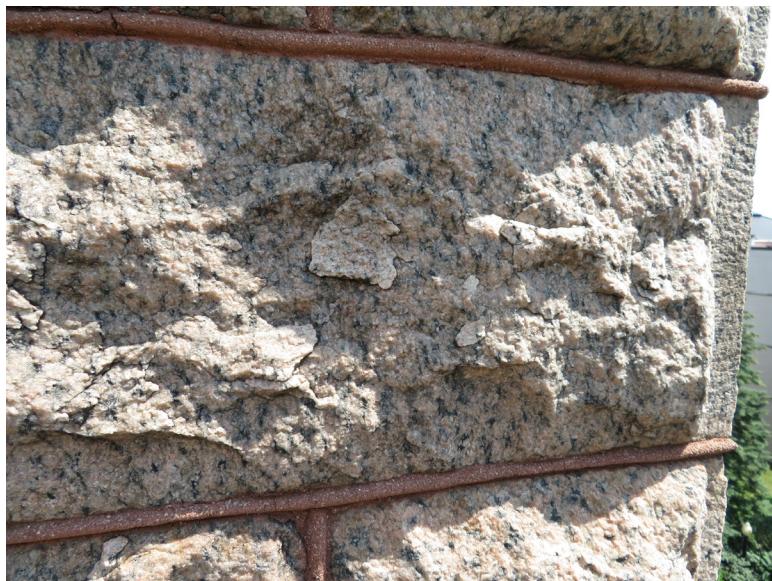
SOUTH ELEVATION

Minor spalling of small areas of the irregular face of the granite. JGWA, 2019.

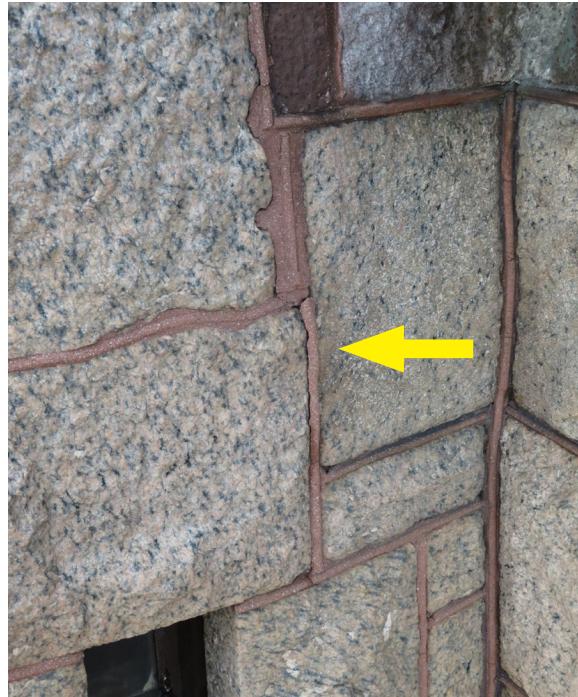
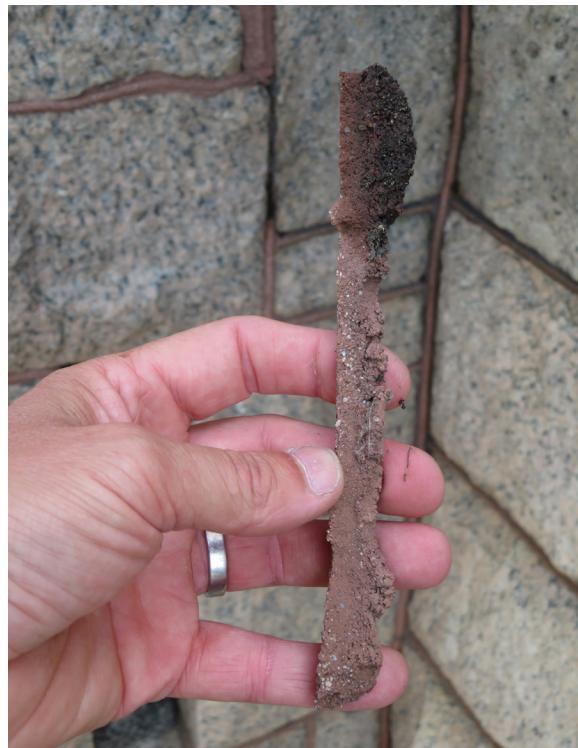
SOUTH ELEVATION

Loose mortar lifted out of position by water and freeze/thaw cycling. The mortar could be removed by hand. The joint was insufficiently prepared. JGWA, 2019.
