ALBANY CITY HALL MASTER PLAN

100% DRAFT: AUGUST 2020

John G. Waite Associates, Architects PLLC
384 Broadway, Albany NY 12207
64 Fulton Street, Suite 402, New York, NY 10038

EXTERIOR CONDITIONS ASSESSMENT

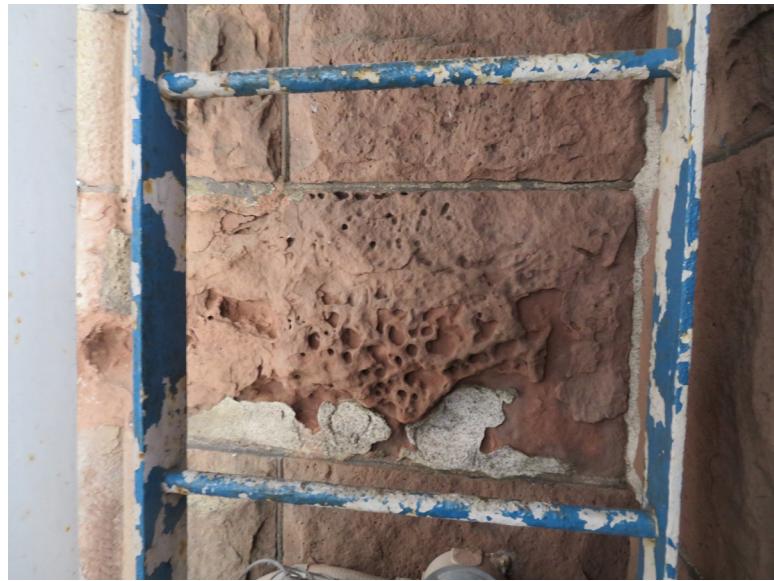
Pitted stone within the bell level of the main tower. The adjacent repairs have not improved the condition. JGWA, 2020.

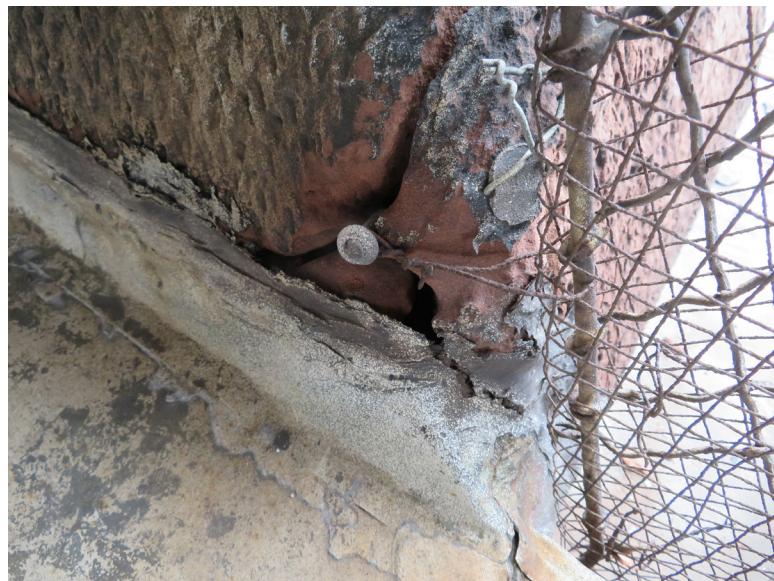
Spalled stone caused by a ferrous metal anchor at the inside of the bell level. JGWA, 2020.

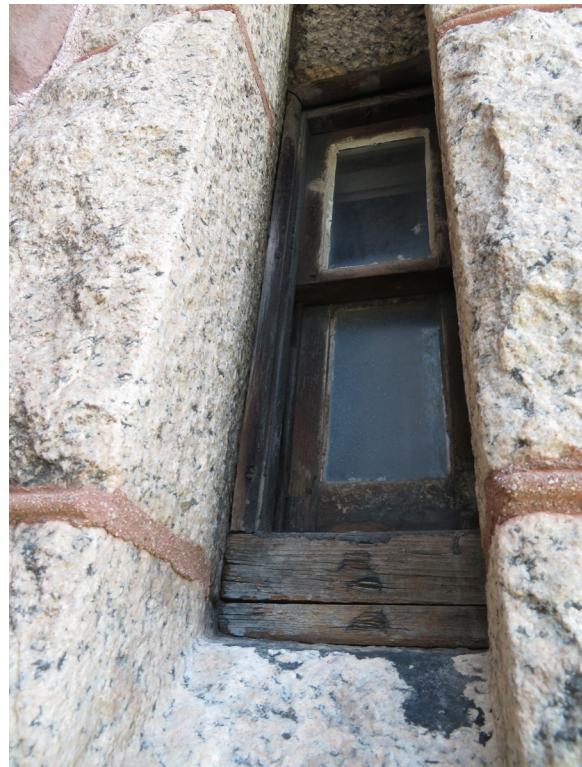
SOUTH ELEVATION

One of approximately ninety unrestored deep-set windows at the main tower. JGWA, 2019

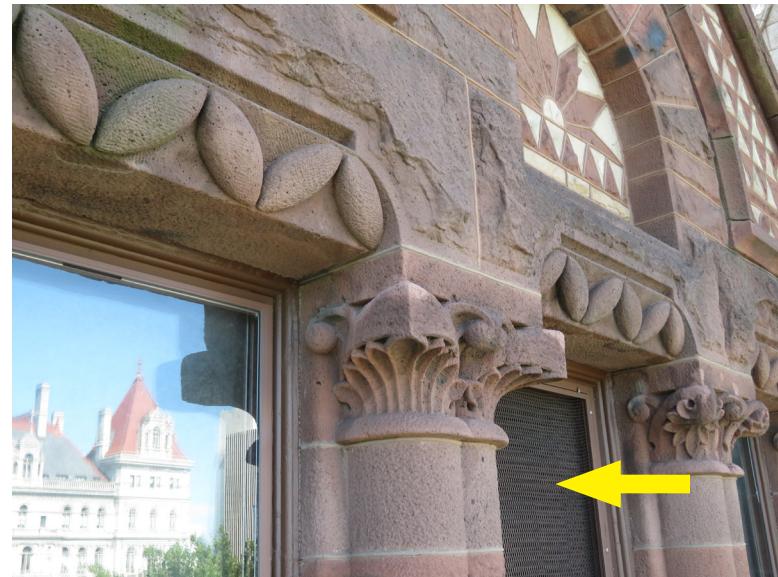
WEST ELEVATION

The intake grille at the center of the west gable. JGWA, 2019.

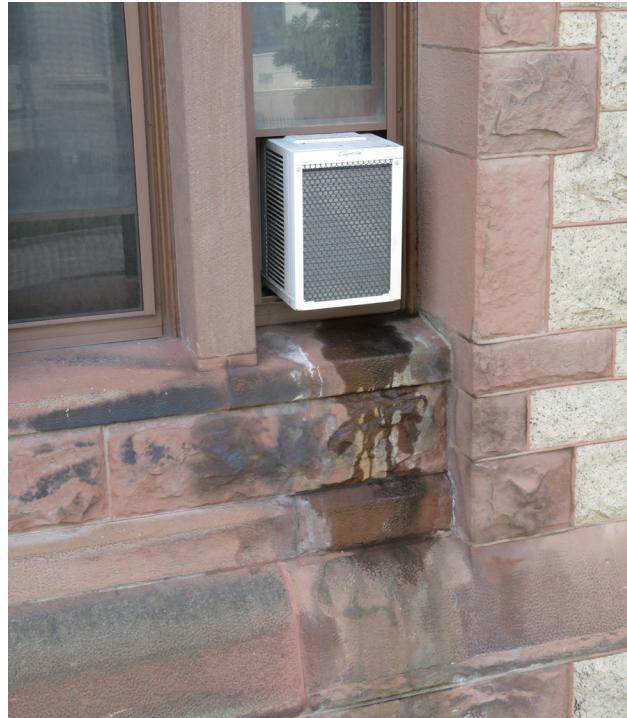
NORTH ELEVATION

Window air conditioner and condensate runoff with long-term staining adjacent. JGWA, 2019.

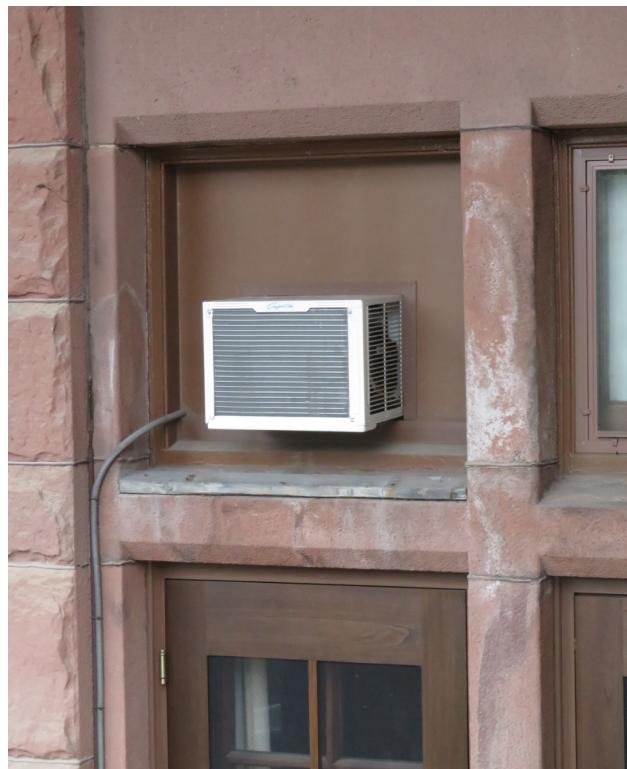
WEST ELEVATION

Wood panel and air conditioner over transom window at the loggia. The white haze is efflorescence caused by moisture from the air conditioner. JGWA, 2019.

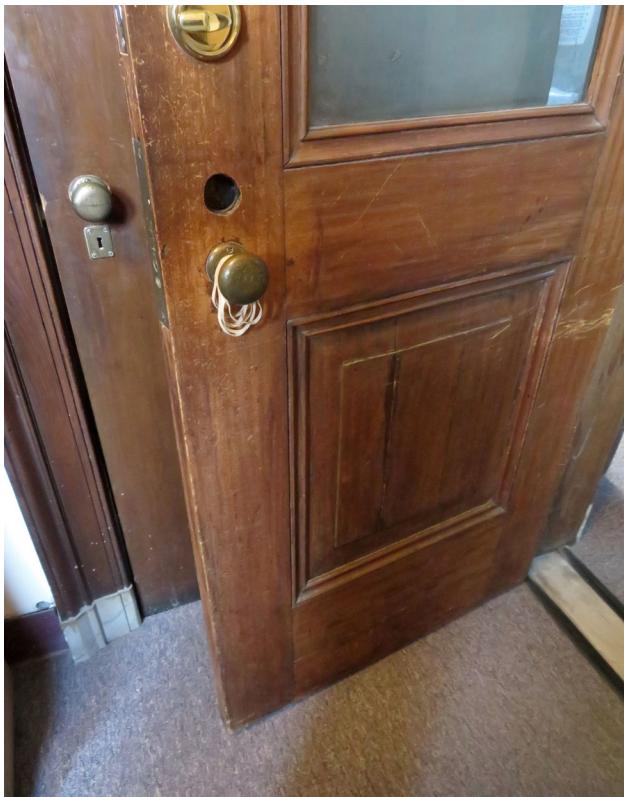
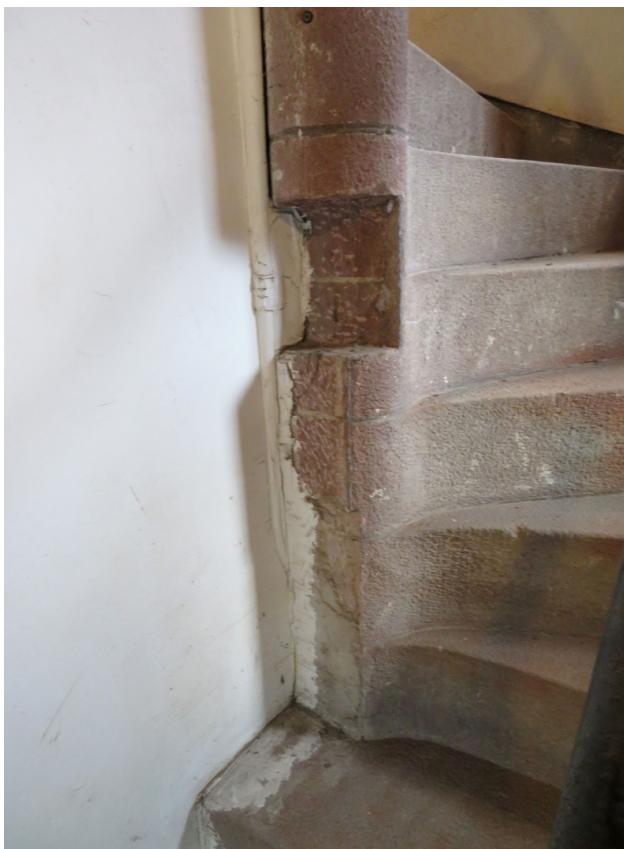
(Upper Left) Typical interior door with cracked lower panel and worn finish, and missing and unmatched hardware.
JGWA, 2020.

(Left) East spiral stair. Large piece of stone missing from newel. JGWA, 2020.

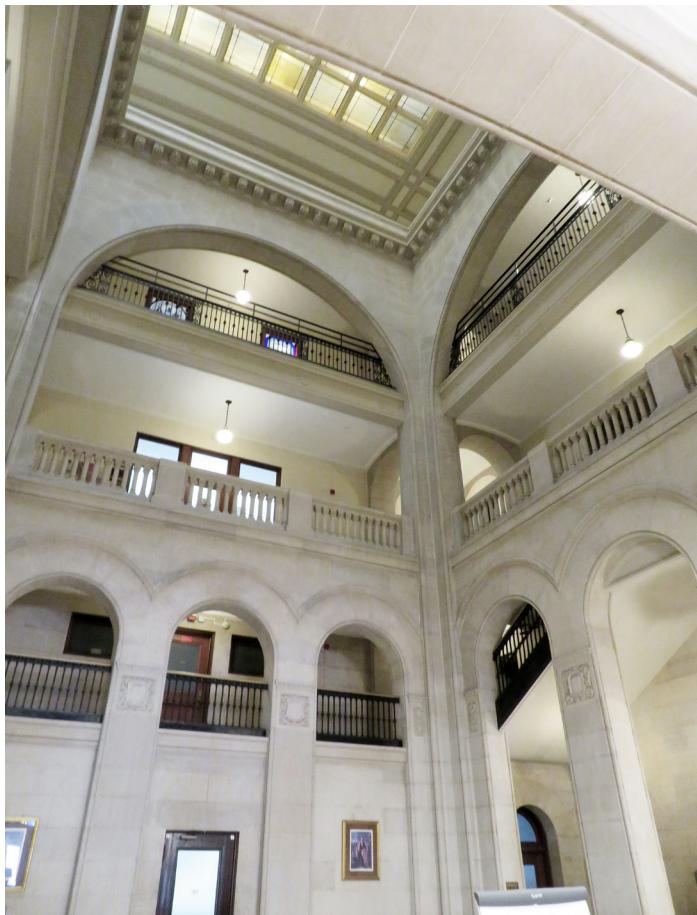
(Left) Room 114
(Atrium). JGWA, 2019.

(Below) Room 114
(Atrium). Haphazard
installation of devices
and fixtures in a highly
visible area. JGWA,
2020.

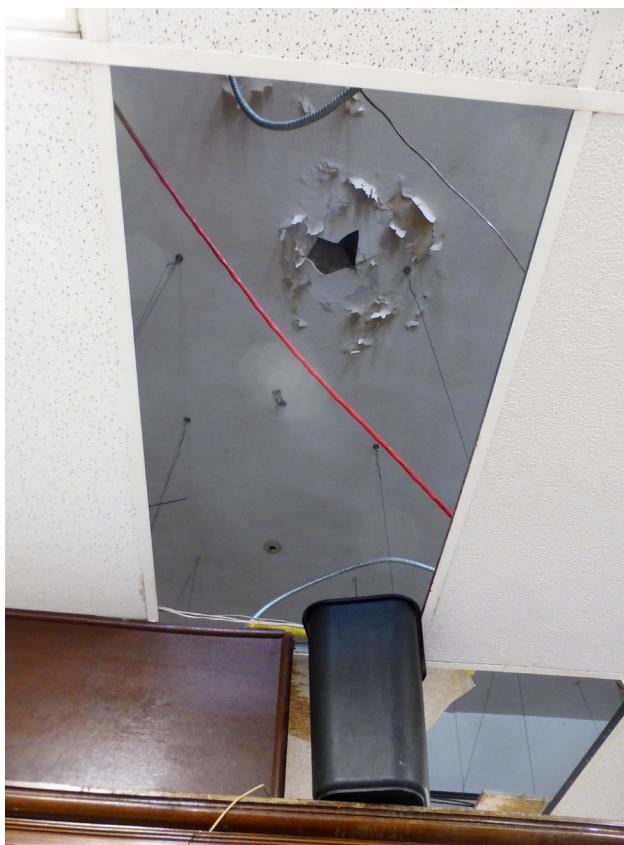
(Upper Left) Room 404
(Southwest Attic). Roof leak
has caused deterioration of
wood sheathing and gypsum
block decking as well as to the
occupied space below. JGWA,
2020.

(Left) Room 303B (Office).
Trash can placed to catch roof
leak. Plaster ceiling exposed
above modern dropped ceiling.
JGWA, 2020.

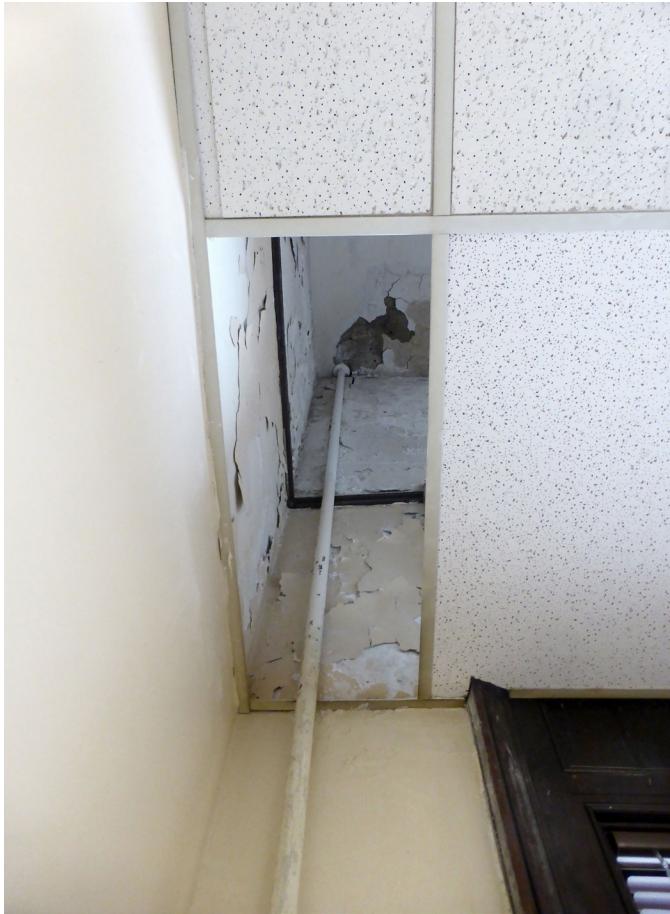
(Left) Room 302
(Assessor's Office). Lay-in ceiling tile conceals water damage above.
JGWA, 2020.

(Below) Room 407
(Lobby). Water damage from leaking skylight above. The historic skylight is completely obscured from view.
JGWA, 2020.
